ENGINEERING BOREHOLE LOG

PROJECT Bruce Highway Upgrade (Cooroy to Curra) Section C 471057.4 E; 7096066.2 N LOCATION **COORDINATES** Cut 12 SURFACE R.L. _ 77.30m PLUNGE _ _ _ _ DATE STARTED _18/08/11_ GRID DATUM MGA94_ PROJECT No FG5799 _ _ _ _ BEARING _ _ _ _ _ 232/10A/2 ___ HEIGHT DATUM _AHD __ DATE COMPLETED _18/08/11_ DRILLER Cairns Drilling Contract JOB No INTACT DEFECT R.L. RQD ADDITIONAL DATA BORING (m) ()% STRENGTH SPACING (mm)

CORE PHOTO LOG - BH C49

Project Name:	BRUCE HIGHWAY UPGRADE - SECTION C					
Project No.:	FG5799	Date:	08/09/2011			
Details:	Cut 12	Start Depth (m):	3.25			
Reference No.:	H11136	Finish Depth (m):	13.90

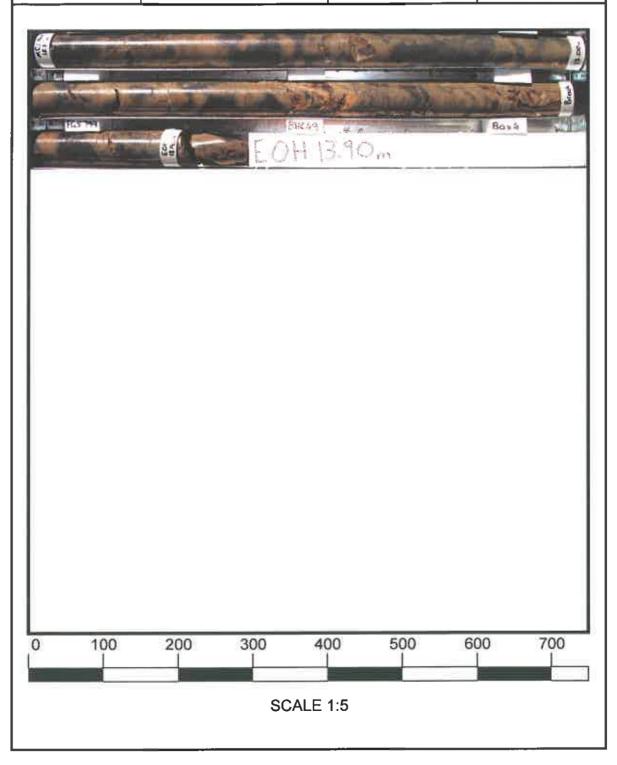
CORE PHOTO LOG - BH C49

Project Name:	BRUCE HIGHWAY UPGRADE - SECTION C					
Project No.:	FG5799	Date:	08/09/2011			
Details:	Cut 12	Start Depth (m):	3.25			
Reference No.:	H11136	Finish Depth (m):	13.90
