ENGINEERING BOREHOLE LOG

BOREHOLE No	<u>BH6</u>
SHEET	<u>1</u> of <u>6</u>
REFERENCE No	<u>H12013</u>

PROJECT	DJECT Mt Whitestone: Slope Instability Investigation - Preliminary Inclinometer Boreholes									
LOCATION	At te	nsion fea	at <u>ure</u>	<u>s</u>				COC	ORDINATES <u>416286.3 E; 6937684.7</u>	7 N
PROJECT N	lo <u>FG6</u>	128		SURFACE R.L263.63m PLUNGE			DATE STARTED _2	<u>5/11/</u>	1 <u>4</u> GRID DATUM <u>MGA94</u>	
JOB No				HEIGHT DATUM <u>AHD</u> BEARING			DATE COMPLETED 2	<u>8/11/</u>	14_ DRILLER Hinterland _	
R.L. (m) HEADO 0 263.6	AUGER CASING WASH BORING CORE DRILLING	RQD ()%	SAMPLE	MATERIAL DESCRIPTION	LITHOLOGY	USC	INTACT DEFECT STRENGTH SPACING (AS1726) (AS1726) □□□□□□□□□□□□□□□□□□□□□□□□□□□□□□□□□□	GRAPHIC LOG	ADDITIONAL DATA AND TEST RESULTS	SAMPLES TESTS
				Sandy CLAY with Cobbles and Boulders (COLLUVIUM) Orange brown, moist. Generally comprises a hard Sandy Clay of intermediate plasticity which contains a mix of high strength cobbles and boulders.		(CI)			Rock roller used to advance through high strength material.

CORE PHOTO LOG

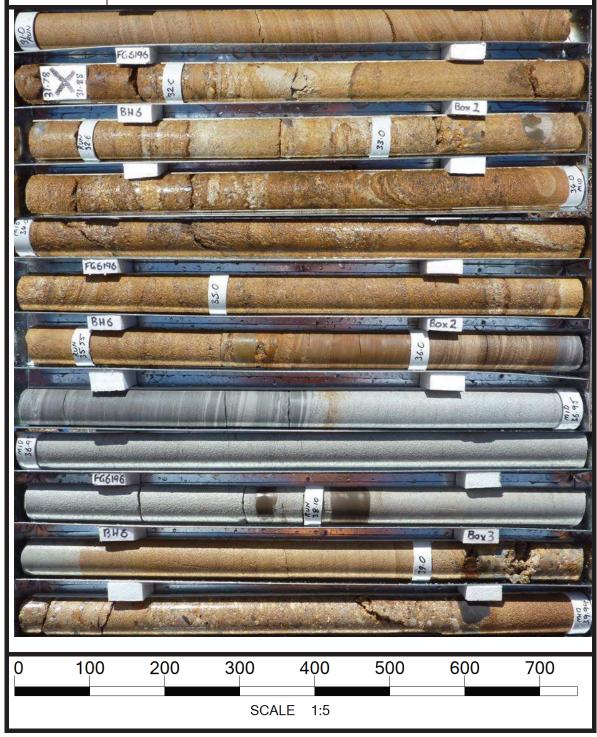
Page 1 GEOT043/2

/
Project Name	Mt Whitestone (Detailed Investigation)		
Project No.	FG6196	Start Date	25/11/14
Borehole No.	BH 6	Finish Date	28/11/14
Location		Start Depth (m)	31.0
Detail	Gatton Clifton Rd -313	Finish Depth (m)	50.20
Chainage	15.04-15.40km	Submitted By	TH
Remarks

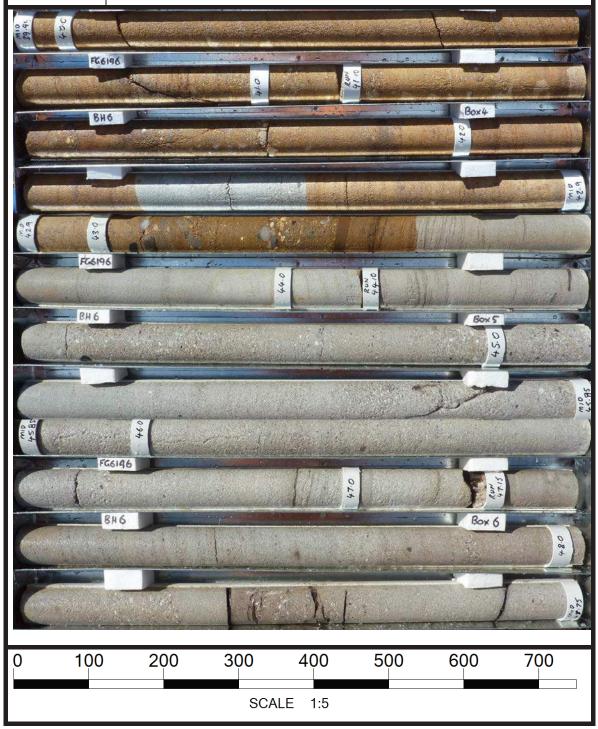
Page 2 GEOT043/2

Project Name	Mt Whitestone (Detailed Investigation)		
Project No.	FG6196	Start Date	25/11/14
Borehole No.	BH 6	Finish Date	28/11/14
Location		Start Depth (m)	31.0
Detail	Gatton Clifton Rd -313	Finish Depth (m)	50.20
Chainage	15.04-15.40km	Submitted By	TH
Remarks

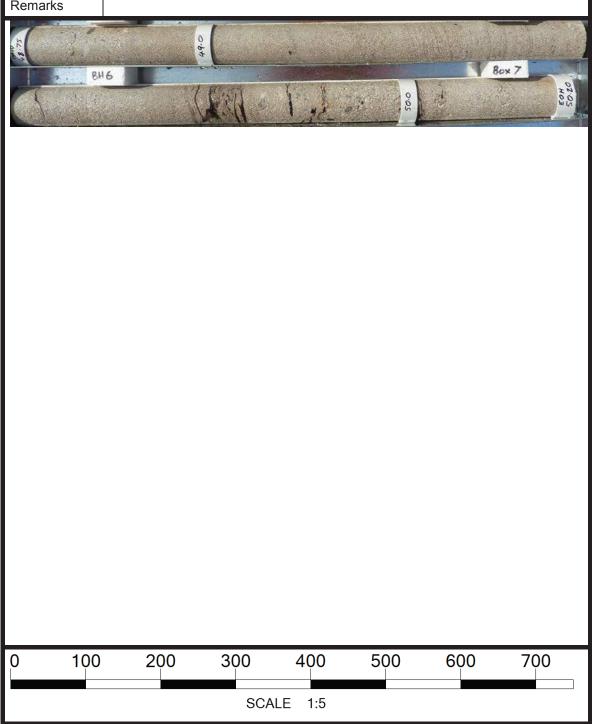
Page 3 GEOT043/2

Project Name	Mt Whitestone (Detailed Investigation)			
Project No.	FG6196	Start Date	25/11/14	
Borehole No.	BH 6	Finish Date	28/11/14	
Location		Start Depth (m)	31.0	
Detail	Gatton Clifton Rd -313	Finish Depth (m)	50.20	
Chainage	15.04-15.40km	Submitted By	TH	
Remarks				
O CONTRACTOR OF THE PARTY OF TH
