# REPORT OF BOREHOLE: CRR 207

PROJECT: Cross River Rail

LOCATION: Riverbank Park

JOB NO: 107632034

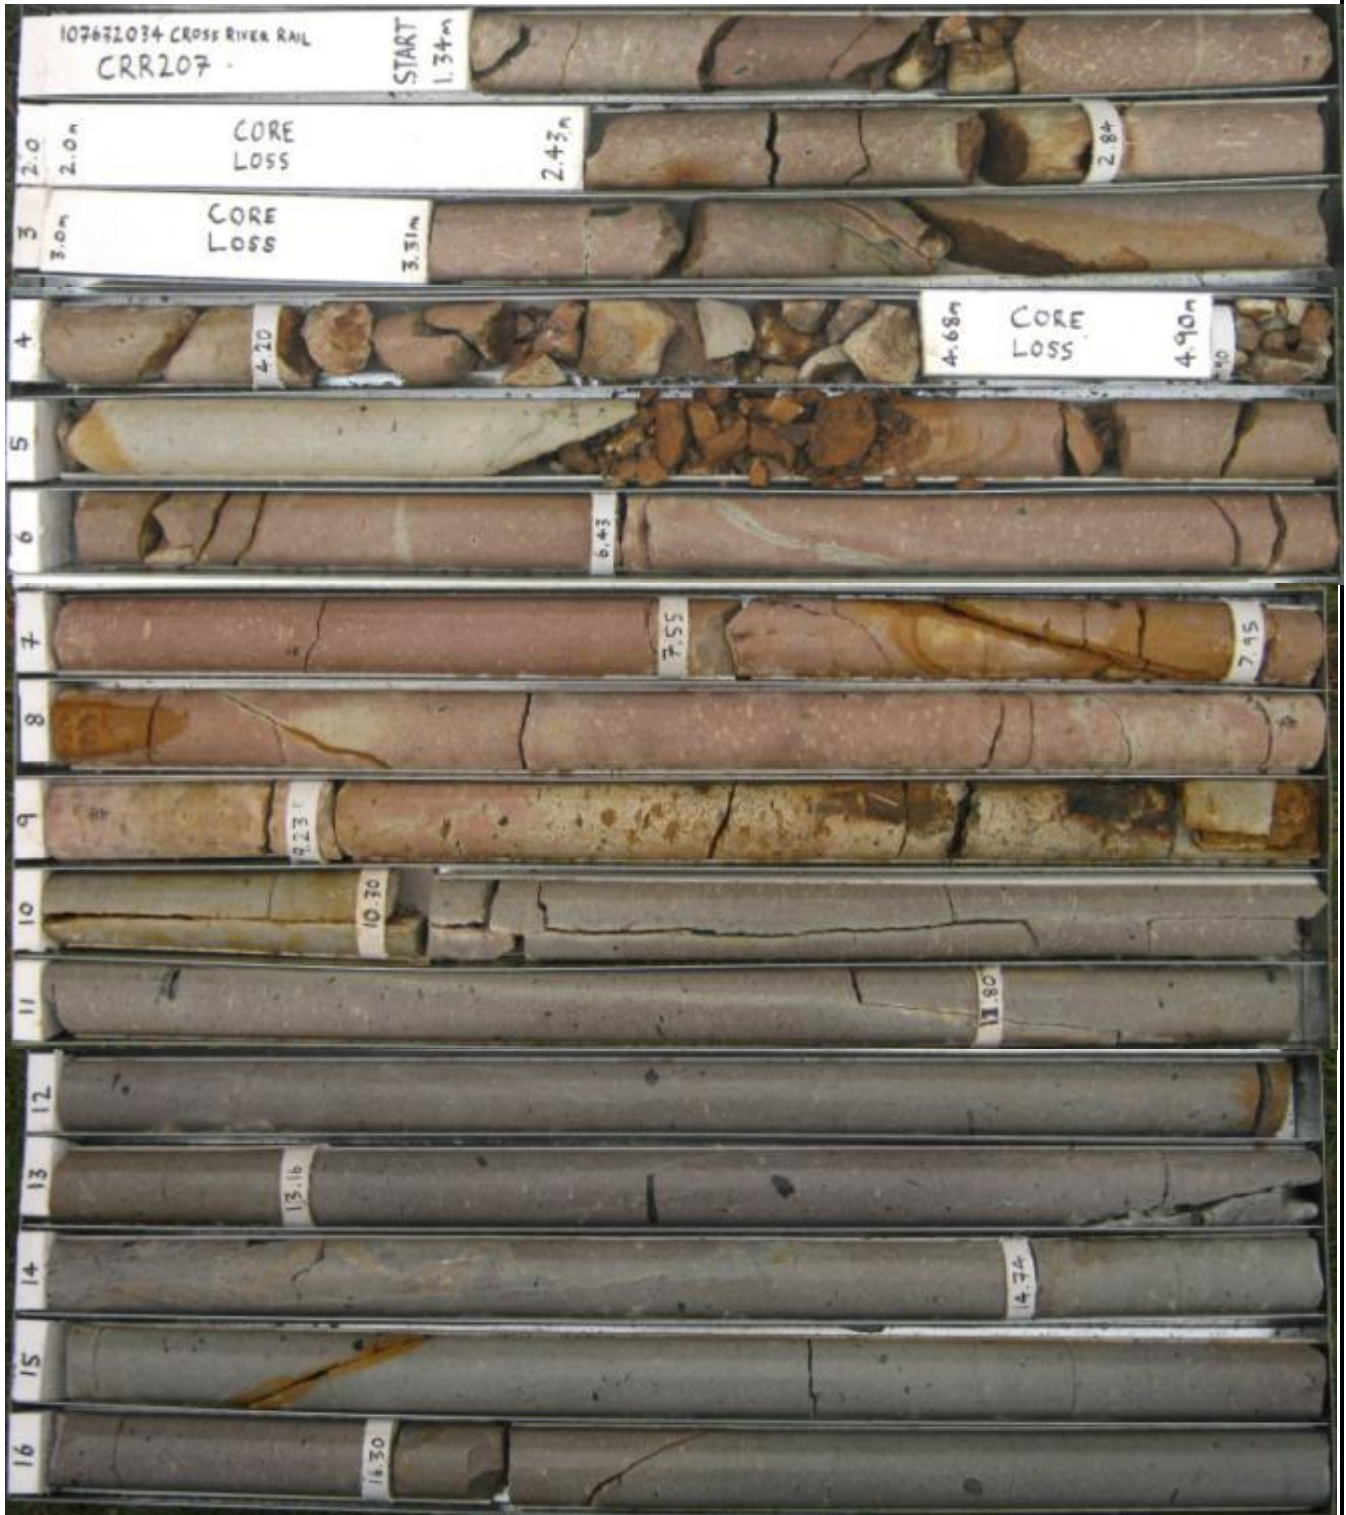
## REPORT OF CORE PHOTOGRAPHS: CRR 207

DEPTH RANGE: 1.34-17.0 m  
DRILL RIG: FD500  
DRILLER: Foundril Pty Ltd  
LOGGED: CA DATE: 20/08/10  
CHECKED: NK DATE: 4/10/10

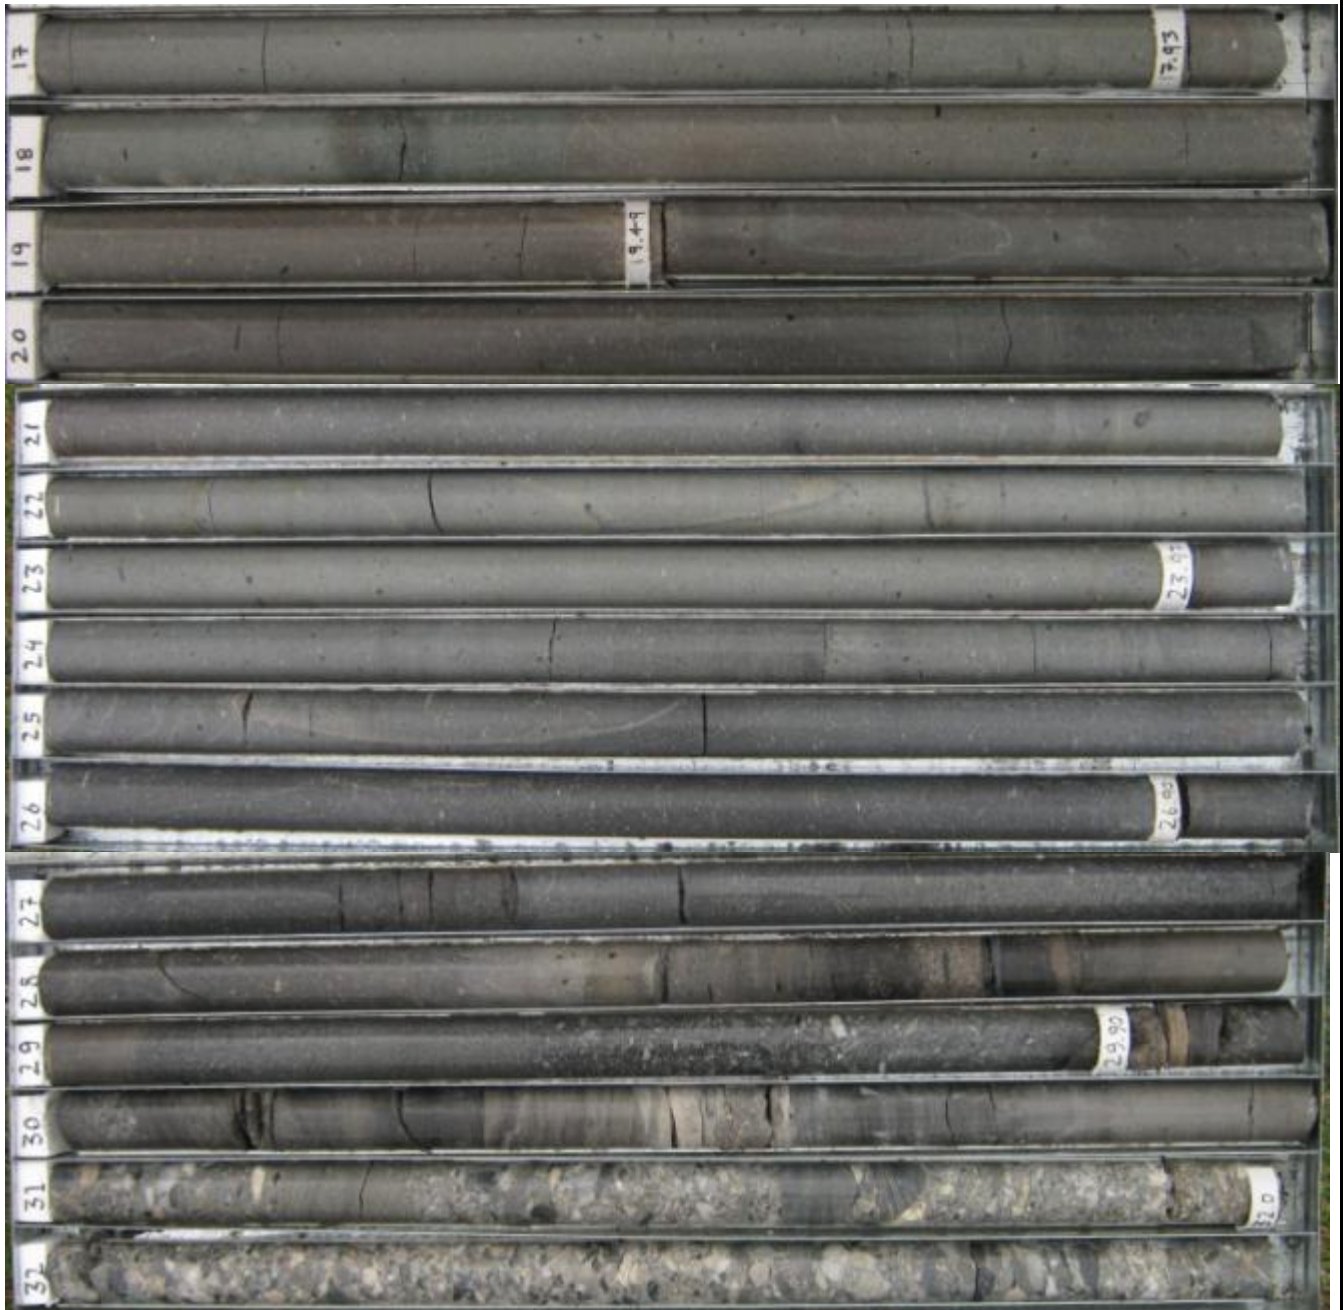
## REPORT OF CORE PHOTOGRAPHS: CRR 207

DEPTH RANGE: 17.0-32.0 m  
DRILL RIG: FD500  
DRILLER: Foundril Pty Ltd  
LOGGED: CA DATE: 20/08/10  
CHECKED: NK DATE: 4/10/10

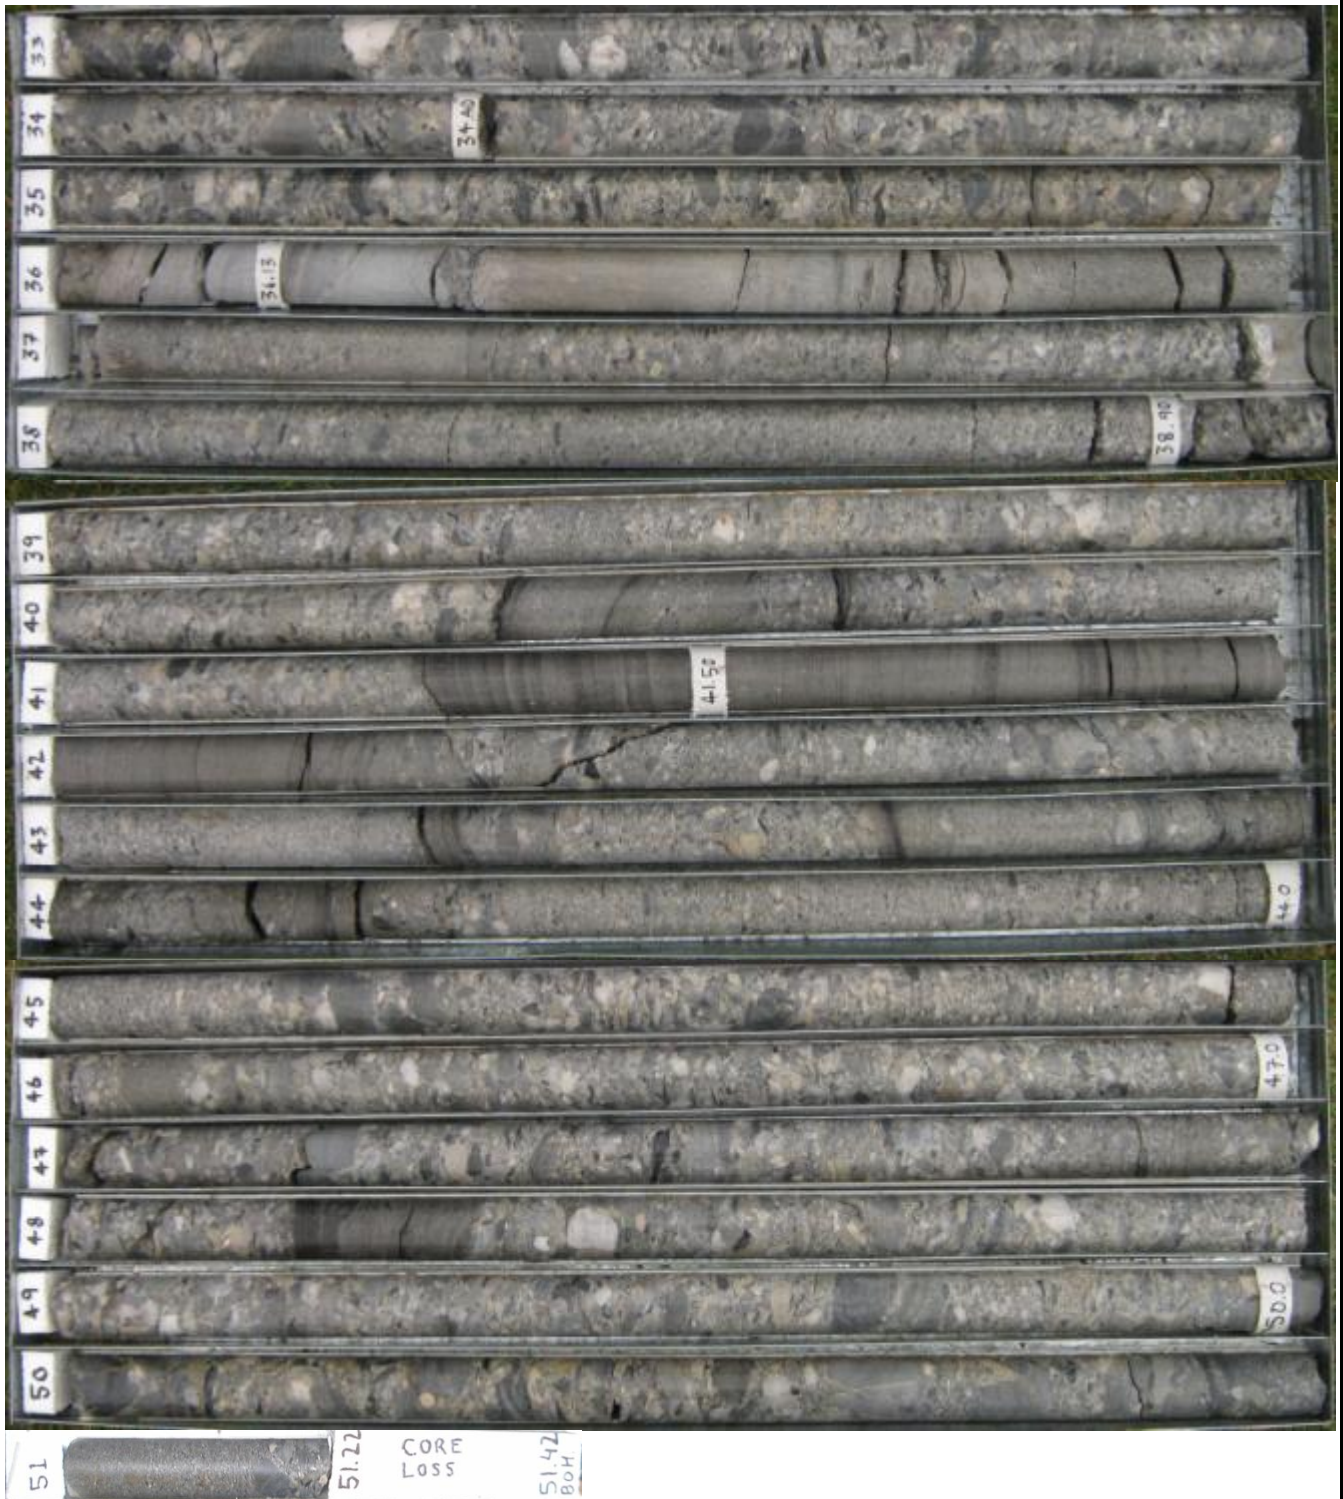
## REPORT OF CORE PHOTOGRAPHS: CRR 207

DEPTH RANGE: 32.0-51.42 m  
DRILL RIG: FD500  
DRILLER: Foundril Pty Ltd  
LOGGED: CA DATE: 20/08/10  
CHECKED: NK DATE: 4/10/10
