FREDERICK STREET OVERPASS FOUNDATION INVESTIGATION

REF. No. H 5855

DATE 8.4.87 JOB No. 140/U18B/104 PROJECT No. 1-563 SURFACE R.L. 15.00

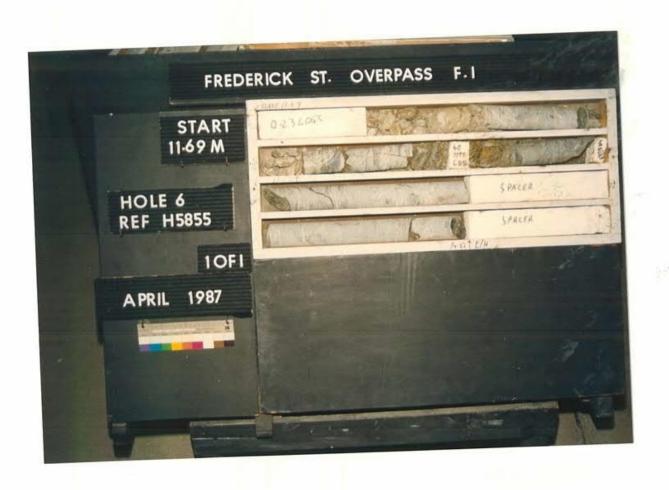
PROJECT No. DATE JOB No. SURFACE R.L. 1:50 STRATA DESCRIPTION R.Q.D. ENGINEERING PROPERTIES E () % INTACT DEFECT DEPTH STRUCTURE R.L SOIL TYPE CORE STRENGTH SPACING LITHOLOGY OR WEATHERING REC. % 5.0 Clayey SAND G27 3.5 30 H 90 HIGHLY WEATHERED Brown, clay throughout. 3.0 MODERATELY WEATHERED Highly siliceous through 70 out, quartz veining common and contorted: foliation obscure. Defects Thinly bedded dip at low angle but closed defects at medium grained, rock. to high angles also visible. Clayey coating on open defect planes. 0.95 97 END OF HOLE 9
