ENGINEERING BOREHOLE LOG

BOREHOLE No
 ____BH12 ___

REFERENCE No
 ____H11022___

Project Name	Moreton Bay Rail Link (MBRL)	50	
Project No	FG5 921	Date	11/05/11
Borehole No	BH 1 2	TMR H No	11022
Location		Start Depth (m)	2.5
Detail	Cut	Finish Depth (m)	16.22
Chainage	Approx	Submitted By	BW
Remarks

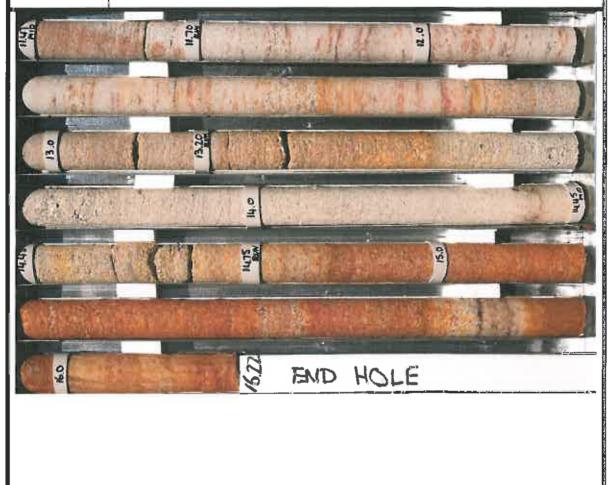
CORE PHOTO LOG DEPARTMENT OF TRANSPORT & MAIN ROADS

Project Name	Moreton Bay Rail Link (MBRL)		
Project No	FG5921	Date	11/05/11
Borehole No	BH 12	TMR H No	11022
Location		Start Depth (m)	2.50
Detail	Cut	Finish Depth (m)	16.22
Chainage	Approx	Submitted By	BW
Remarks			·
