BOREHOLE No BH119
SHEET 1 of 4
REFERENCE No H10894

PROJECT WALKERSTON BYPASS PROJECT GEOTECHNICAL INVESTIGATION - COWLEYS ROAD OVERPASS BRIDGE
LOCATION PIER 1 - (Ch. 84514.9 on control line) COORDINATES 721508.2 E; 7654820.8 N
PROJECT No FG5635 SURFACE R.L. 9.10m PLUNGE DATE STARTED 2/11/10 GRID DATUM MGA 94
JOB No 242/33B/6 HEIGHT DATUM AHD BEARING DATE COMPLETED 2/11/10 DRILLER Drillsure Pty Ltd

Project: **Walkerston Bypass Geotechnical Investigation**
Borehole No: BH119 (Cowleys Rd Bridge Ch. 84514.9 on control line)
Start Depth: 27.00m
Finish Depth: 30.75 m
Project No: FG5635
H No: H10894

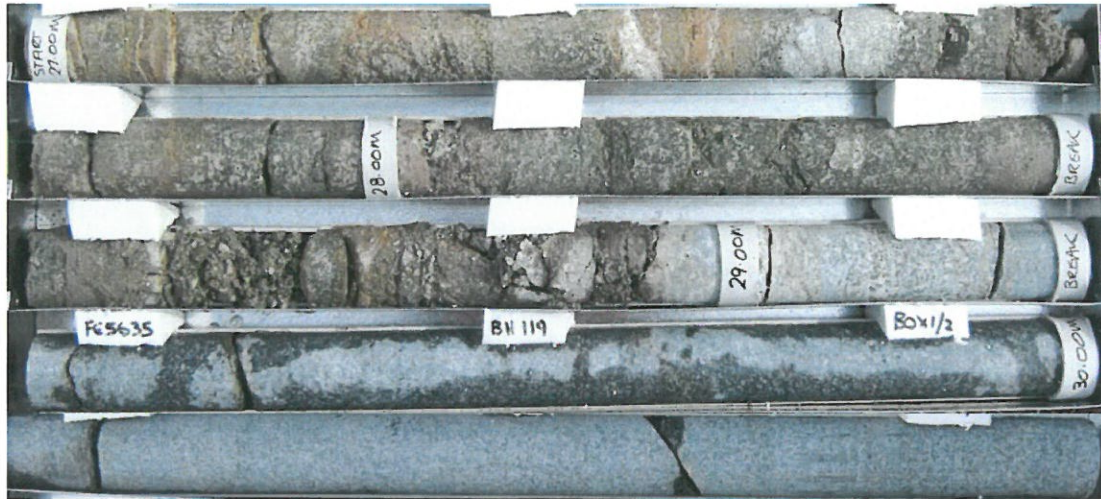
DEPTH (m)	R.L. (m)	AUGER LOG WASH BORING CORE DRILLING	RQD (%)	CORE REC %	SAMPLE	MATERIAL DESCRIPTION	LITHOLOGY	USC WEATHERING	INTACT STRENGTH	DEFECT SPACING (mm)	GRAPHIC LOG	ADDITIONAL DATA AND TEST RESULTS	SAMPLES TESTS
20	-10.90					Clayey Sandy SILT (RESIDUAL) (Cont'd)							
21					P			(MH)				10,14,18 N=32	SPT
22	-12.40				Q	GRANODIORITE Intrusive, medium to coarse grained, massive, crystalline, porphyritic, acidic, igneous rock HW: Generally exhibits the engineering properties of pale grey and orange, moist, hard, silty clay.						12,15,30 N=45	SPT
23					R							30,30/100mm N>50	SPT
24								HW					
25					S							30/60mm N>50	SPT
26													
27	-17.90					MW: Grey and brown, speckled pale grey, generally low to medium strength. Defects: - Joints @ 5-15° (10/m) Defect surfaces are generally planar, rough and open.							
28			100					MW				Is(50) = 0.03MPa; * Is(50) = 0.17MPa; * Is(50) = 0.55MPa Is(50) = 0.03MPa; *	o x o o

29	-19.85		100			SW: Grey to speckled pale grey, very high to extremely high strength.		HW				Is(50) = 0.16MPa; * CLy & gravel in parts	x
30			100					SW				Contact: boundary unclear Is(50) = 1.14MPa Is(50) = 0.18MPa; *	x o

DEPTH (m)	R.L. (m)	AUGER Casing Wash Boring Core Drilling	RQD (%)	CORE REC %	SAMPLE	MATERIAL DESCRIPTION	LITHOLOGY	USC	WEATHERING	INTACT STRENGTH	DEFECT SPACING (mm)	GRAPHIC LOG	ADDITIONAL DATA AND TEST RESULTS	SAMPLES	TESTS
30	-20.90					GRANODIORITE SW: (Cont'd) Defects: Generally rare. - Joints @ 5-35° (1/m)		SW					Is(50) = 14.74MPa Is(50) = 12.01MPa	x o	
31	-21.65		100			Defects are generally planar, rough, open to closed. Borehole terminated at 30.75m							Is(50) = 6.68MPa	x	
32															
33															
34															
35															
36															
37															
38															
39															
40
