d	M	2	, M	ai	n	Ro	ads	GEOTECHNICA EXCAVA					F	HOLE NO. : TP19
															SHEET : 1 OF 1
															JOB NO : C15733
CLI	EN	T :						STR				•			Co-ords: 4619.883 E 9017.254 N
PRC LOC					M	IL	E IN	TER	SECTION UPGRADE						RL: 498.558m
		EX	ĊA	VA	AT:	101	V		SUBSTANCE	_			TE	STS	ADDITIONAL OBSERVATIONS
D E P T H	METHOD	S U P P O R T	F A S T	M E D I U M	5 L 0 W	W A T E R	G L R O A G P H 1 C	U S C	DESCRIPTION Soil Type: grain size, plasticity, colour structure, minor components.	M O I S T	C D O E N N S S I I S T T Y	5 A P L 5	T Y P E	R E S U L T	Structure and Origin

Commenced : 24/8/2000	Logged by : J Kleindienst		
Weather : Fine, cold	Checked by :

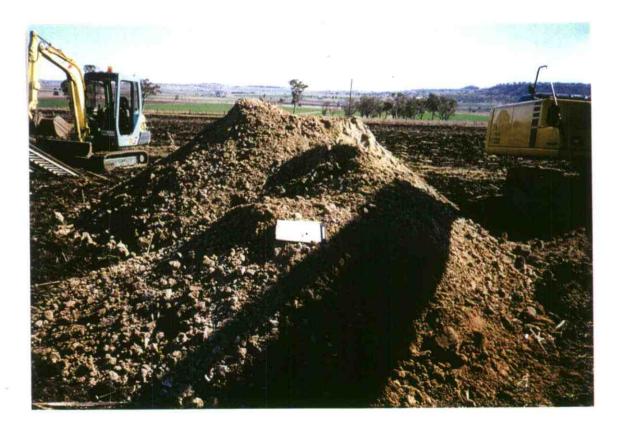
Plate 34: Excavated material from TP19

0.6	-			6. V. F.	-			xw	BASALT	M	Н				Lava flow
0.8	1								Grey to pink orange, moist, with the properties						0.3-1.4m: LL=52.0%,
1.0	1			UEN					of a hard high plasticity silty clay						PI=25.8%, LS=14.2%

1.2]			的行为,而且是					Contains white caliche nodules to 5cm.						
1.4			 			-	L		Easily crumbled in hand	-					
1.6	-							HW	Brown to grey, fine grained, with occasional vesicles, and weathered olivine crystals.						Lava flow
