## REPORT ON CONE PENETROMETER TEST

Client **Main Roads**  
 Project **Brisbane Port Road Stage 3**  
 Job Ref.  
 Location **Easting 46755.00 Northing 34249.800**  
 Chainage  
 Sounding **CPTU105**  
 Test Date **29/11/1999**  
 Remarks

Project No. **C60323**  
 Surface RL **3.775**  
 Water Table **2.500**  
 Start Depth **4.000**  
 Refusal **6.575**

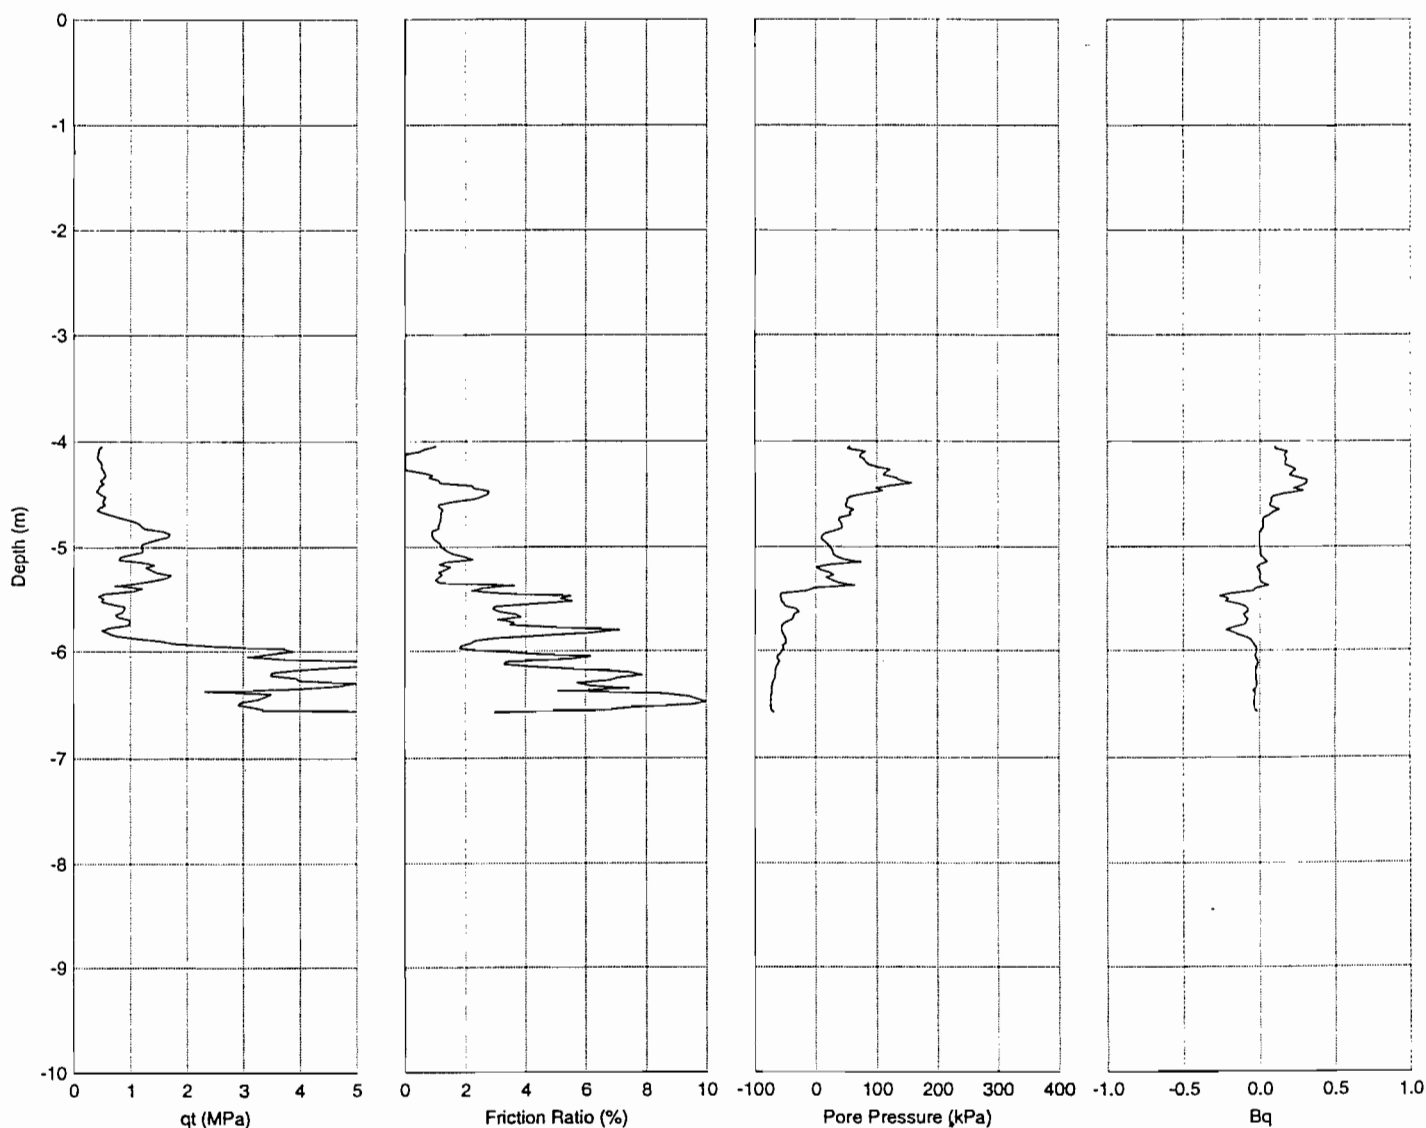
Date	8/12/1999	Cone Type	Piezococone
		Cone ID	3167
Checked

Factor "a"	0.580
		Factor "b"	0.014
Signatory
