# REPORT OF BOREHOLE: CRR 202

PROJECT: Cross River Rail

LOCATION: Mary St, East of Albert St

JOB NO: 107632034

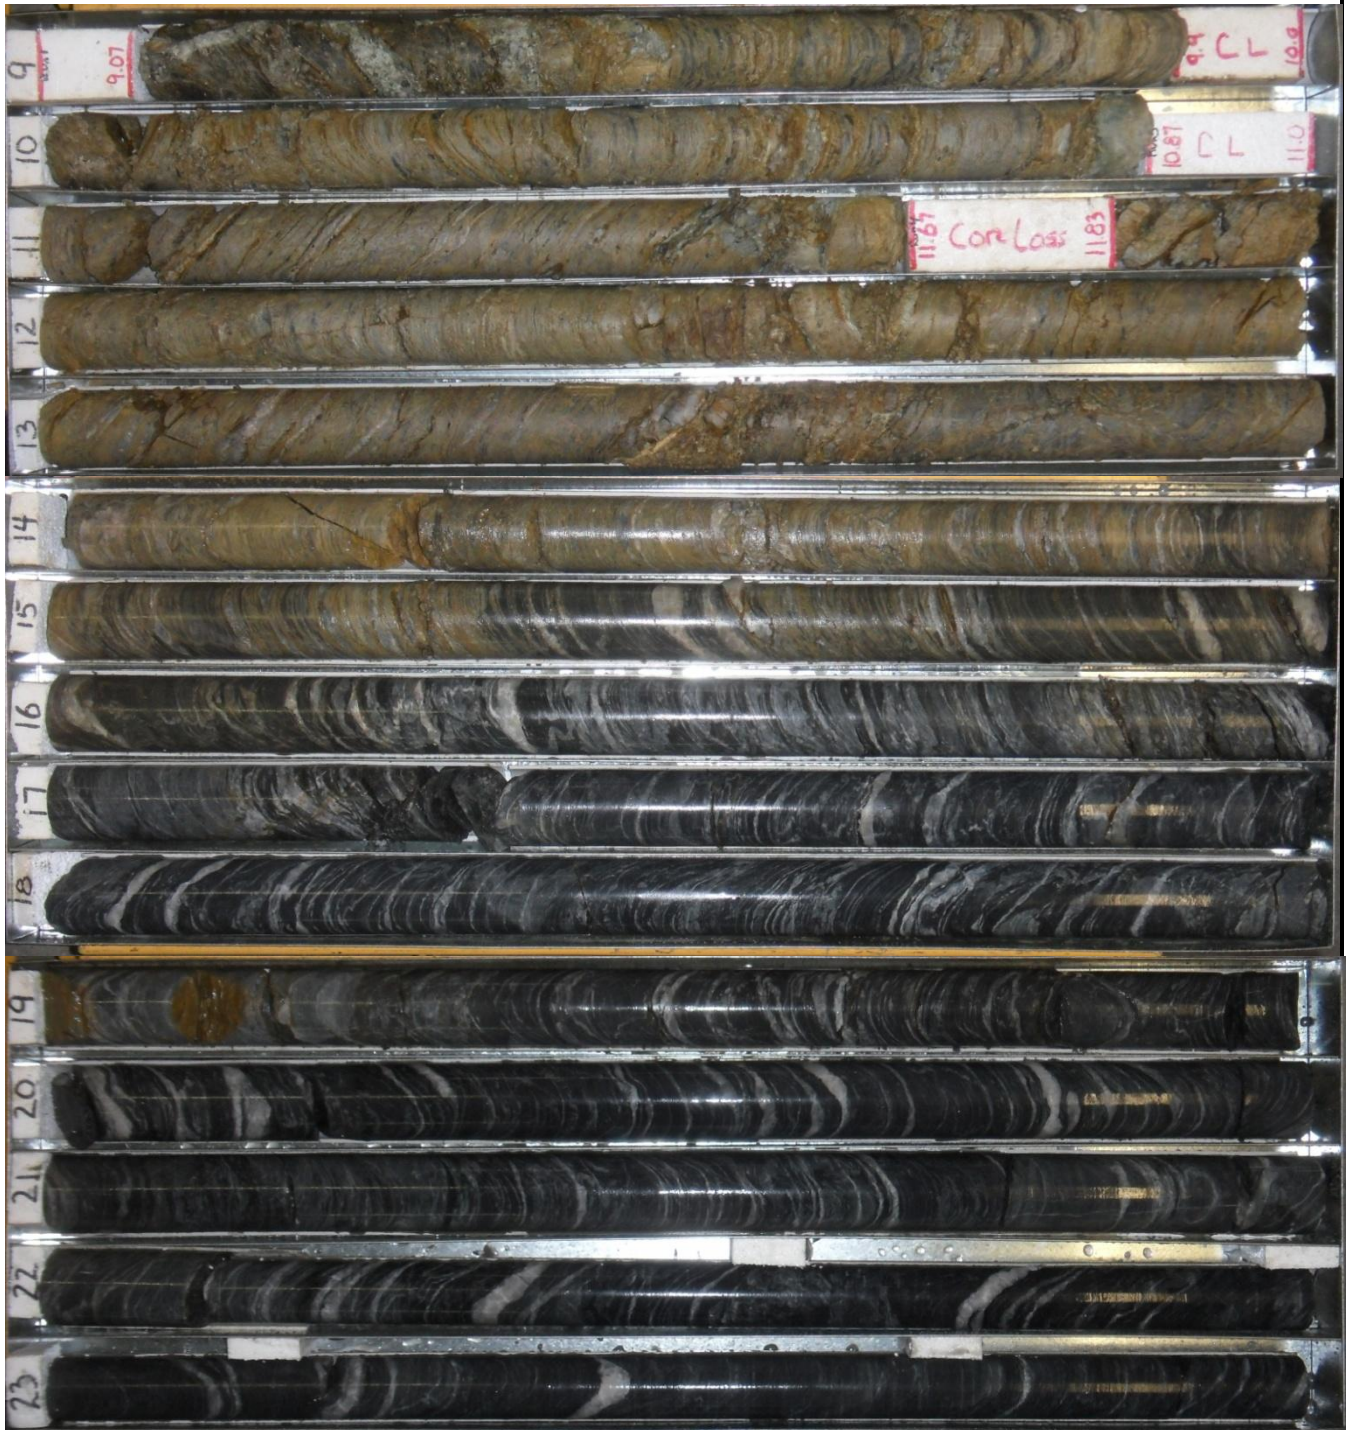
## REPORT OF CORE PHOTOGRAPHS: CRR 202

DEPTH RANGE: 9.0-24.0 m  
DRILL RIG: Fox B40  
DRILLER: Schneider Drilling Pty Ltd  
LOGGED: MGM DATE: 10/08/10  
CHECKED: NK DATE: 4/10/10

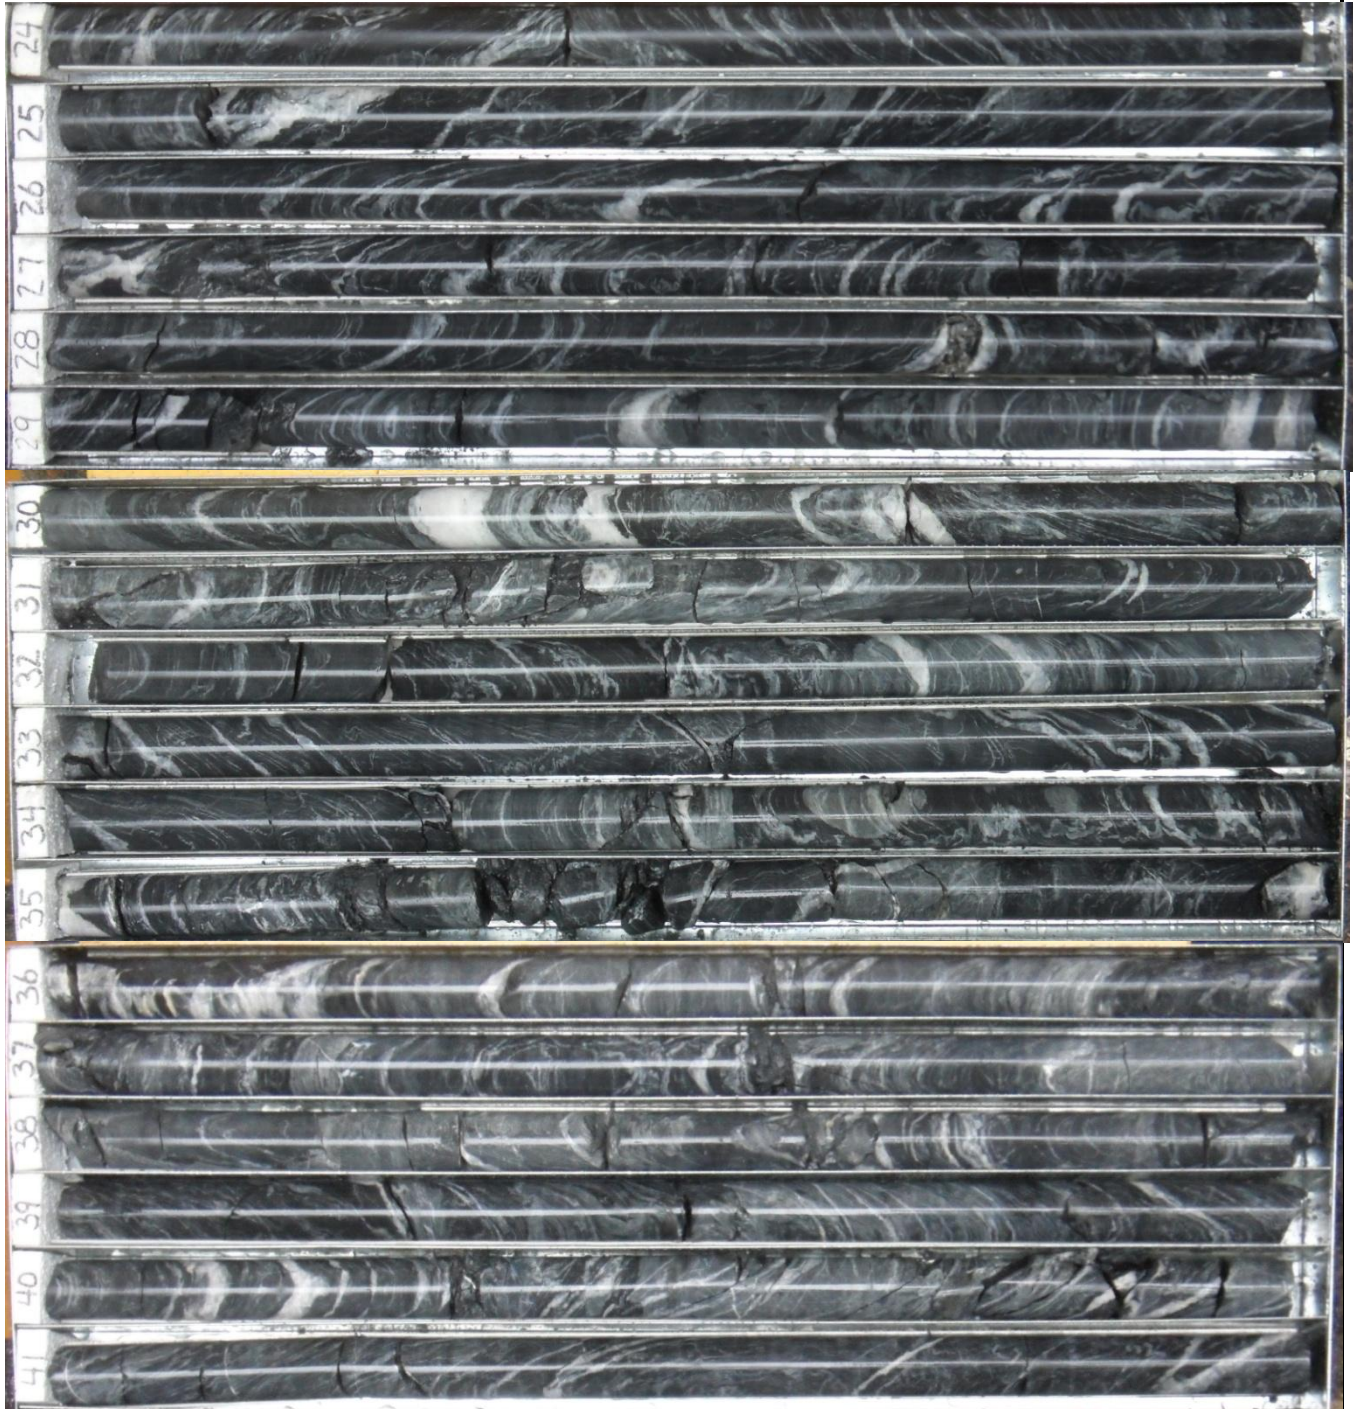
## REPORT OF CORE PHOTOGRAPHS: CRR 202

DEPTH RANGE: 24.0-42.0 m  
DRILL RIG: Fox B40  
DRILLER: Schneider Drilling Pty Ltd  
LOGGED: MGM DATE: 10/08/10  
CHECKED: NK DATE: 4/10/10

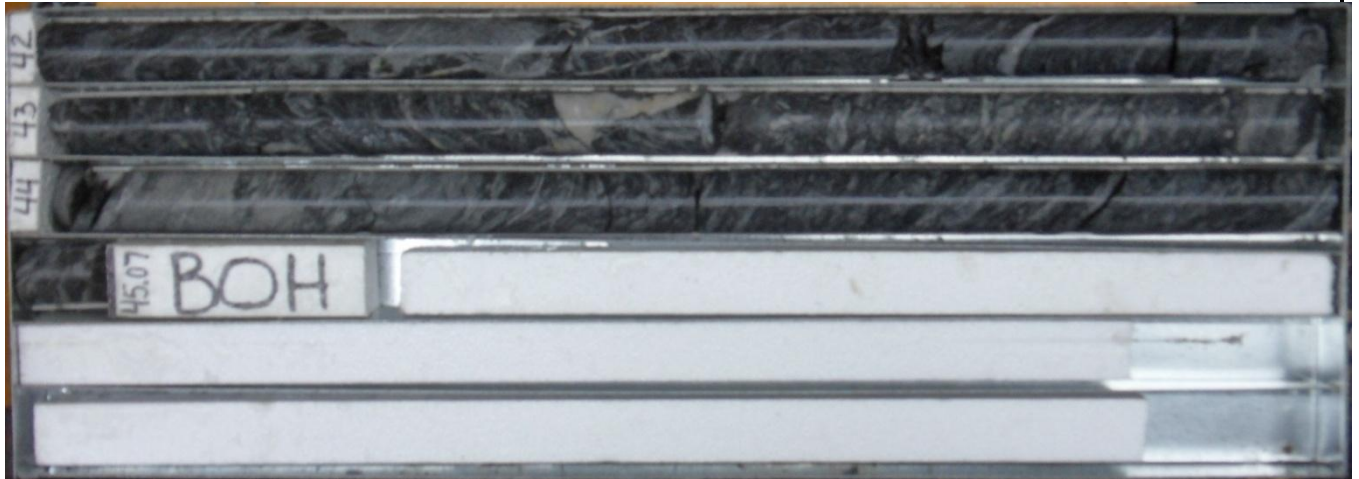
## REPORT OF CORE PHOTOGRAPHS: CRR 202

DEPTH RANGE: 42.0-45.07m  
DRILL RIG: Fox B40  
DRILLER: Schneider Drilling Pty Ltd  
LOGGED: MGM DATE: 10/08/10  
CHECKED: NK DATE: 4/10/10
