ENGINEERING BOREHOLE LOG

BOREHOLE No BH110
SHEET 1 of 3
REFERENCE No 12056

PROJECT Mackay Ring Road Geotechnical Investigation - Stage 1
LOCATION Stotts Road Overpass Abutment B; CH: 5080m; COORDINATES 720889.3 E; 7657440.9 N
PROJECT No FG6184 SURFACE R.L. 12.24m PLUNGE _____ DATE STARTED 19/9/14 GRID DATUM GDA 94 /MGA Zone 55
JOB No _____ HEIGHT DATUM AHD BEARING _____ DATE COMPLETED 20/9/14 DRILLER Saxon Drilling

CORE PHOTO LOG

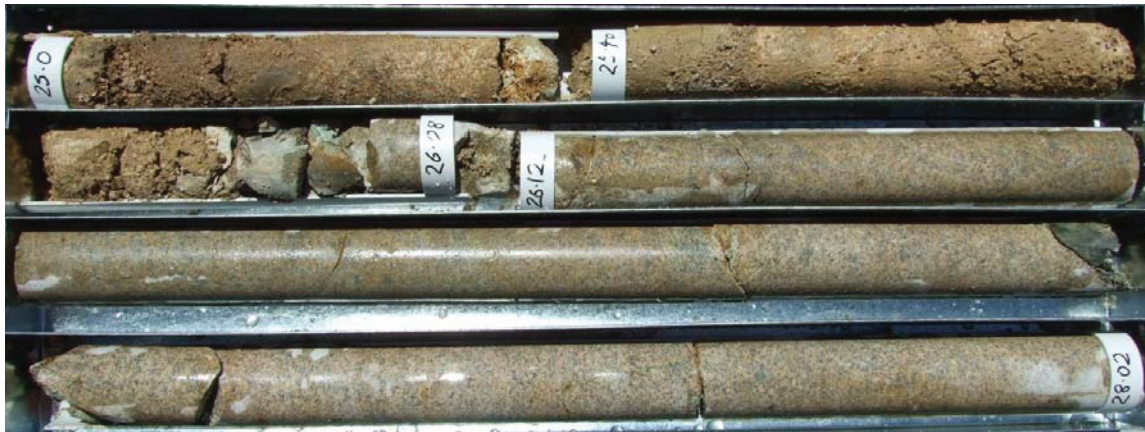
25.00	-12.76				(0)	GRANODIORITE (Kgwu) HW: Pale grey and white, medium grained, massive, very low strength.	HW					hb	SPT
25.90	-13.66				100 (0) (88)	GRANODIORITE (Kgwu) SW: Pale grey and pink, medium to coarse grained, massive, very high strength.	SW					Is(50) = 7.86MPa; # D (26.30m) Is(50) = 4.94MPa; # A (26.35m) UCS=40.2MPa Is(50) = 3.26MPa; # A (27.15m) Is(50) = 6.87MPa D (27.20m) Is(50) = 6.88MPa; # D (27.75m) Is(50) = 1.37MPa; # A (27.80m)

Project Name	Mackay – Ring Road		
Project No	FG6184	Date	19/09/14
Borehole No	BH 110	TMR H No	12056
Location	Stotts Road Overpass	Start Depth (m)	25.0
Detail	Abutment B	Finish Depth (m)	28.02
Chainage	5080	Submitted By	M.Ensor
Remarks
