ENGINEERING BOREHOLE LOG

BOREHOLE No **BH109**
SHEET **1** of **3**
REFERENCE No **12055**

PROJECT Mackay Ring Road Geotechnical Investigation - Stage 1
LOCATION Stotts Road Overpass Abutment A; CH: 5055m; COORDINATES 720899.9 E; 7657414.1 N
PROJECT No FG6184 SURFACE R.L. 12.05m PLUNGE _____ DATE STARTED 21/9/14 GRID DATUM GDA 94 /MGA Zone 55
JOB No _____ HEIGHT DATUM AHD BEARING _____ DATE COMPLETED 22/9/14 DRILLER Saxon Drilling

CORE PHOTO LOG

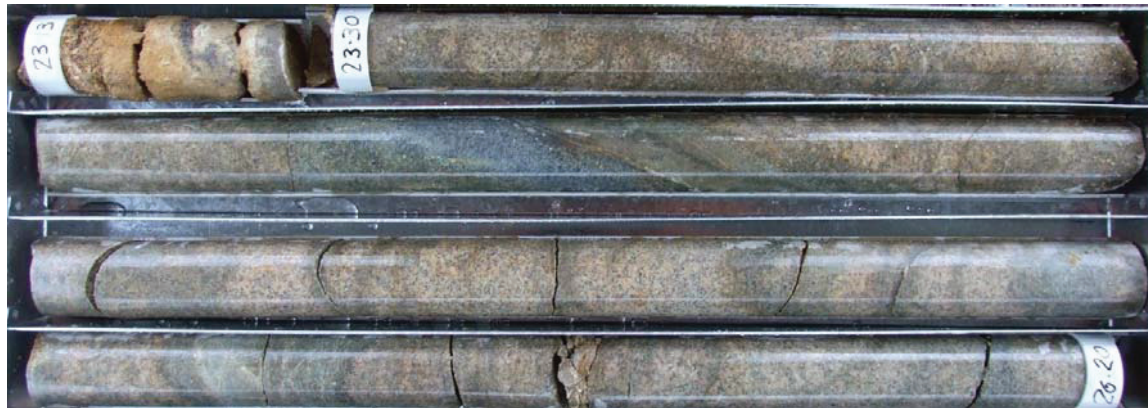
Project Name	Mackay – Ring Road		
Project No	FG6184	Date	21/09/14
Borehole No	BH 109	TMR H No	12055
Location	Stotts Road Overpass	Start Depth (m)	23.3
Detail	Abutment A	Finish Depth (m)	26.2
Chainage	5055	Submitted By	M.Ensor
Remarks

SCALE 1:5

21.60	-9.55				X	GRANODIORITE (Kgwu) HW: Pale grey and orange-brown, medium to coarse grained, very low strength.						16,30/140	SPT
22					Y							30/130	SPT
23	-11.25		(0) 100 (95)			GRANODIORITE (Kgwu) SW: Pale grey and pink, medium to coarse grained, massive, very high strength.						Is(50) = 5.18MPa	D (23.48m)
24												Is(50) = 2.75MPa; # Is(50) = 6.22MPa Is(50) = 7.87MPa	A (24.25m) A (24.39m) D (24.45m)
25												Is(50) = 9.79MPa Is(50) = 9.94MPa	A (24.97m) D (25.05m)
26	-14.15			100								Is(50) = 6.35MPa; # Is(50) = 8.05MPa UCS=190MPa	A (25.50m) D (25.57m)
