# REPORT ON ELECTRIC FRICTION-SLEEVE CONE PENETROMETER

REPORT No. 2-4075E 927

PROJECT GATEWAY ARTERIAL

SOUNDING No. CP73

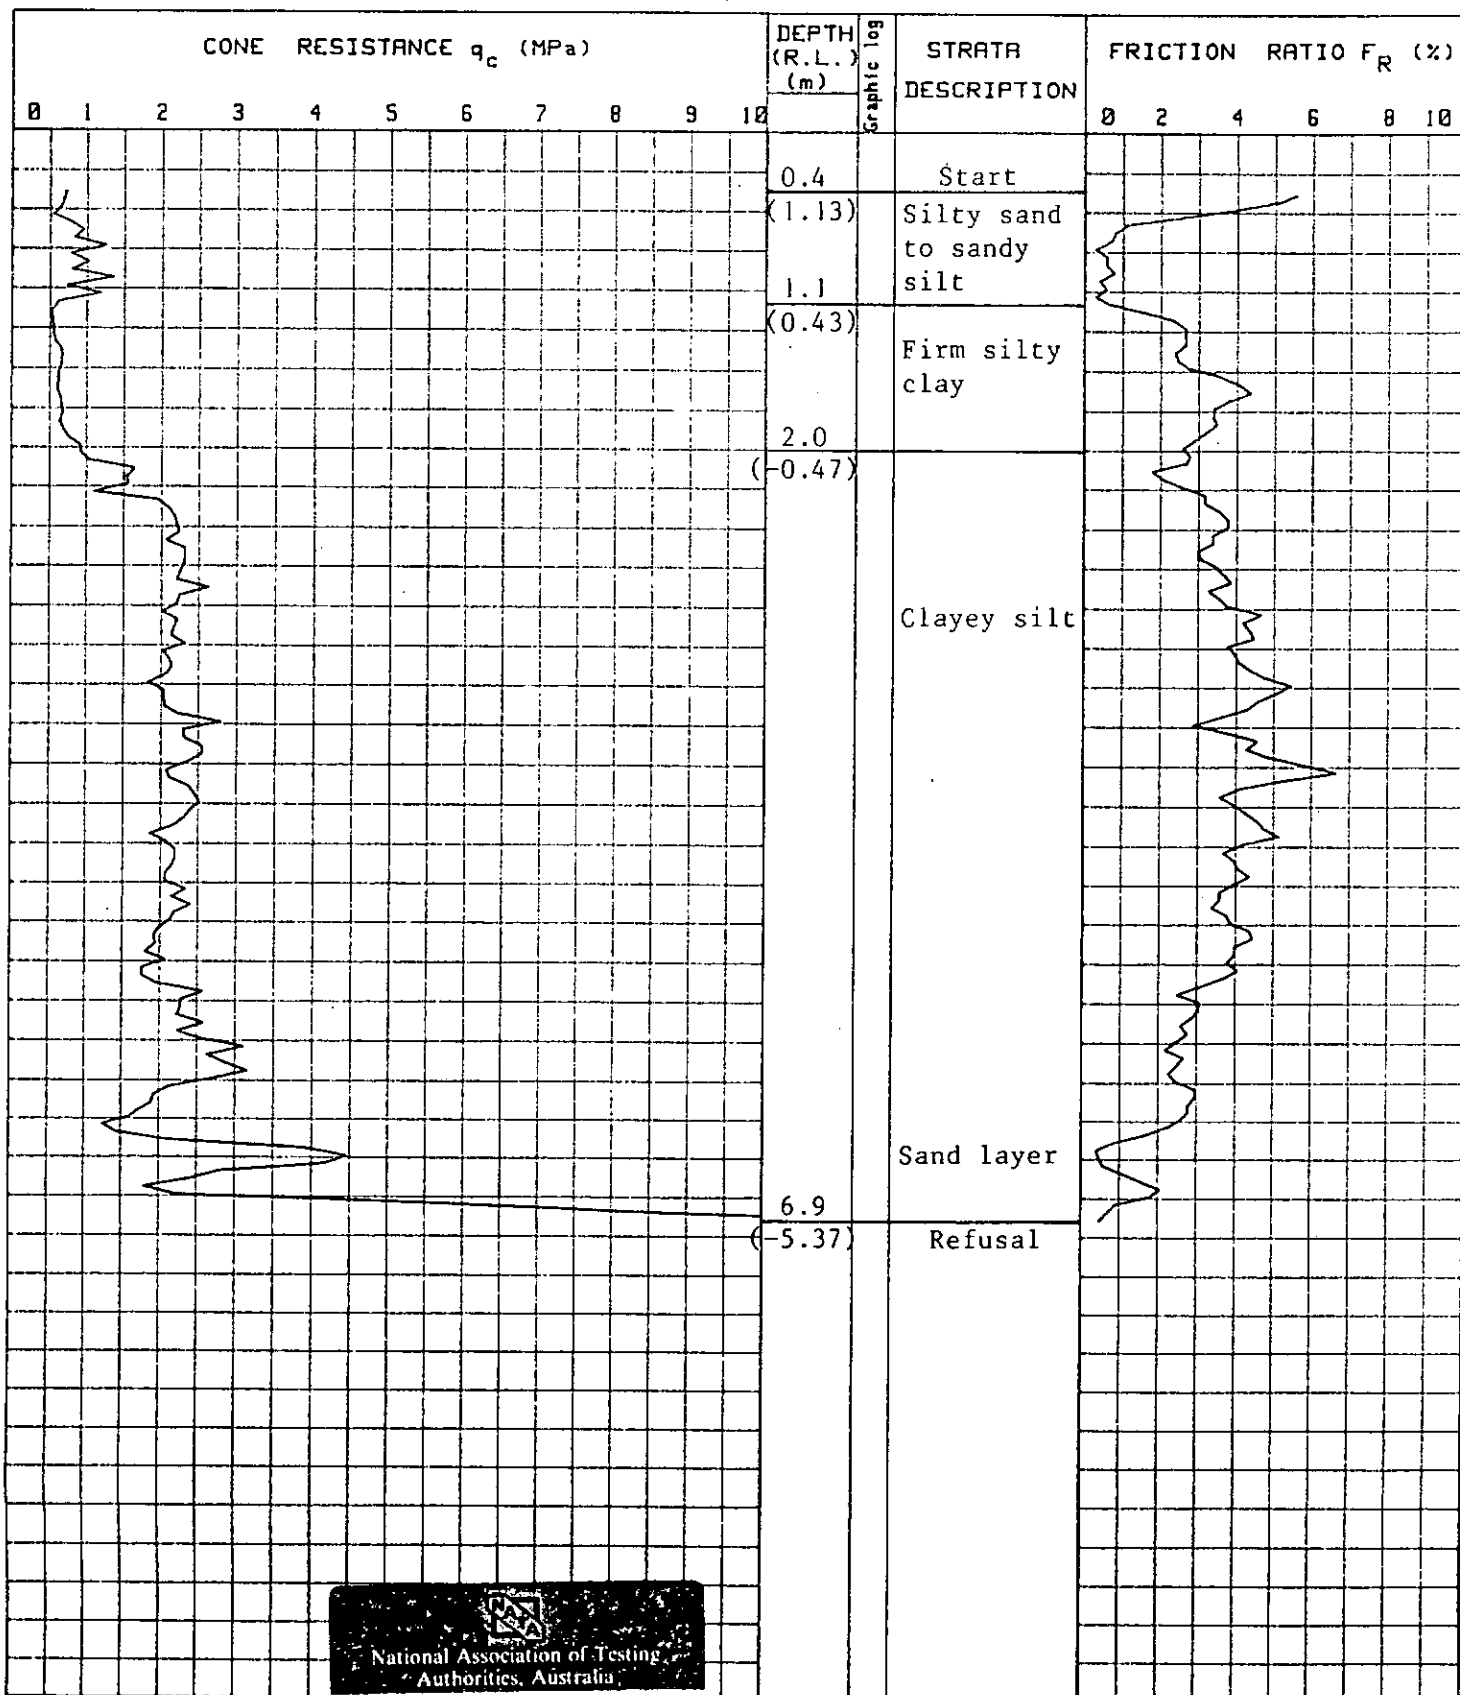
LOCATION E 41603.566, N 44469.330  
at approx. Ch. 6300

SURFACE RL 1.532 m
