GEOTECHNICAL LOG OF **EXCAVATION**

HOLE NO.: TP18

PROJECT: **8 MILE INTERSECTION UPGRADE**

BORDER DISTRICT

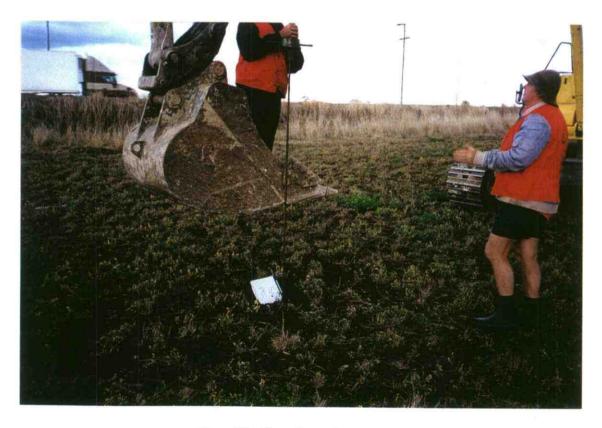
Plate 30: Site view of TP18

Test pit excavated away from planned position, about 15m away from road due to the close proximity of Optus cable.
