BOREHOLE: BHUA-23

Project: Pioneer-Burdekin PHES

Position: Upper Reservoir

Pioneer Burdekin Pumped Hydro Energy Storage: Tranche 2 – BHUA-23  
Defects List

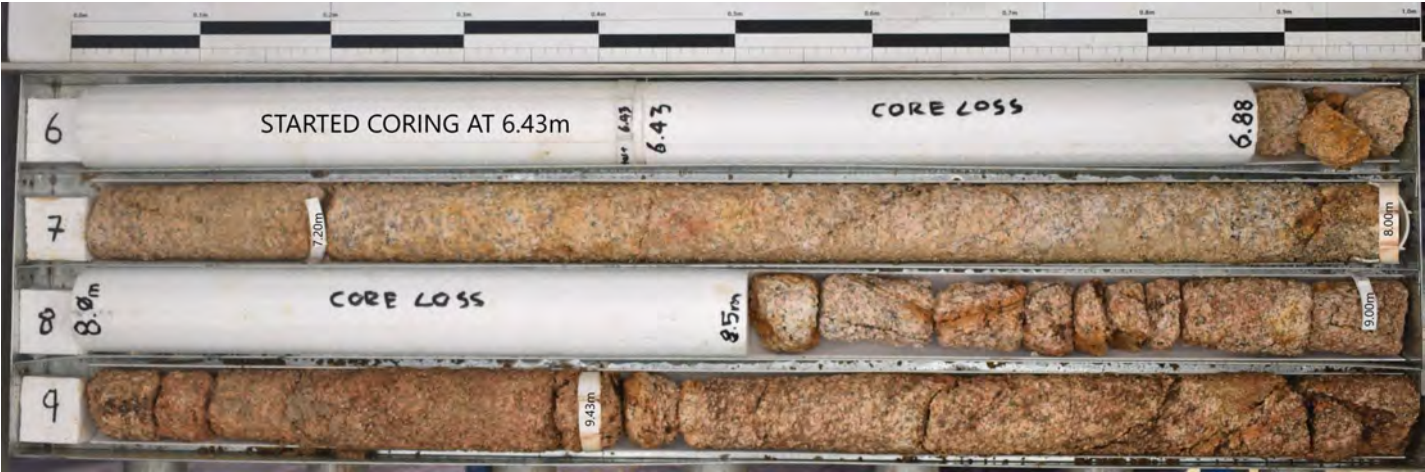
PointID : BHUA-23 Depth Range: 6.00 - 10.00 m

| | TITLE<br><br>Queensland Hydro<br>Netherdale/Dalrymple Heights<br>Pioneer-Burdekin PHES<br>Core photo - BHUA-23 | DRAWN<br>RC | DATE<br>25/11/2024 |

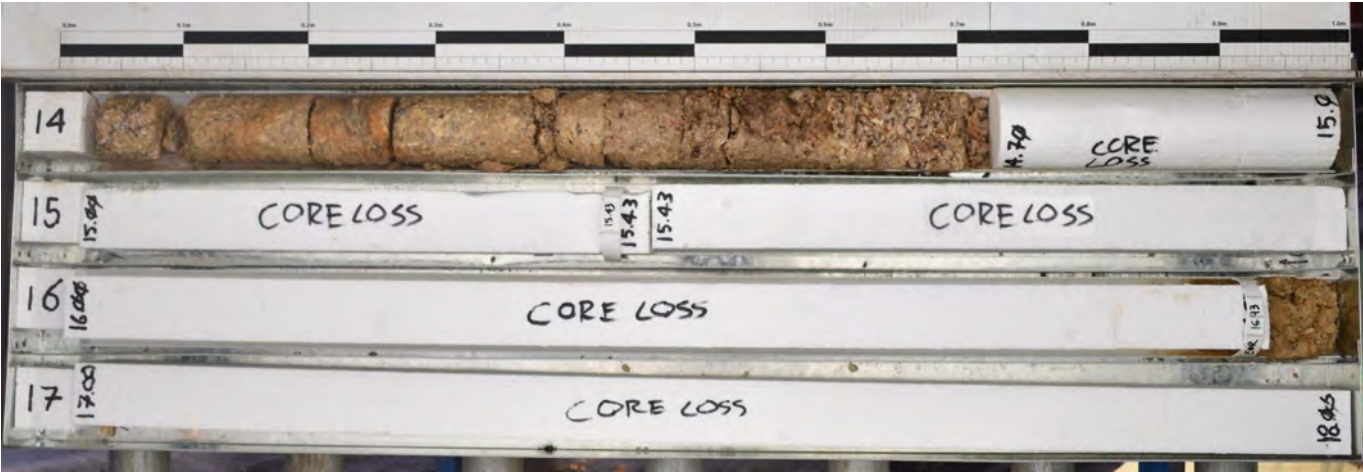
PointID : BHUA-23 Depth Range: 14.00 - 18.00 m

| | TITLE<br><br>Queensland Hydro<br>Netherdale/Dalrymple Heights<br>Pioneer-Burdekin PHES<br>Core photo - BHUA-23 | DRAWN<br>RC | DATE<br>25/11/2024 |

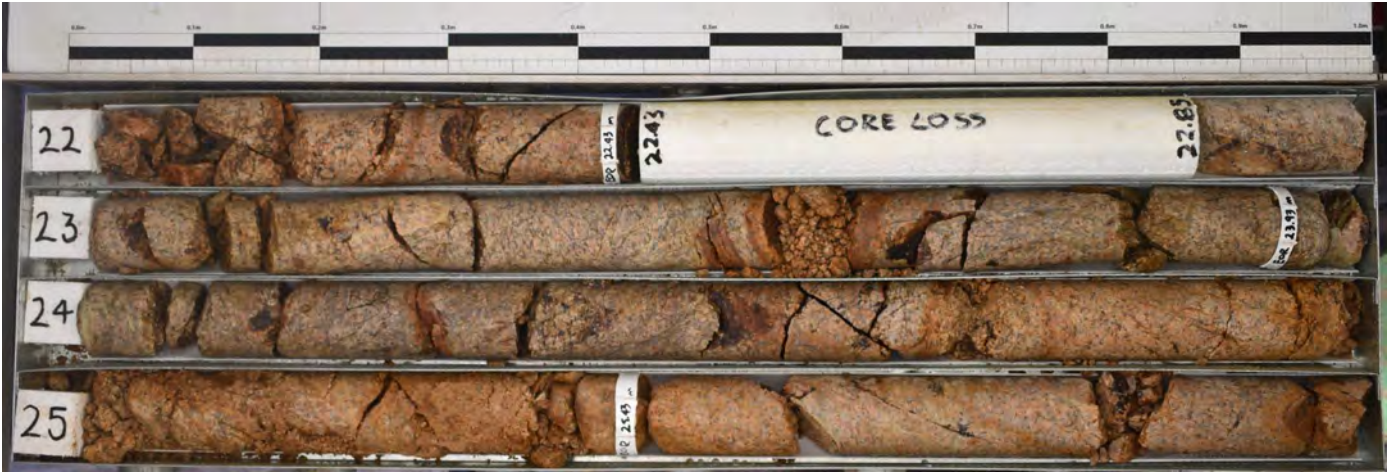
PointID : BHUA-23 Depth Range: 22.00 - 26.00 m

| | TITLE<br><br>Queensland Hydro<br>Netherdale/Dalrymple Heights<br>Pioneer-Burdekin PHES<br>Core photo - BHUA-23 | DRAWN<br>RC | DATE<br>25/11/2024 |

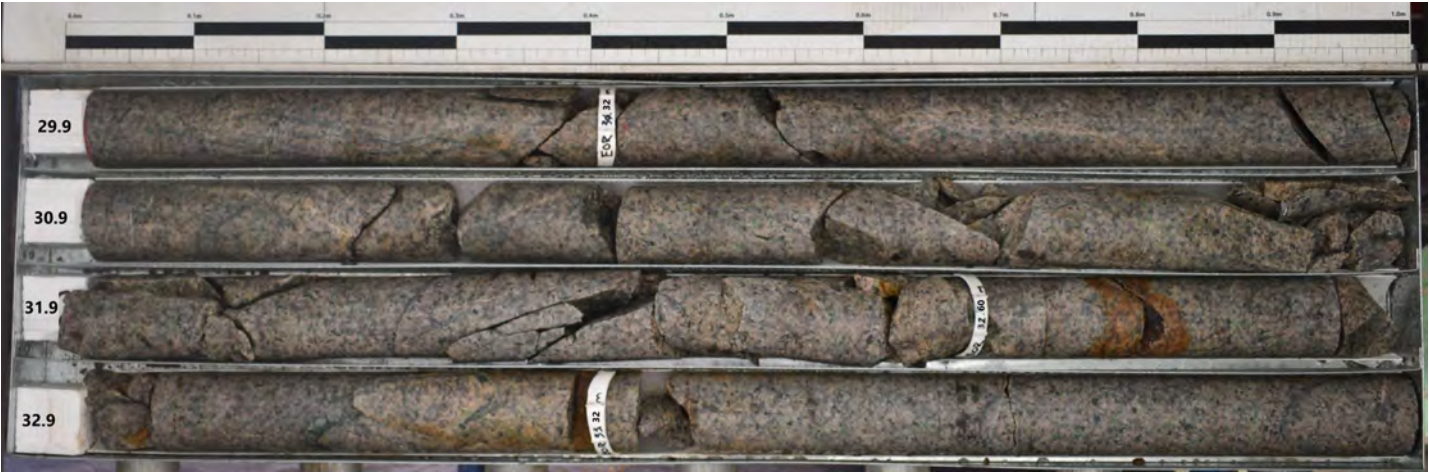
PointID : BHUA-23 Depth Range: 29.90 - 33.90 m

| | TITLE<br><br>Queensland Hydro<br>Netherdale/Dalrymple Heights<br>Pioneer-Burdekin PHES<br>Core photo - BHUA-23 | DRAWN<br>RC | DATE<br>25/11/2024 | | |

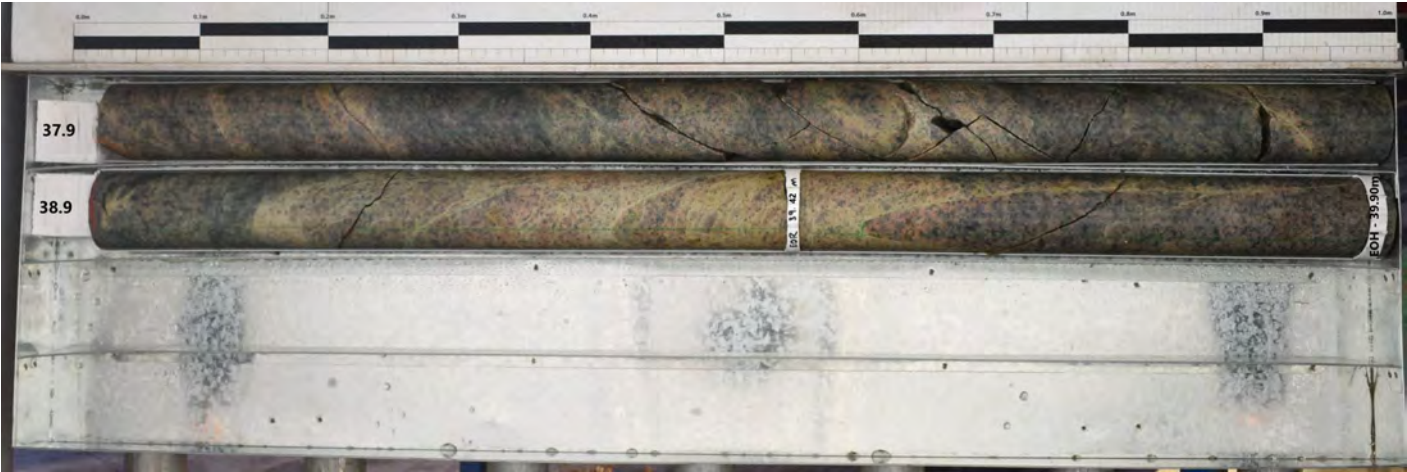
PointID : BHUA-23 Depth Range: 37.90 - 39.90 m

| | TITLE<br><br>Queensland Hydro<br>Netherdale/Dalrymple Heights<br>Pioneer-Burdekin PHES<br>Core photo - BHUA-23 | DRAWN<br>RC | DATE<br>25/11/2024 |

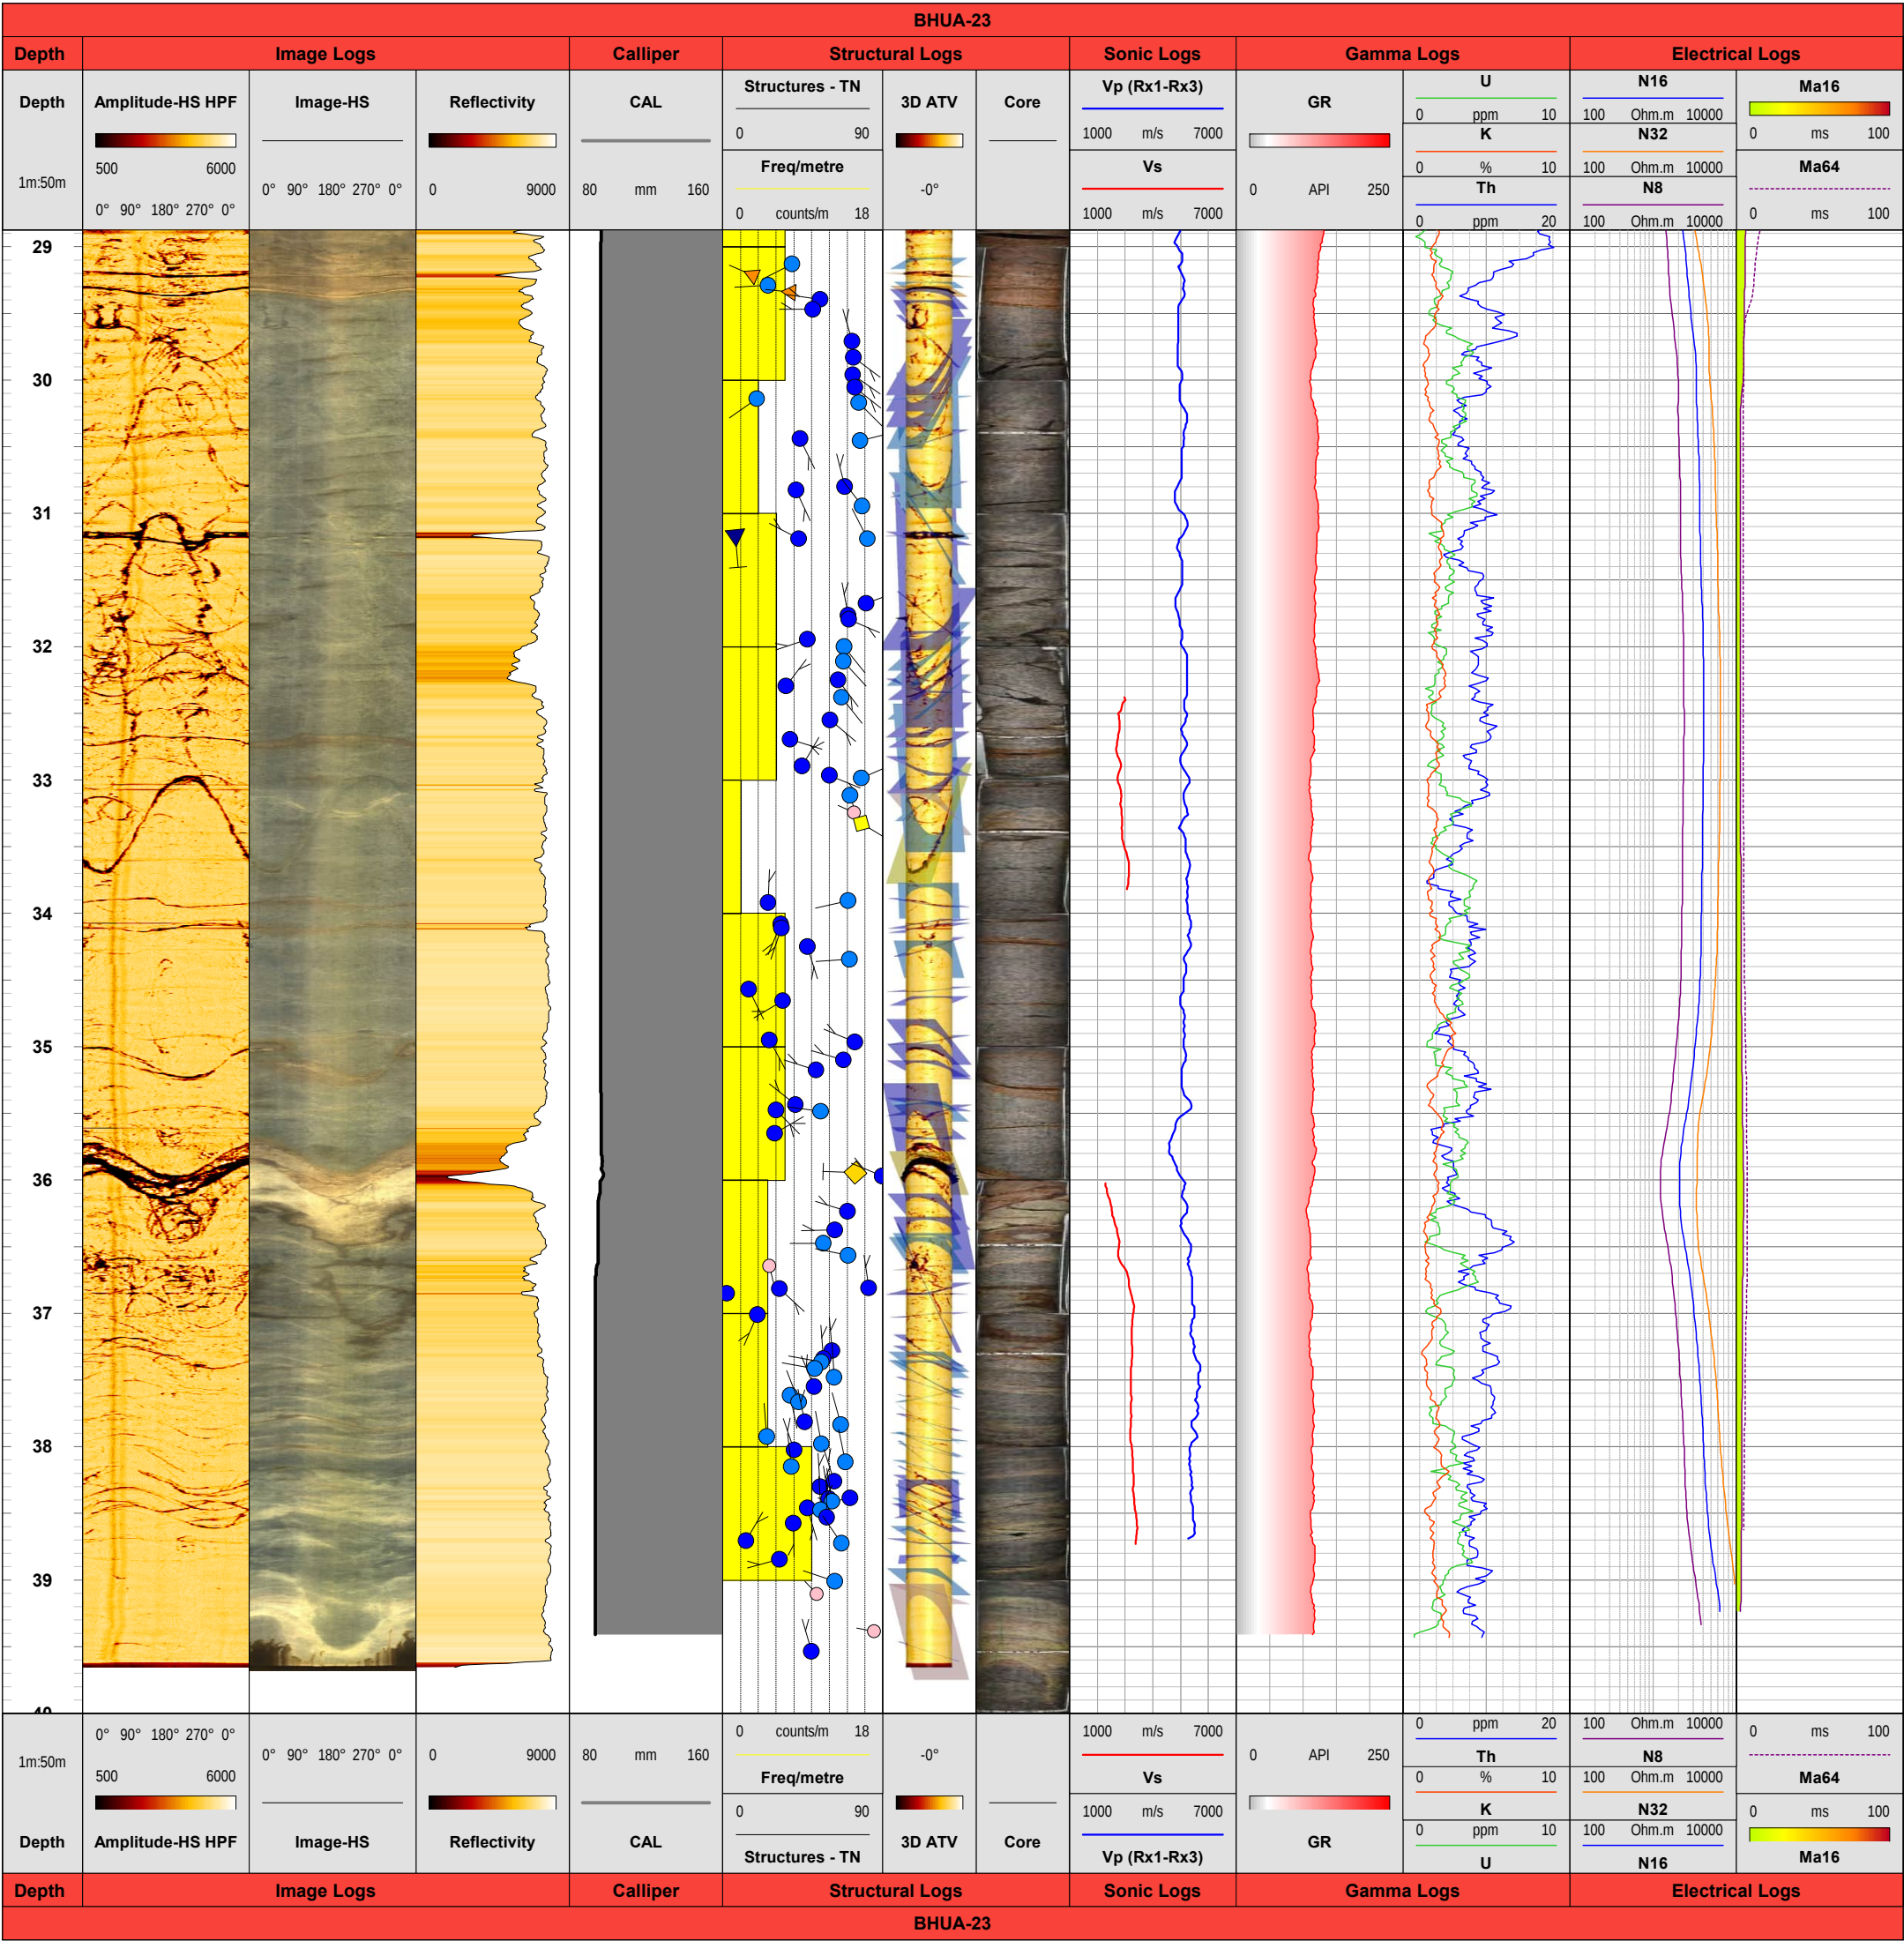
## BHUA-23 Structural Logs

All logs zeroed to ground level. Cased section assumed straight for deviation calculations.

P-wave velocity assessed using first principles due to low semblance values in slow formations.
