REPORT ON  
ELECTRIC FRICTION-SLEEVE CONE PENETROMETER  
Test Method No. QMRD 151(B)

MAIN ROADS  
Materials Branch, Herston  
Geomechanical Services  
REPORT No. 2-407SE 914

PROJECT            GATEWAY ARTERIAL

SOUNDING No.        CP60

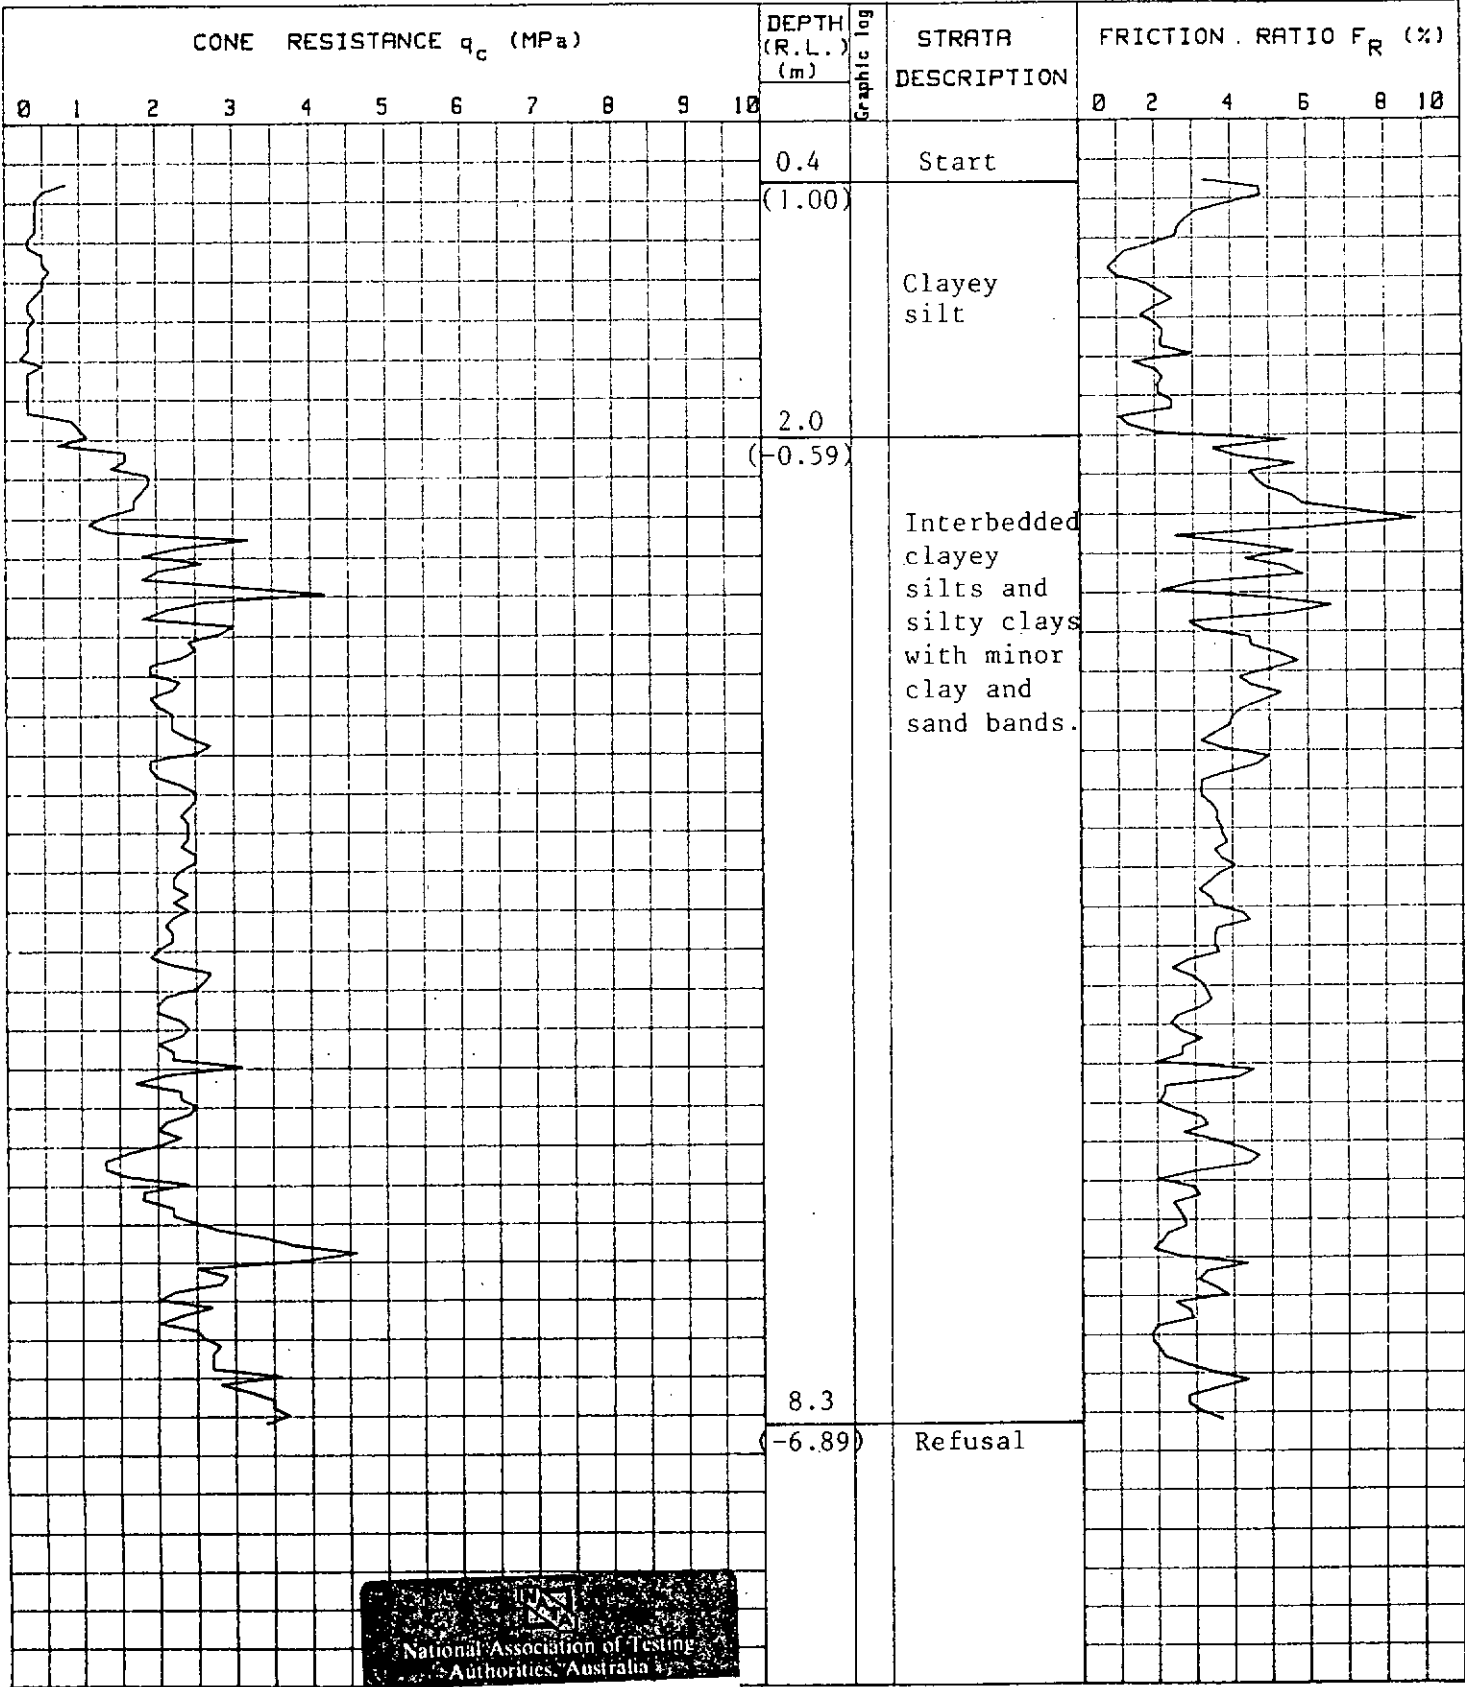
LOCATION            E 42786.159, N 44277.572  
                         at approx. Ch. 5075

SURFACE RL        1.405 m
