## CORED BOREHOLE RECORD

BH-6

FORGAN SMITH BUILDING - U OF Q

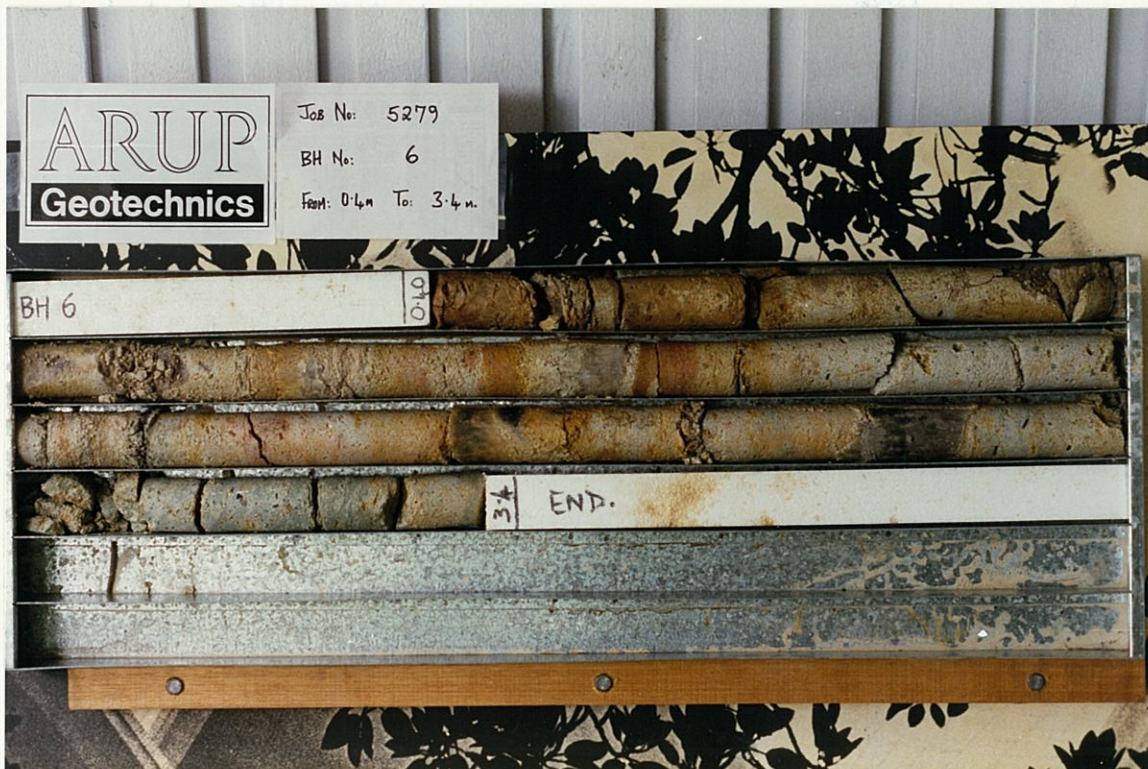
DRILLING			STRATA			MATERIAL DESCRIPTION										DISCONTINUITIES					
CASING RUN, REC. (%)	WATER	SAMPLE TEST	R.L.	DEPTH	LEGEND	ROCK TYPE Colour, Grain Size, Structure, Minor Components	WEATHERING	ESTIMATED ROCK STRENGTH										SPECIFIC			GENERAL DESCRIPTION Planarity, Roughness, Coating, Infill
			AHD	m				EL	VL	LM	HM	VEH	30	10	3	1	TYPE	ANGLE	THICKNESS (mm)		
AUGER				0		Clayey SAND: TOPSOIL

0.4		TUFF: Light grey and yellow brown, fine to coarse grained, massive	EW MW/ SW											We	0	30	Defects are mostly joints at 0-5°, rough, irregular stained, clay filled
		P.L.		1														Jo	60	5	
				2														We	0	20	
				3														We	0	30	
		P.L.		3.4														We	0	100	
						END OF HOLE															
				4																	
				5																	
				6																	
				7																	
				8																	
NOTES						TYPE OF DISCONTINUITY						FIGURE			JOB

1. Auger drilled 00-0.4 m						Jo-JOINT															
2. NMLC Core drilled 0.4						Be-BEDDING PLANE PARTING															
						Fo-FOLIATION PARTING															
						Ci-CLAY SEAM															
						We-WEATHERED SEAM															
						Cr-CRUSHED SEAM															
						Sh-SHEARED ZONE															
															5279
