ENGINEERING BOREHOLE

BOREHOLE No BH7

PROJECT Caboolture River Bridge Foundation Investigation

Project: FOUNDATION INVESTIGATION FOR THE WIDENING OF THE CAPTAIN WHISH BRIDGES (NORTH AND SOUTHBOUND) – CABOOLTURE RIVER

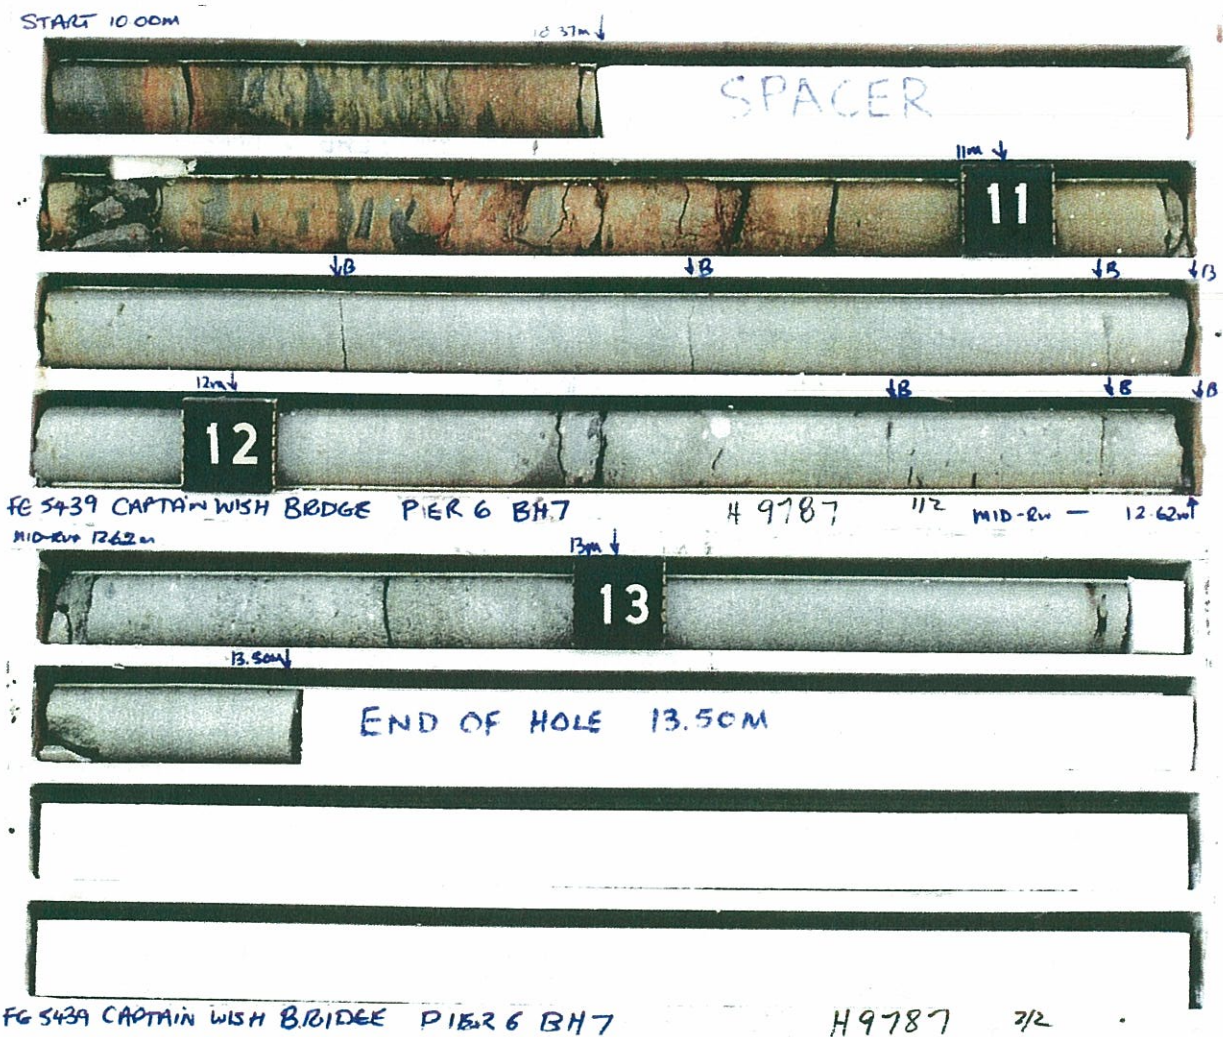
Borehole No: BH7 Pier 6

Start Depth: 10.00m

Finish Depth: 13.50m

DEPTH (m)	R.L. (m)	AUGER CASING WASH BORING CORE DRILLING	RQD (%)	SAMPLE	MATERIAL DESCRIPTION	USC WEATHERING	INTACT STRENGTH	DEFECT SPACING (mm)	GRAPHIC LOG	ADDITIONAL DATA AND TEST RESULTS	SAMPLES TESTS
10	-6.76		(70)		SANDSTONE: As above.					Is(50)=0.45 MPa	o
			100		MW:					Is(50)=0.34 MPa	x
			(83)		Pale grey with orange-brown ironstaining, medium grained, low to medium strength, brown and grey siltstone rip-up clasts throughout.	MW					
11	-7.66				SW:					Is(50)=0.28 MPa	o
					Light grey, medium to coarse grained, low-medium to high strength, occasional thin black coal laminae.					Is(50)=0.10 MPa	x
					Defects:	SW					
					Subhorizontal bedding partings.						
12											
13	-10.26		100								
14					Borehole terminated at 13.5m						
15											
16											
17											
18											
19											
20
