BOREHOLE ENGINEERING LOG

HOLE NO : CURVE 22_BH05

PROJECT : BLACK SPOT PROJECT

LOCATION : KENNEDY HWY (CAIRNS - MAREEBA)

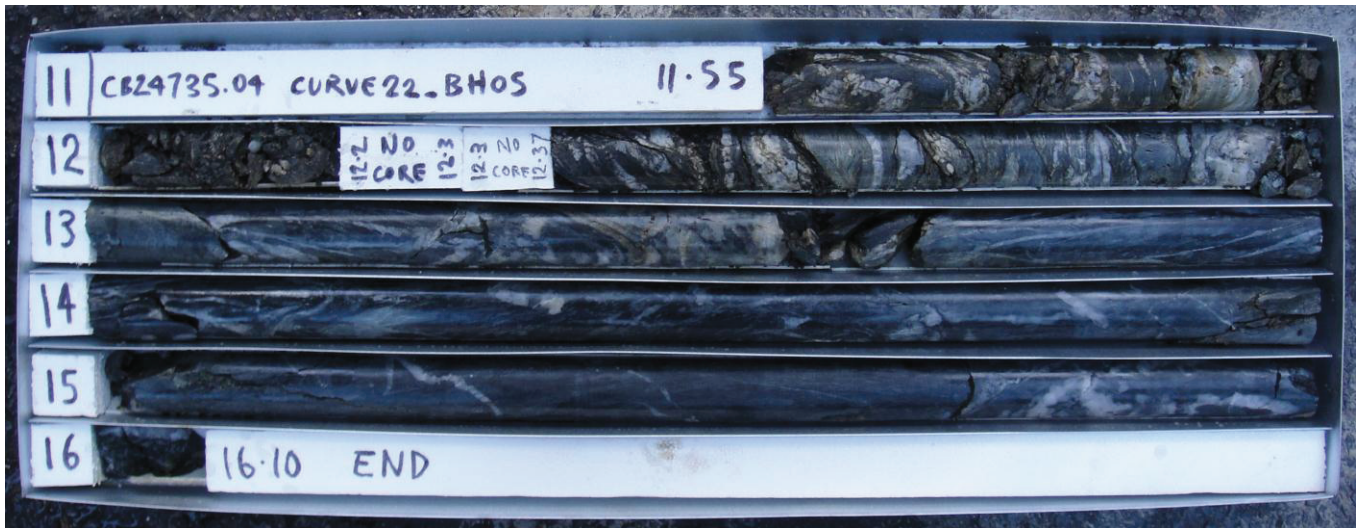
Client: Transport and Main Roads		
		Project: Black Spot		
drawn	AJ	Core Photograph – Curve 22_BH05		
date	14/08/2013	Project no. CB24735.04		
scale	NTS	Photo No: Curve 22_BH05		1 of 1

12.30	CORE LOSS 0.17m (12.20-12.37)								
		95% TCR 27% RQD	98.6	13.0		From 13.00 m indistinct foliation	MW			12.37 JT 40° IR RF 12.45 JT 80° ST RF 12.50 JT 30° IR RF 12.53 JT 20° IR RF 12.57 JT 40° IR RF 12.65 JT 0° IR VR 12.66 JT 40° IR RF 12.69 JT 50° IR RF 12.76 JT 20° ST RF 12.82 JT 0° IR RF 12.84 JT 0° IR RF 12.88 JT 0° IR RF 12.95 CZ 5 - 40° IR RF 50 mm 13.04 JT 60° ST VR 13.28 JT 50° ST RF 13.31 JT 40° IR RF 13.40 VN 60° Qz PR RF 13.45 VN 10° Qz PR RF 13.48 VN 10° Qz PR RF 13.56 JT 60 - 90° IR RF 13.68 JT 30° IR VR

13.65	97.6	14.0		F					
		100% TCR 80% RQD	96.6	15.0							
		16.10	95.6	16.0		Terminated Cored Drill Hole at 16.10 m					
			94.6	17.0							
			93.6	18.0
