# ENGINEERING BOREHOLE LOG

BOREHOLE No **BH102**  
SHEET **1** of **5**  
REFERENCE No **11461**

PROJECT Townsville Ring Road Section 4  
LOCATION Kalynda Parade Overpass COORDINATES 467716.2 E; 7866465.9 N  
PROJECT No FG6020 SURFACE R.L. 14.79m PLUNGE \_\_\_\_\_ DATE STARTED 15/3/13 GRID DATUM GDA 94  
JOB No 268/10M/5 HEIGHT DATUM AHD BEARING \_\_\_\_\_ DATE COMPLETED 19/3/13 DRILLER Cairns Drilling

# CORE PHOTO LOG

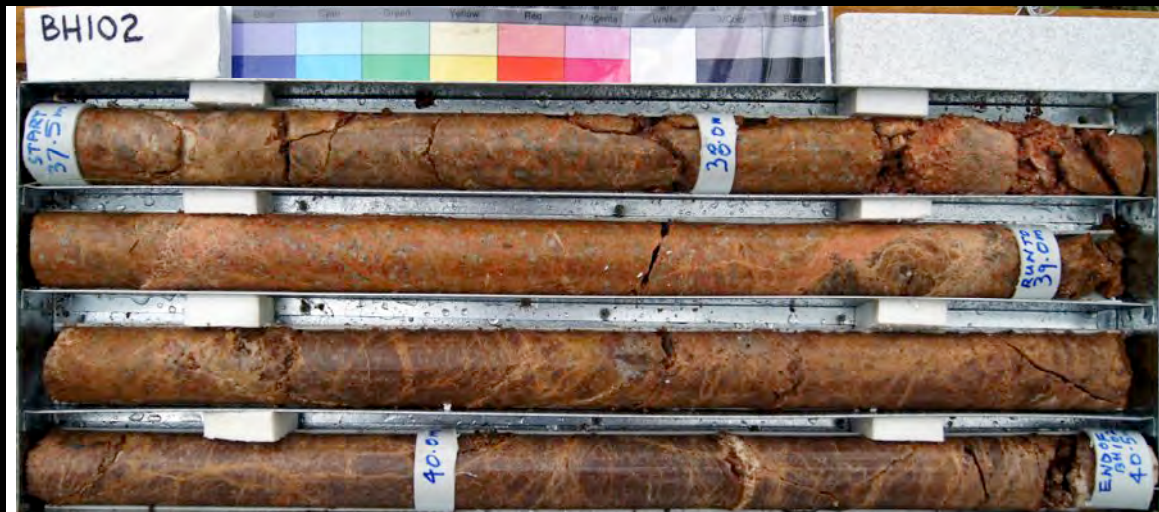
Project Name	Townsville Ring Road Section 4		
Project No	FG 6020	Date	19/03/13
Borehole No	BH 102	TMR H No	11461
Location	Kalynda Parade Overpass	Start Depth (m)	37.50
Detail	Abutment A (Left)	Finish Depth (m)	40.50
Chainage		Submitted By	BW
Remarks

39													Is(50) = 0.36MPa UCS = 2.33 MPa  Is(50) = 0.26MPa Is(50) = 2.22MPa Is(50) = 0.42MPa	o o o o
40						<b>SW:</b> Red, pink to grey, brown, medium to coarse grained, massive, generally high to very high strength. Some medium & extremely high strength zones.							Is(50) = 0.56MPa UCS = 20.8 MPa	o

DEPTH (m)	R.L. (m)	AUGER WASH BORING CORE DRILLING	RQD ( ) %	CORE REC %	SAMPLE	MATERIAL DESCRIPTION	LITHOLOGY	USC	WEATHERING	INTACT STRENGTH						DEFECT SPACING (mm)				GRAPHIC LOG	ADDITIONAL DATA AND TEST RESULTS	SAMPLES TESTS
										EH	VH	H	M	L	EL	20	60	200	600			
40	-25.21					SW: (Cont'd) Defects: - Joint at 25° (2/m) - Joint at 60° (2/m) Defects are generally medium spaced, planar or irregular, close, or tight, rough and weathered.	+	+	SW												Is(50) = 8.87MPa	o
-25.71			100			Borehole terminated at 40.5m
