ENGINEERING BOREHOLE

BOREHOLE No **BH23**

REFERENCE No **H9572**

PROJECT **GATEWAY BRIDGE DUPLICATION FOUNDATION INVESTIGATION - GATEWAY UPGRADE PROJECT**

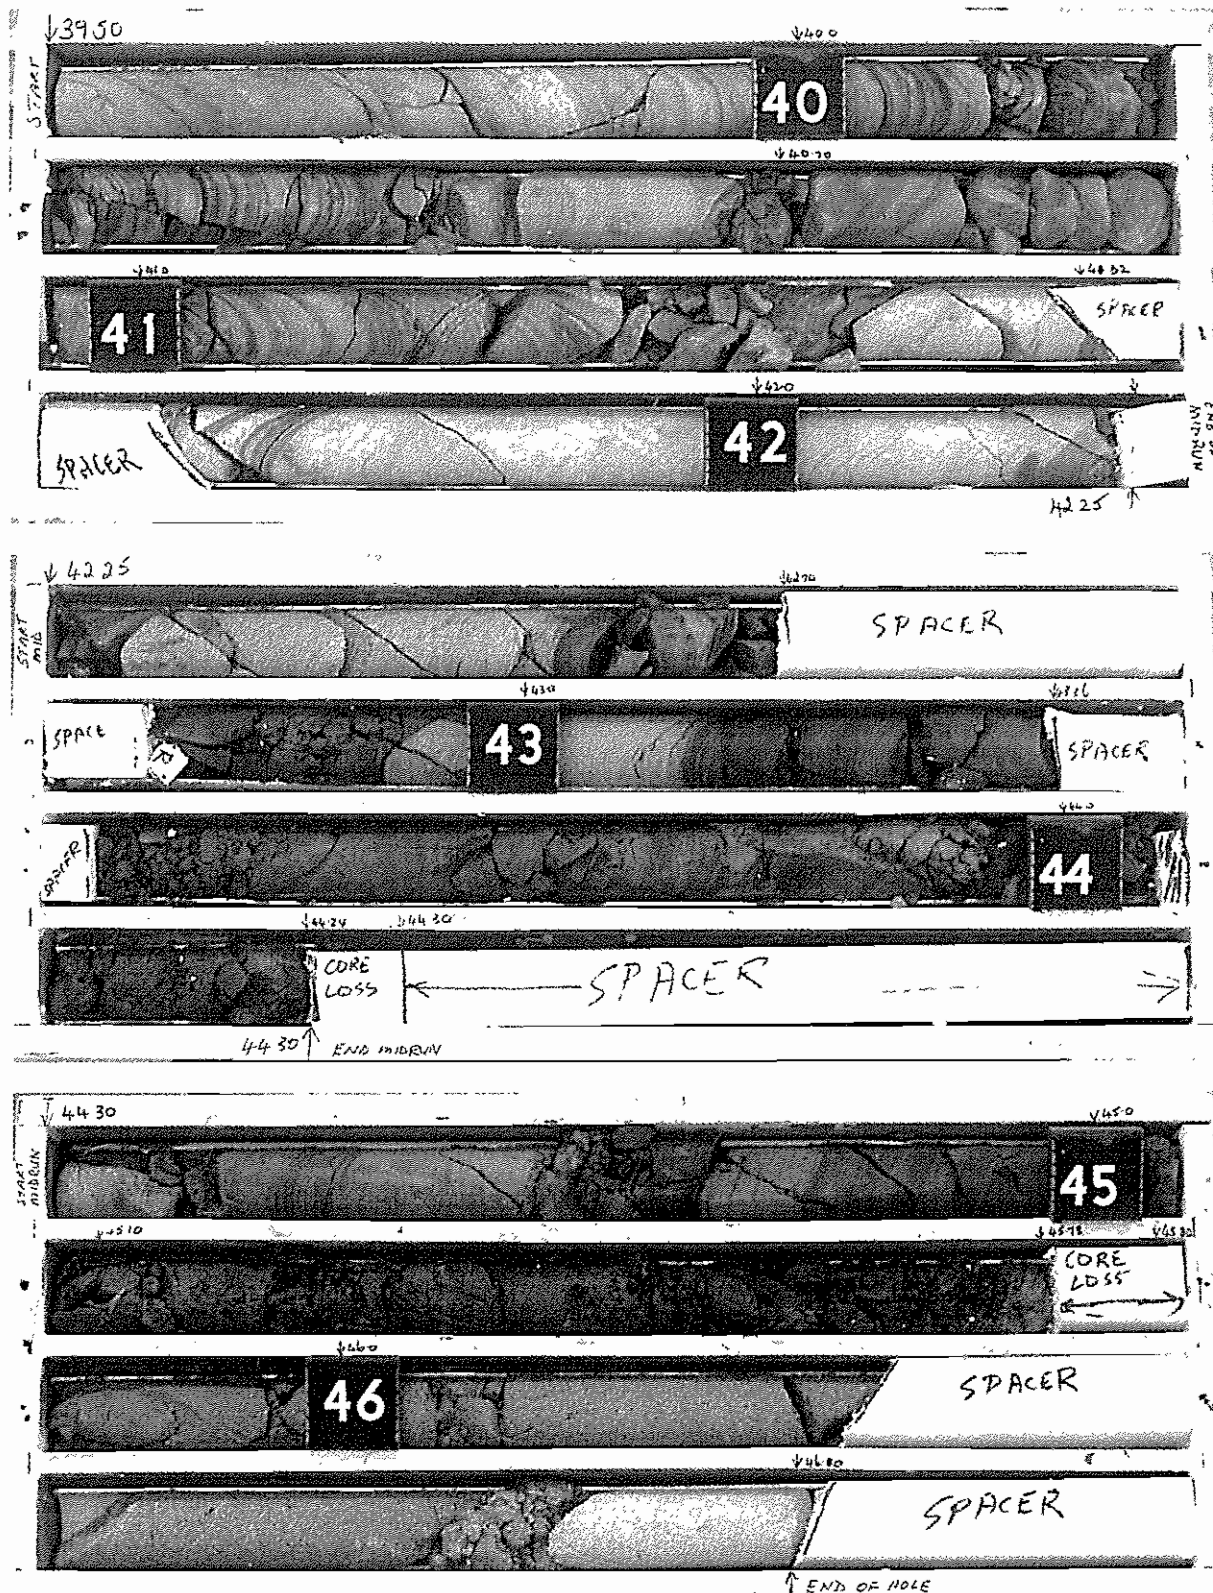
Borehole No: **BH 23**

Project: **Gateway Bridge Duplication Investigation**

Start Depth: 39.50m

Finish Depth: 46.80m
