# ENGINEERING BOREHOLE LOG

BOREHOLE No BH15  
SHEET 1 of 2  
REFERENCE No H11025

PROJECT Moreton Bay Rail Link  
LOCATION Halpine Lake Bridge, Bridge 9, Ch.6100 COORDINATES 502912.9 E; 6986533.2 N  
PROJECT No FG5921 SURFACE R.L. 16.90m PLUNGE \_\_\_\_\_ DATE STARTED 5/5/11 GRID DATUM MGA94 Zone 56  
JOB No 250/120/3 HEIGHT DATUM AHD BEARING \_\_\_\_\_ DATE COMPLETED 5/5/11 DRILLER R&D Drilling Pty Ltd

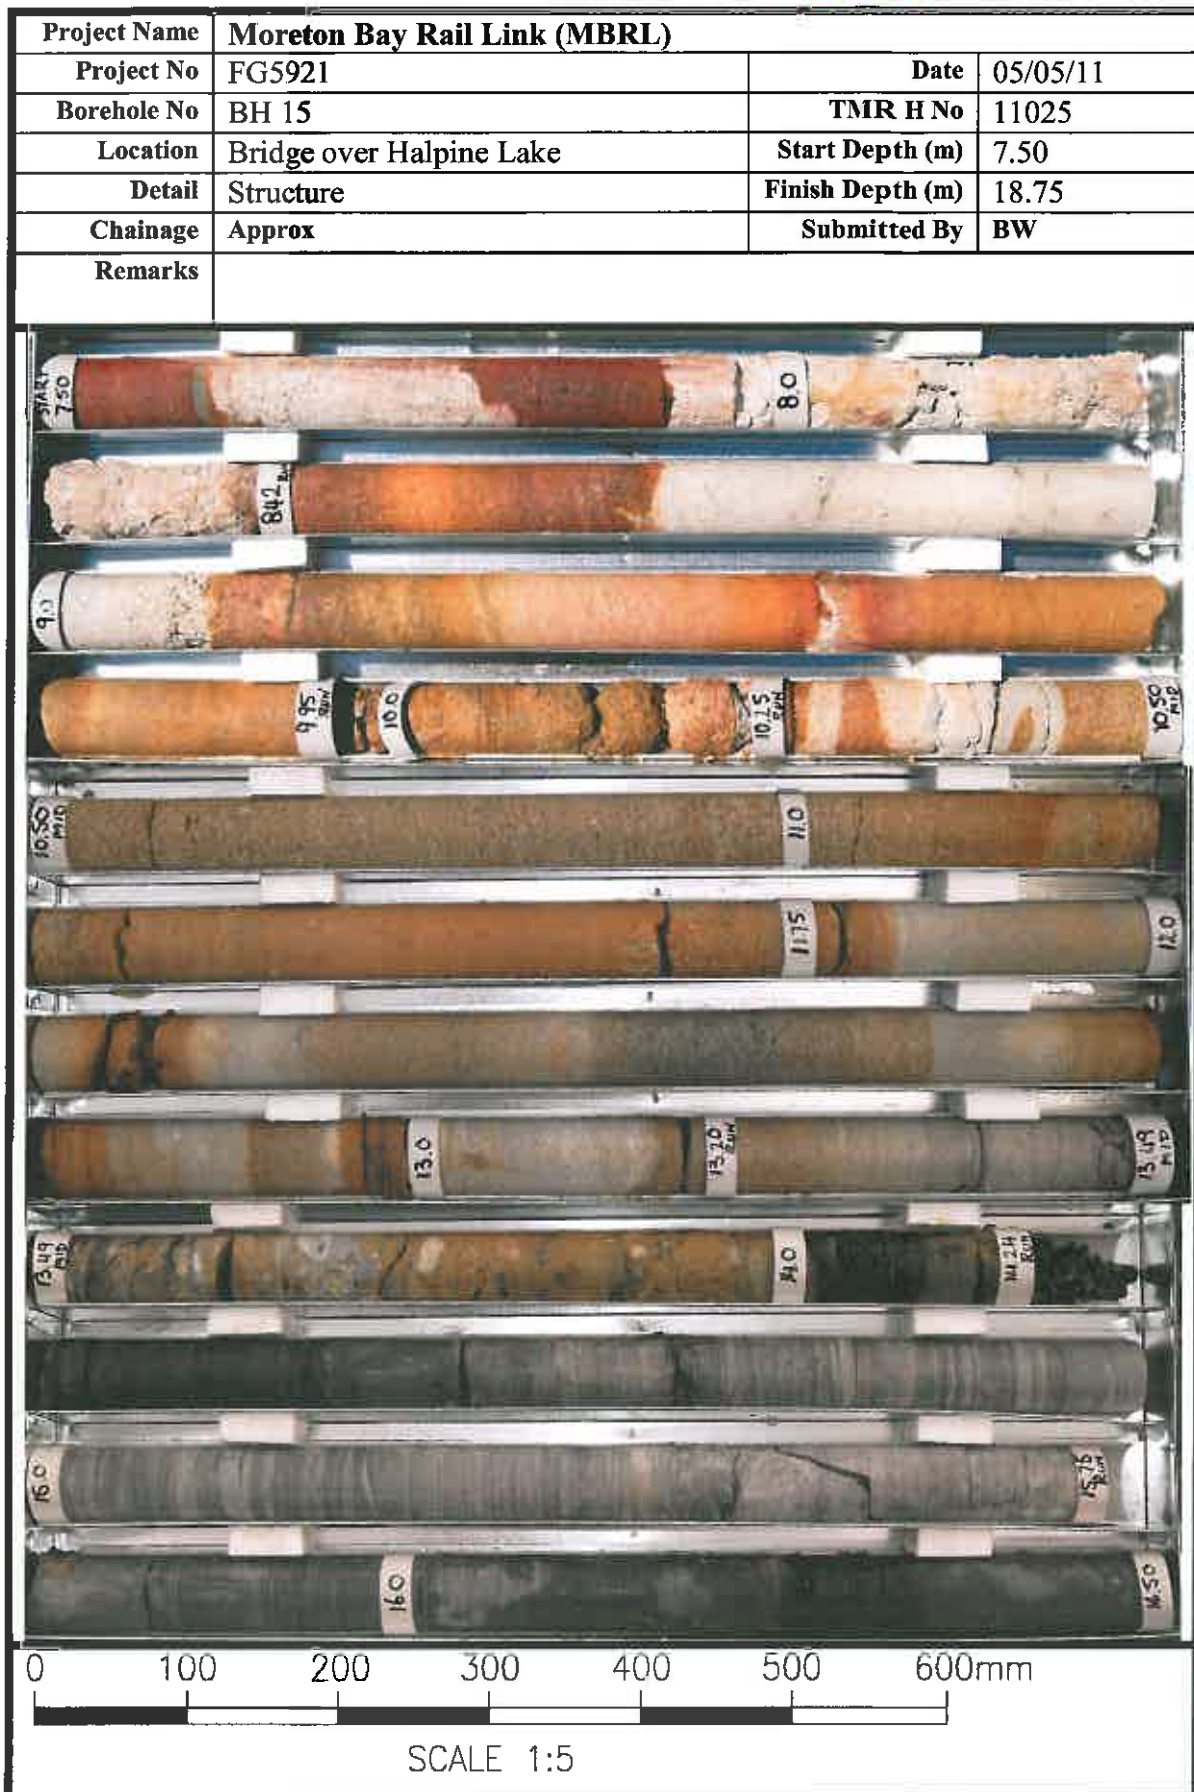
<b>Project Name</b>	<b>Moreton Bay Rail Link (MBRL)</b>		
<b>Project No</b>	FG5921	<b>Date</b>	05/05/11
<b>Borehole No</b>	BH 15	<b>TMR H No</b>	11025
<b>Location</b>	Bridge over Halpine lake	<b>Start Depth (m)</b>	7.50
<b>Detail</b>	Structure	<b>Finish Depth (m)</b>	18.75
<b>Chainage</b>	Approx	<b>Submitted By</b>	BW
<b>Remarks</b>
