# ENGINEERING BOREHOLE LOG

BOREHOLE No BH C32  
SHEET 1 of 3  
REFERENCE No H11122

PROJECT Bruce Highway Upgrade (Cooroy to Curra) Section C  
LOCATION Cut 9 COORDINATES 471861.5 E; 7094360.9 N  
PROJECT No FG5799 SURFACE R.L. 83.30m PLUNGE \_\_\_\_\_ DATE STARTED 22/07/11 GRID DATUM MG94  
JOB No 232/10A/2 HEIGHT DATUM AHD BEARING \_\_\_\_\_ DATE COMPLETED 22/07/11 DRILLER Drillsure Pty Ltd

## CORE PHOTO LOG - BH C32

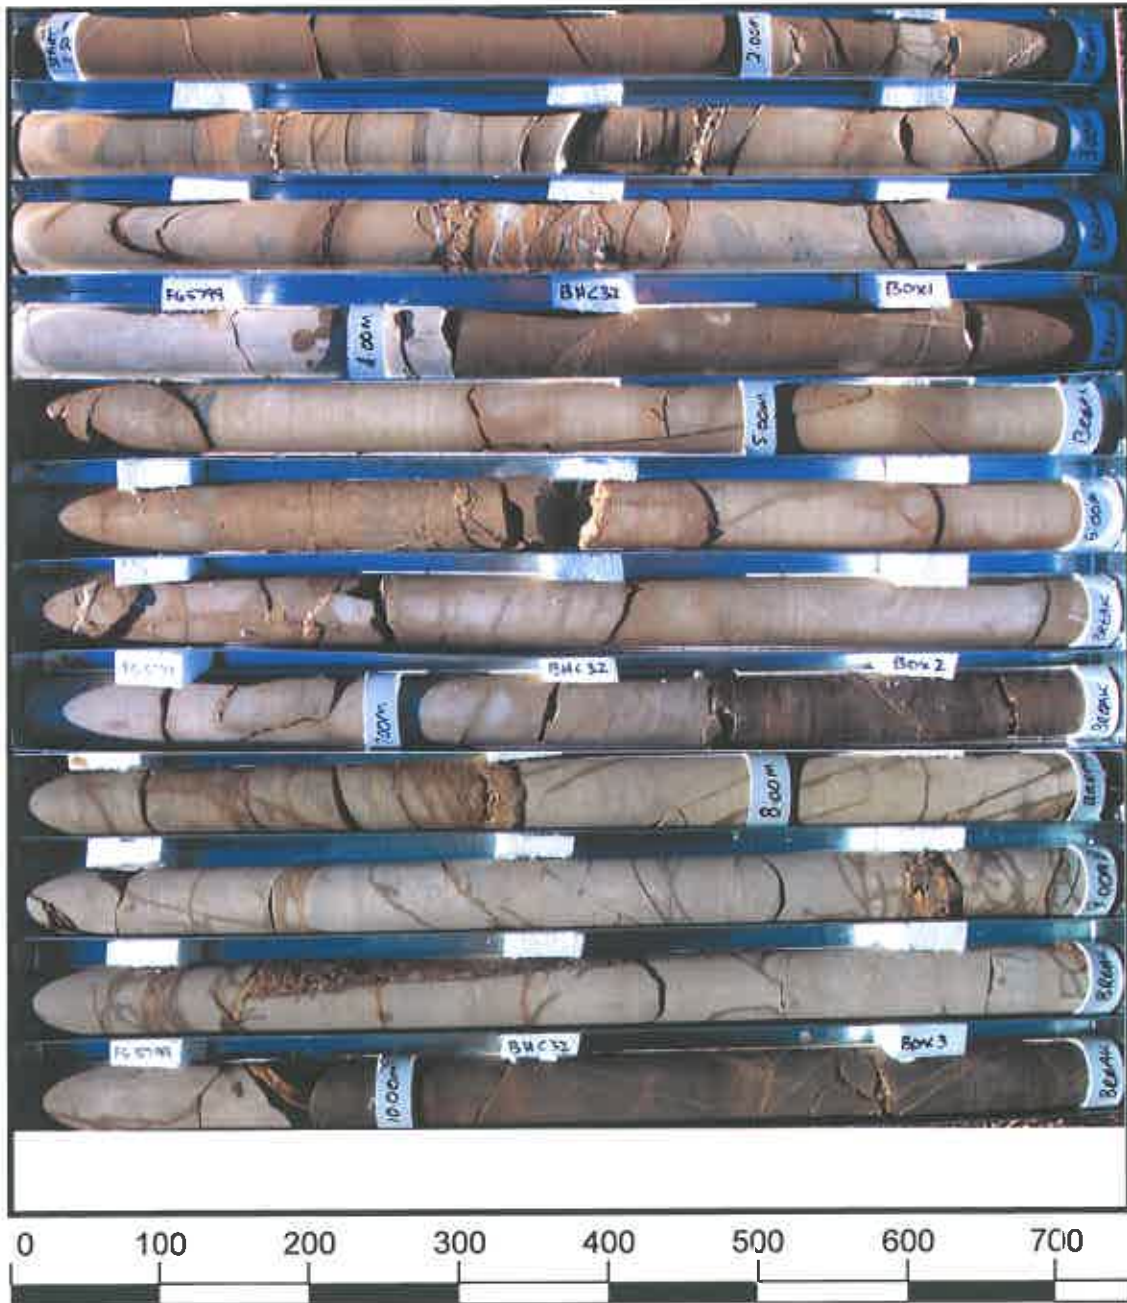
Project Name:	BRUCE HIGHWAY UPGRADE - SECTION C		
Project No.:	FG5799	Date:	08/09/2011
Details:	Cut 9	Start Depth (m):	1.50
Reference No.:	H11122	Finish Depth (m):	20.35

SCALE 1:5

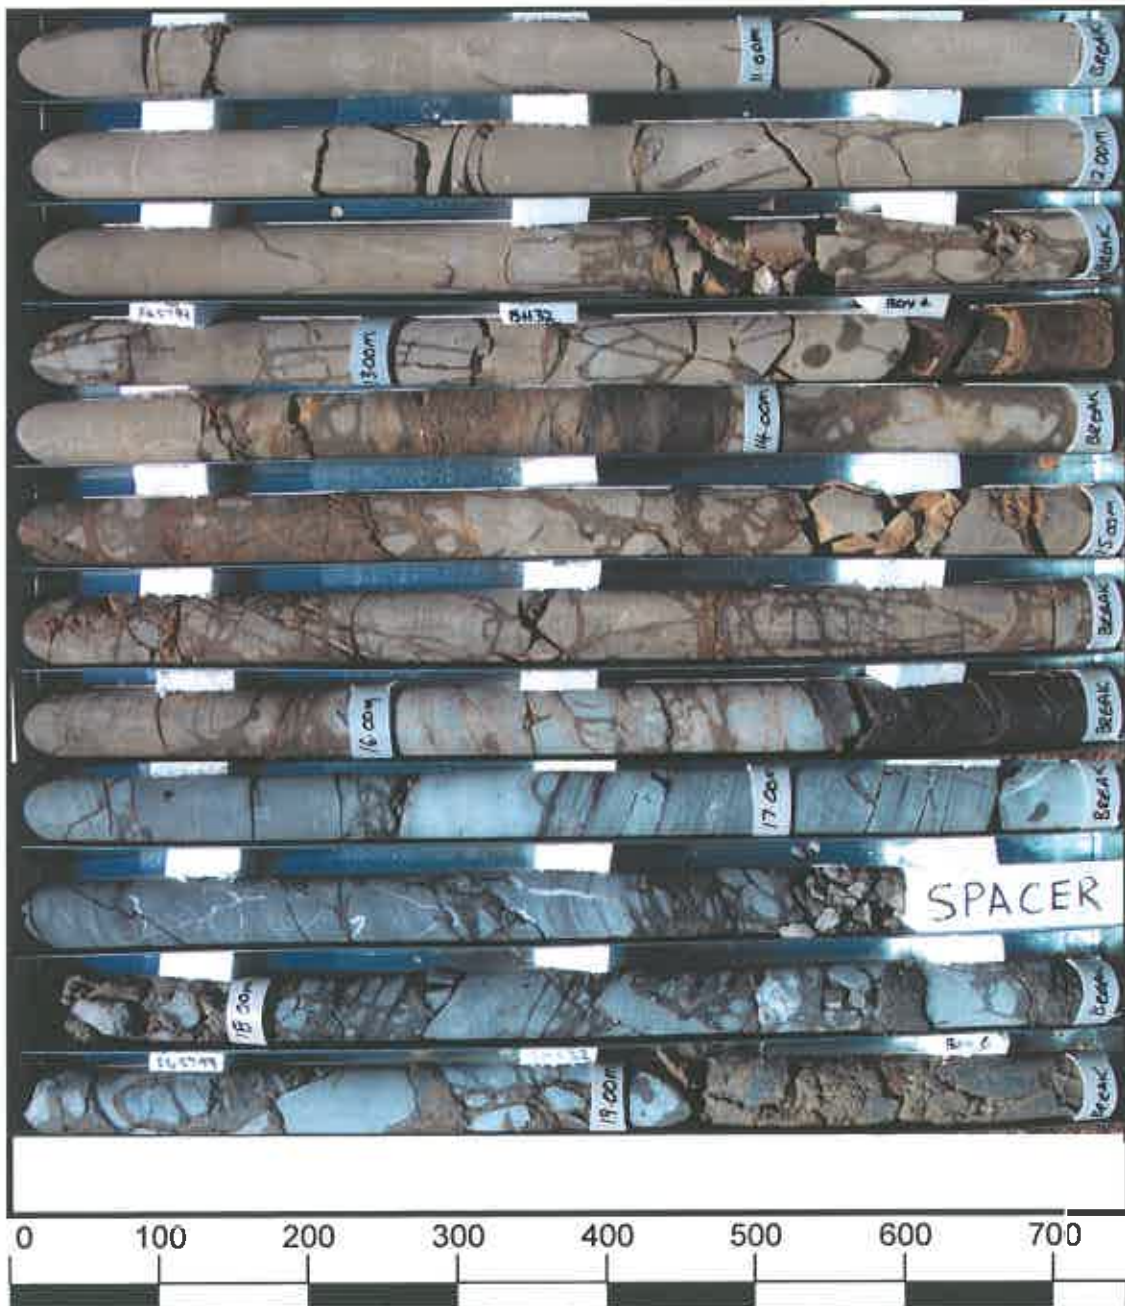
**CORE PHOTO LOG - BH C32**

Project Name:	BRUCE HIGHWAY UPGRADE - SECTION C		
Project No.:	FG5799	Date:	08/09/2011
Details:	Cut 9	Start Depth (m):	1.50
Reference No.:	H11122	Finish Depth (m):	20.35

SCALE 1:5

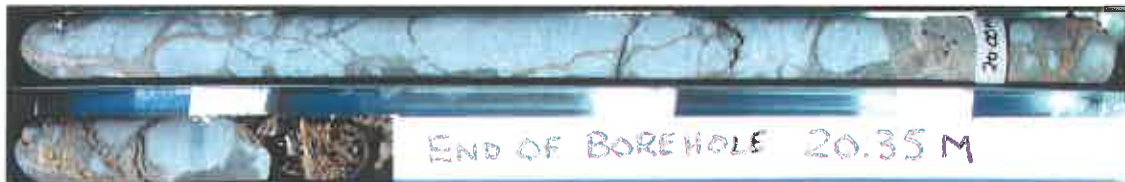
## CORE PHOTO LOG - BH C32

Project Name:	BRUCE HIGHWAY UPGRADE - SECTION C		
Project No.:	FG5799	Date:	08/09/2011
Details:	Cut 9	Start Depth (m):	1.50
Reference No.:	H11122	Finish Depth (m):	20.35

SCALE 1:5
