BOREHOLE ENGINEERING LOG

100

Gold Coast Rapid Transit

Barney Street, Ch: 24874.5

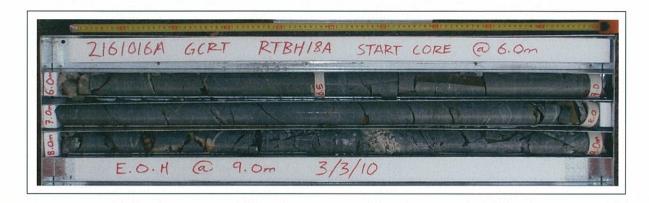
Borehole location: Ch: 24869.3 Hole angle: 90 ° Drill model/mounting: Hydrapower Scout

Project number: 2161016A Bearing: – Borehole diameter: 75 mm
