REFERENCE No **H11130**

ENGINEERING BOREHOLE LOG

Project Name:	BRUCE HIGHWAY UPGRADE - SECTION C		
Project No.:	FG5799	Date:	08/09/2011
Details:	Cut 10	Start Depth (m):	2.00
Reference No.:	H11130	Finish Depth (m):	15.85

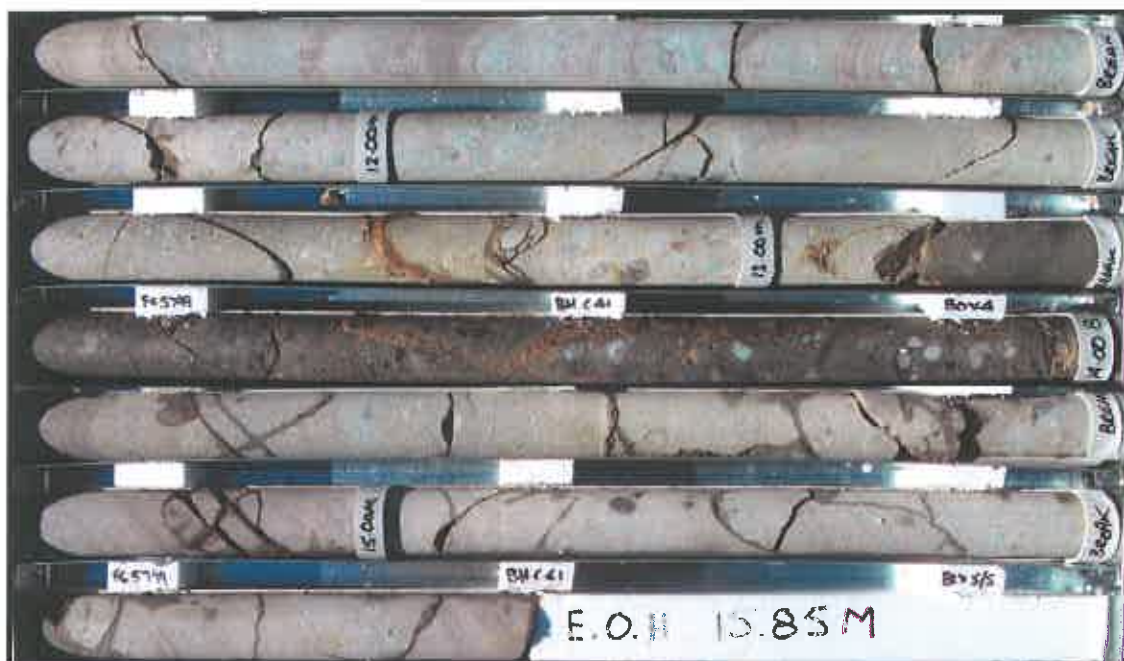
CORE PHOTO LOG - BH C41

Project Name:	BRUCE HIGHWAY UPGRADE - SECTION C		
Project No.:	FG5799	Date:	08/09/2011
Details:	Cut 10	Start Depth (m):	2.00
Reference No.:	H11130	Finish Depth (m):	15.85
