# ENGINEERING BOREHOLE LOG

BOREHOLE No BH C34

PROJECT Bruce Highway Upgrade (Coogoy to Curra) Section C

LOCATION Cut 9

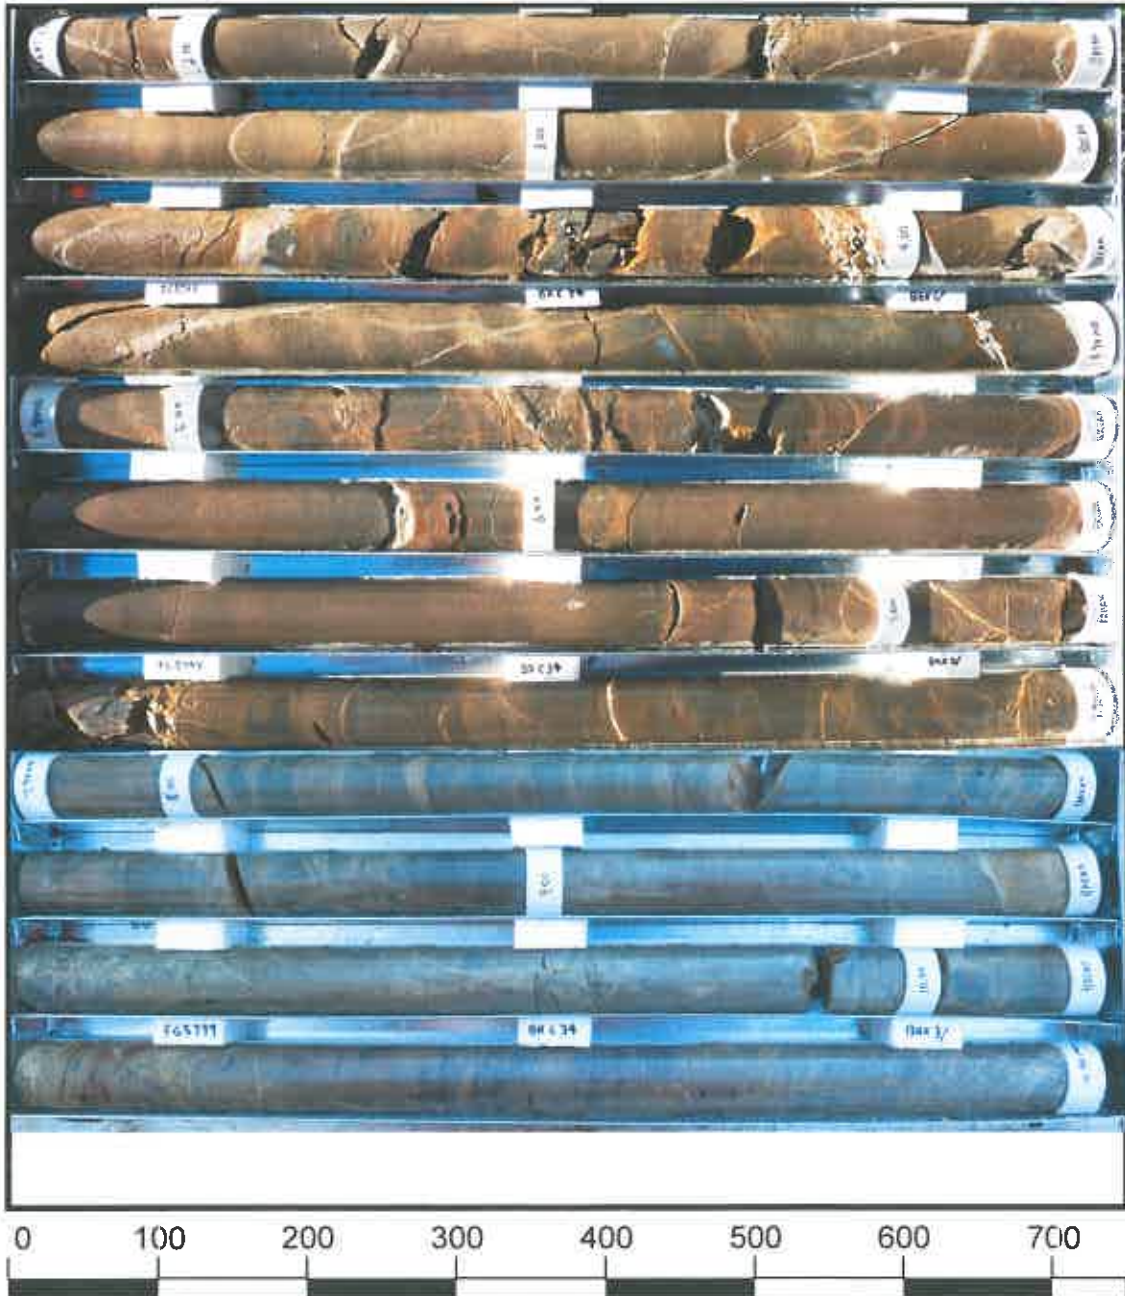
## CORE PHOTO LOG - BH C34

Project Name:	BRUCE HIGHWAY UPGRADE - SECTION C		
Project No.:	FG5799	Date:	08/09/2011
Details:	Cut 9	Start Depth (m):	1.90
Reference No.:	H11124	Finish Depth (m):	25.80

SCALE 1:5

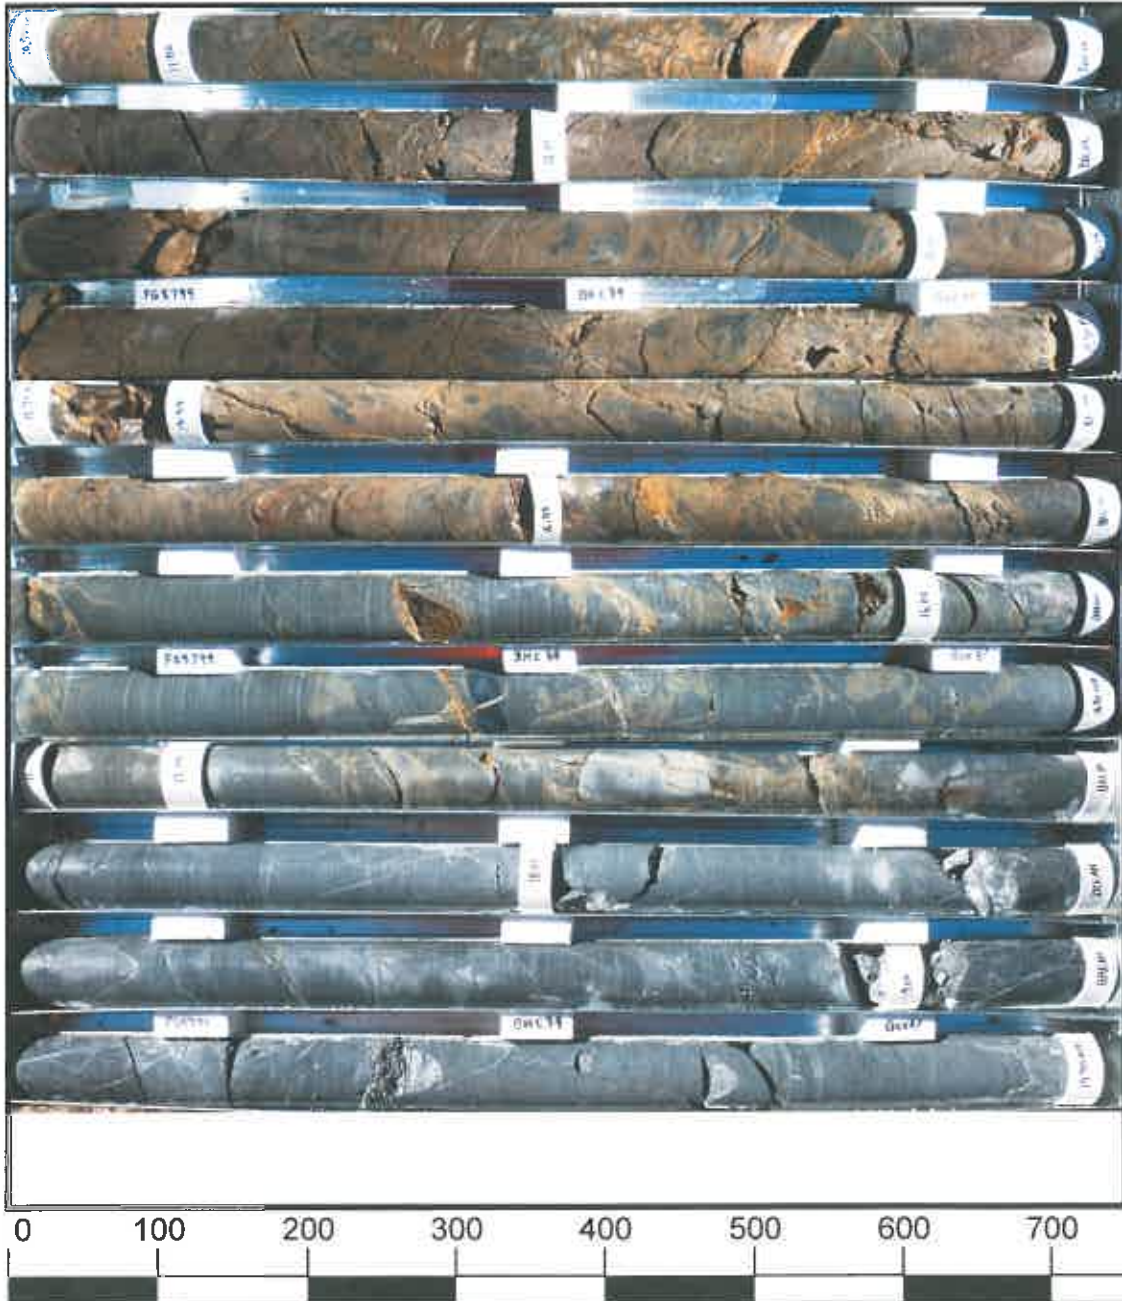
**CORE PHOTO LOG - BH C34**

Project Name:	BRUCE HIGHWAY UPGRADE - SECTION C		
Project No.:	FG5799	Date:	08/09/2011
Details:	Cut 9	Start Depth (m):	1.90
Reference No.:	H11124	Finish Depth (m):	25.80

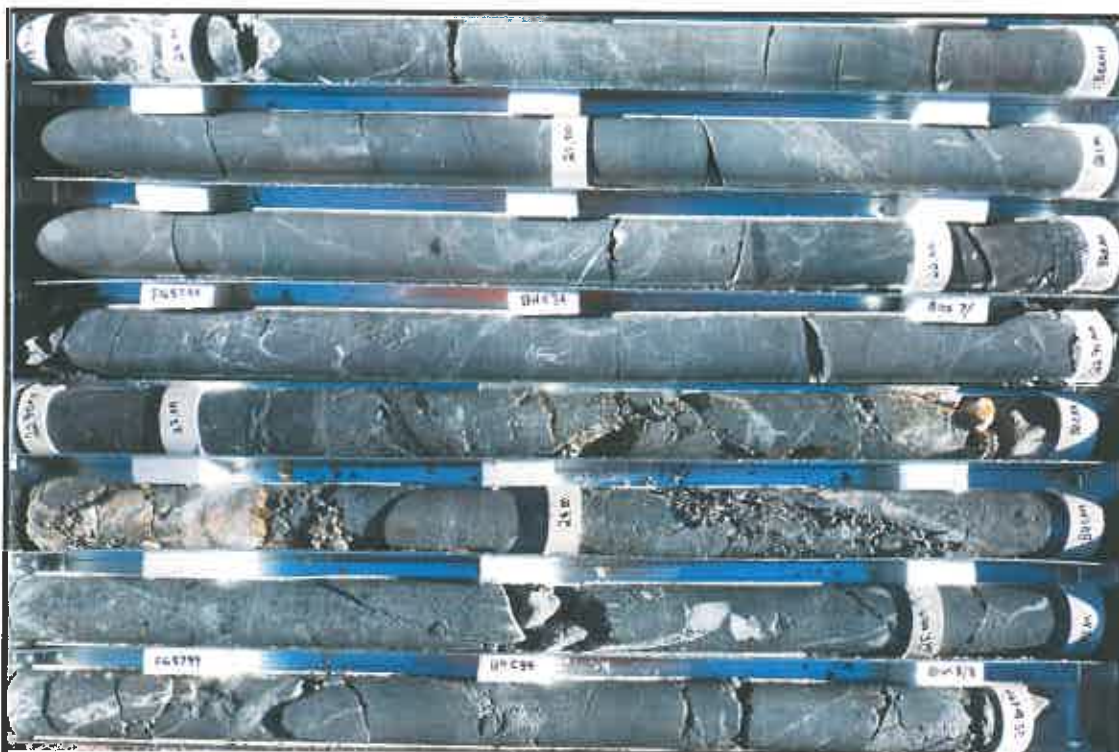
## CORE PHOTO LOG - BH C34

Project Name:	BRUCE HIGHWAY UPGRADE - SECTION C		
Project No.:	FG5799	Date:	08/09/2011
Details:	Cut 9	Start Depth (m):	1.90
Reference No.:	H11124	Finish Depth (m):	25.80

SCALE 1:5
