BRUCE HIGHWAY (COORDY - CURRA) SECTION A GEOTECHNICAL INVESTIGATION **PROJECT** Cut 11 LOCATION COORDINATES 485953.1 E; 7080881.9 N PROJECT No FG5825 DATE STARTED 13/7/09 GRID DATUM MGA94 SURFACE R.L. __167.79m PLUNGE _____ JOB No 128/10A/901 HEIGHT DATUM __AHD_ BEARING _ _ _ _ _ DATE COMPLETED 13/7/09 DRILLER R&D Drilling R.L. RQD INTACT DEFECT ADDITIONAL DATA ()% STRENGTH SPACING (m) (E) MATERIAL (mm) DEPTH (LITHOLOGY AND SAMPLES SAMPLE DESCRIPTION TESTS TOWAND CAN CORP. TO SERVICE CORP. TO SER CORE 28888 **TEST RESULTS** SETET REC % 0 Clayey SILT Pale grey with minor mottled red iron staining, moist, hard. 2,23,14 (CI-Organics throughout. SPT ML N = 37166.29 SILTSTONE (XW): 8,14,21 Datgel CPT Tool gINt Add-in 12/05/2010 10:30 В SPT Generally exhibits engineering properties XW N=35 of pale grey to mottled red, moist, hard 165.79 clayey silt. (42)SILTSTONE (HW): HΜ Grey with red mottling, fine grained Is(50) = 0.07MPa0 165.26 Is(50) = 0.05MPaX SILTSTONE (MW): Pale grey with mottled red and orange, fine grained, medium bedded. Is(50) = 0.07MPaDefects generally dip at <10° and are open. Is(50) = 0.14MPa 0 100 Defect surfaces are typically planar, Is(50) = 0.04MPa X (53)smooth, iron

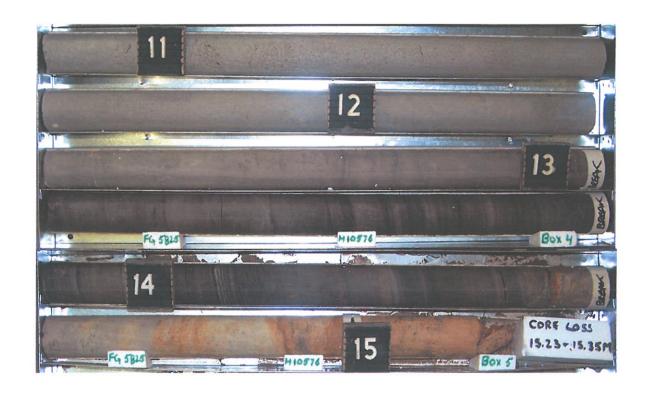
Borehole No: BH26
Start Depth: 2.00m
Finish Depth: 15.35m
Project No: FG5825
H No: 10576

Project: <u>Bruce Highway Upgrade (Cooroy - Curra) Section A</u>
