## ENGINEERING BOREHOLE

BOREHOLE No **BH12**

REFERENCE No **H9561**

PROJECT **GATEWAY UPGRADE PROJECT - GATEWAY BRIDGE DUPLICATION FOUNDATION INVESTIGATION**

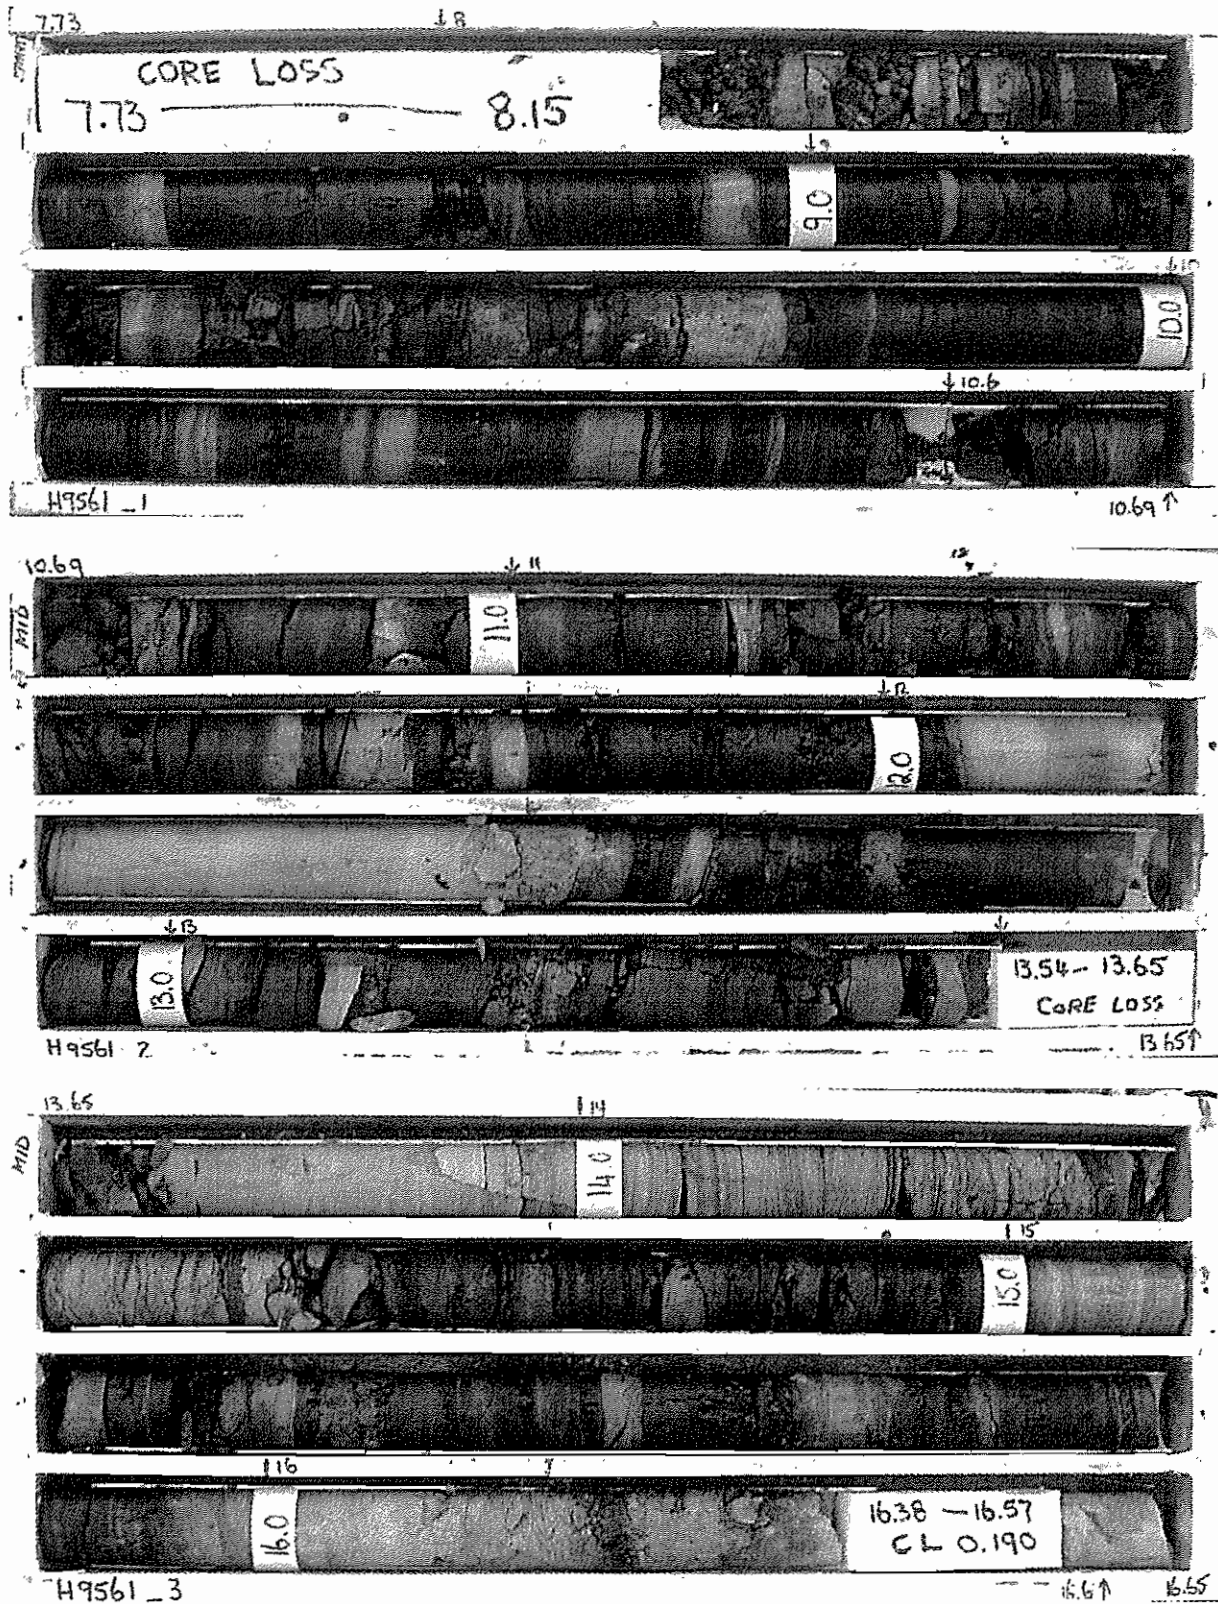
Project: **Gateway Upgrade Project - Gateway Bridge**  
Borehole No: **BH 12**  
Start Depth: 7.73  
Finish Depth: 37.18  
Project No: FG 5388  
H No: 9561

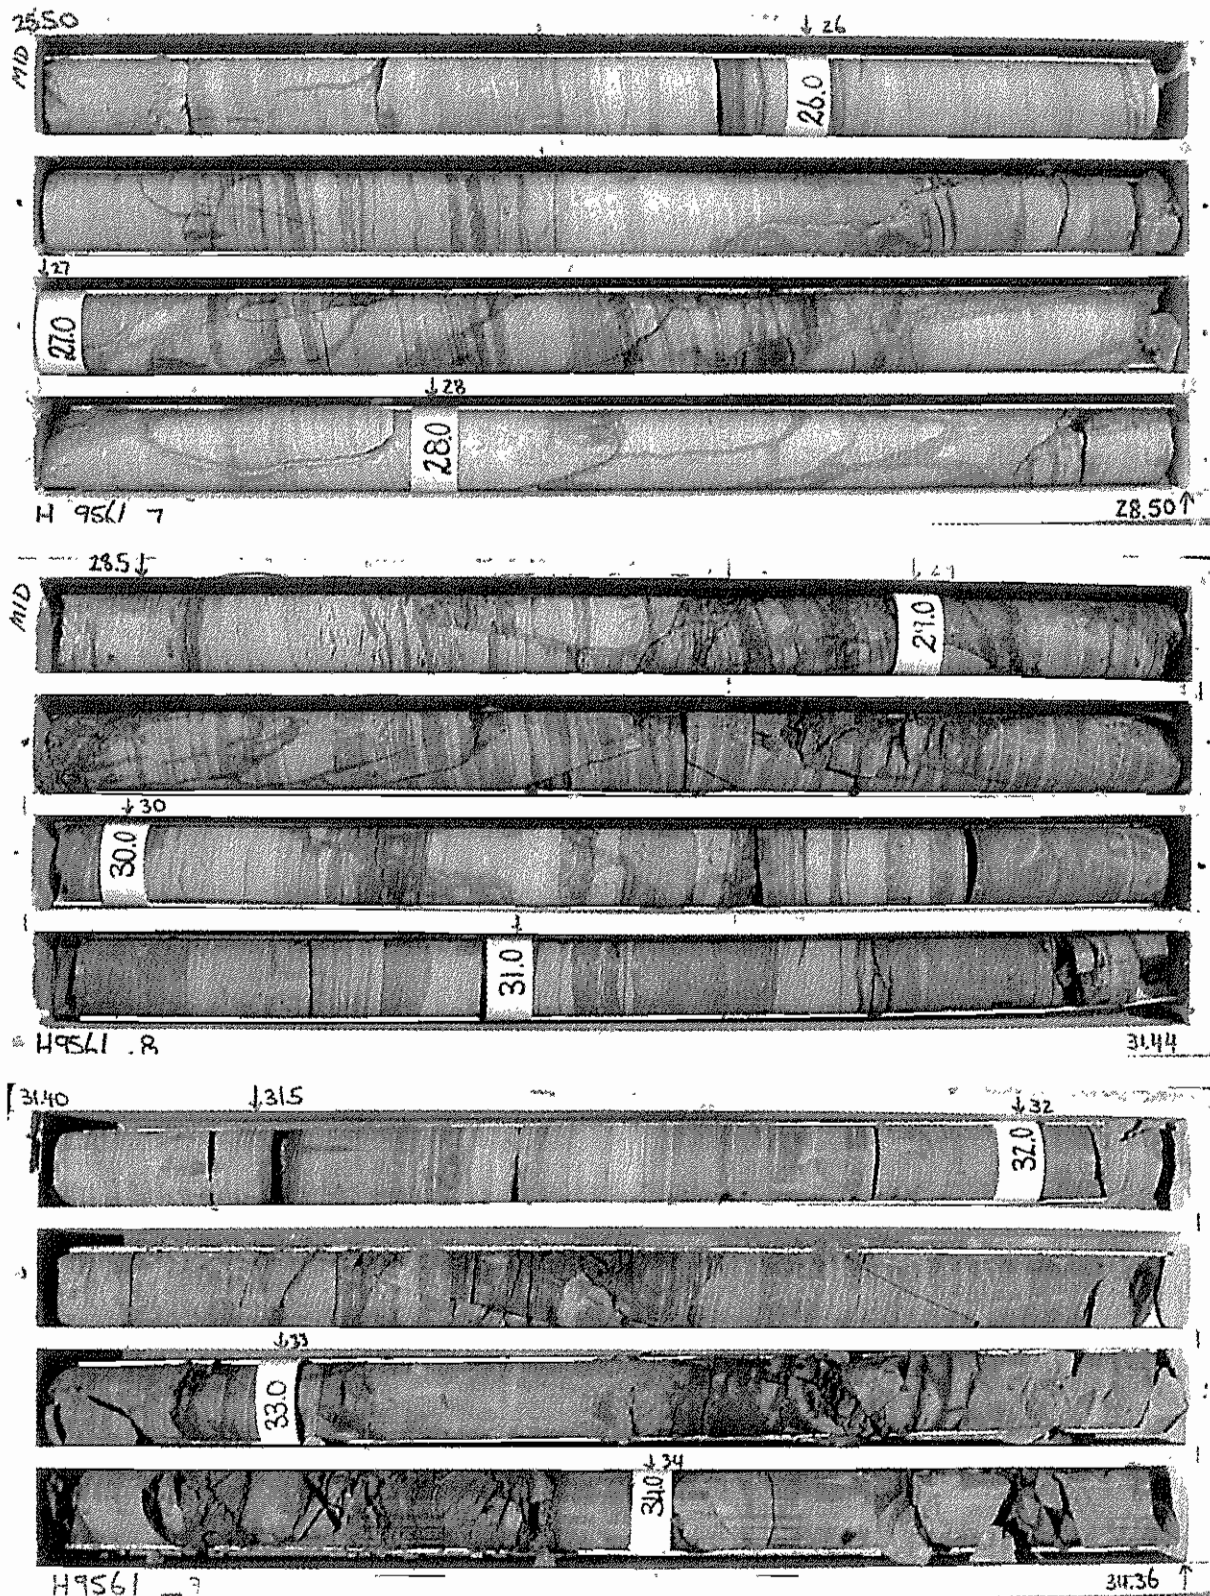
Project: **Gateway Upgrade Project - Gateway Bridge**

Borehole No: **BH 12**
