FREDERICK STREET OVERPASS FOUNDATION INVESTIGATION

Sheet 1 of 2

HOLE No. 5

DATE 7-4-87

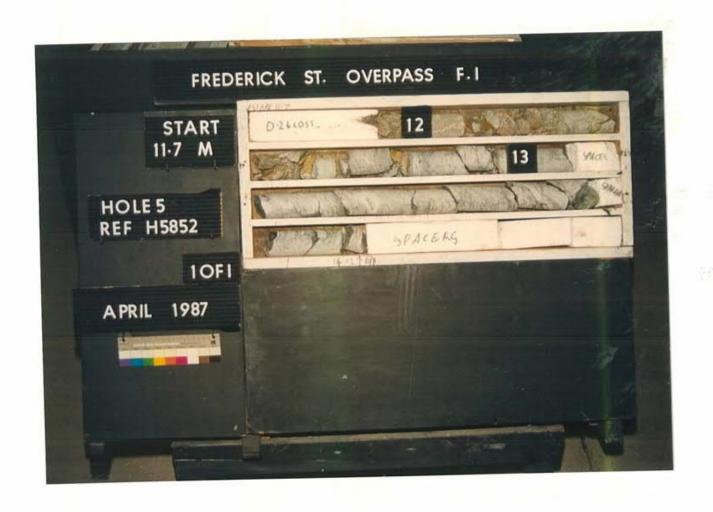
of Sheet 2 2

JOB		0.	PROJECT No.	DATE	SURFACE R.L.		
CASING	(m)	1:50	STRATA DESCRIPTION	R.Q.D.	Log		ENGINEERING PROPERTIE
50"	TH (R.L	SOIL TYPE	7 / 10/		STRUCTURE	INTACT DEFECT STRENGTH SPACING
OTHE	DEPTH	5.22	OR WEATHERING	REC. %	GRAPHIC		STRENGTH SPACING
			Clayey SAND	G23			1111111111
I	1-		Minor gravel present below 10.0m		8		
	-	3.72		30*			4
ľ	2-	3.22	HIGHLY WEATHERED Clayey throughout	H 90			
			HIGHLY WEATHERED Clayey throughout MODERATELY WEATHERED Highly, siliceous throughout, quartz veining common and contorted: foliation obscure. Defects div	73	1	High angle defect, brown ironstained.	
	3-	0.	No at low (<20°) and		A Day of		*
	4-	1.17	high angles brown ironstained on defections	97	1	981	
			END OF HOLE				7
	5-						
	6-						
	7-		7				
	-						
	8-						
	9-						T
	-
