## REPORT ON CONE PENETROMETER TEST

Client **MAIN ROADS - GATEWAY UPGRADE PROJECT TEAM**  
Project **GATEWAY UPGRADE**  
Job Ref.  
Location **E 9319.91 N 169918.74 SET DATUM**  
Chainage  
Sounding **CPTU153E**  
Test Date **28/06/2004**  
Remarks **Dissipation Test @ 7.5m**

## REPORT ON CPT<sub>u</sub> DISSIPATION TEST

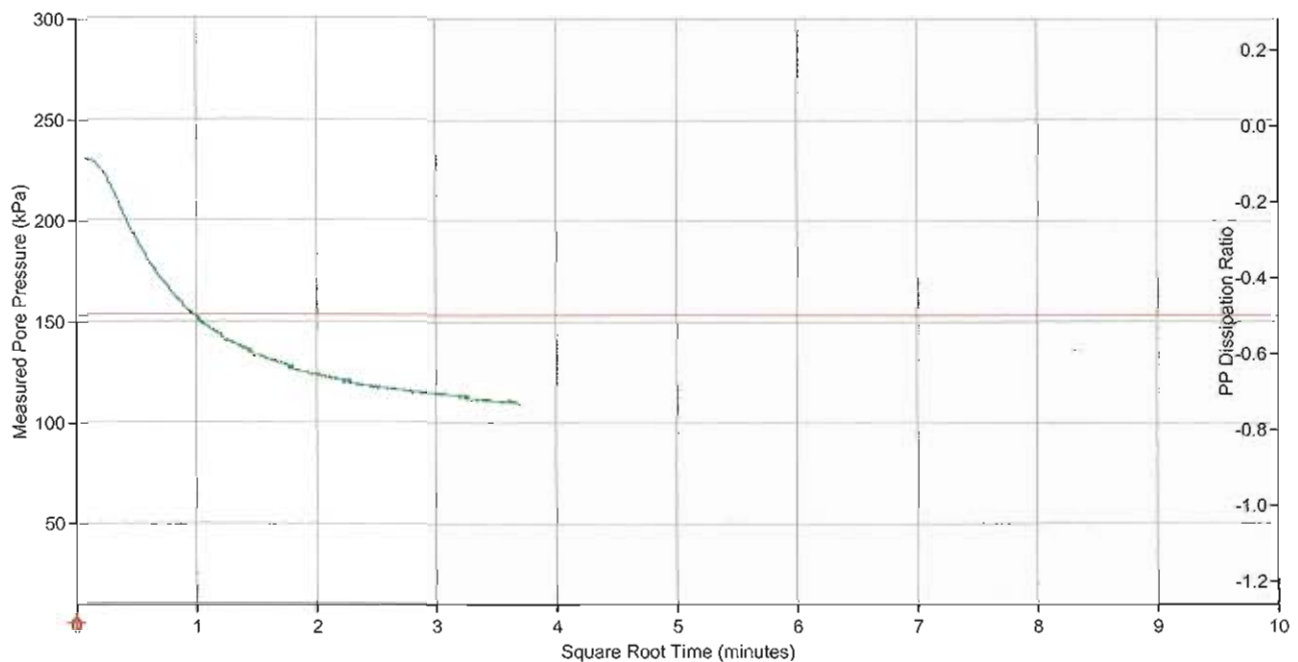
Client **MAIN ROADS - GATEWAY UPGRADE PROJECT TEAM**  
 Project **GATEWAY UPGRADE**  
 Job Ref.  
 Location **E 9319.909 N 169918.7**  
 Chainage  
 Sounding **CPTU153A**  
 Test Date **10/02/2005**  
 Remarks **Dissipation Test @ 7.0m**

Project No. **FG5389**  
 Surface RL **2.745**  
 Water Table **1.000**  
 Start Depth **1.000**

Depth (m) **7.00**  
 Start Pressure (kPa) **247**  
 Dissipation (%) **50**  
 Dissipation Pressure (kPa) **153**  
 Time for Dissipation (min) **1.0**
