# ENGINEERING BORELOG

BOREHOLE No : 202
SHEET : 1 OF 2

REFERENCE No : H8147

## SOUTH EAST TRANSIT PROJECT BH 202 1.00 - 3.40 M

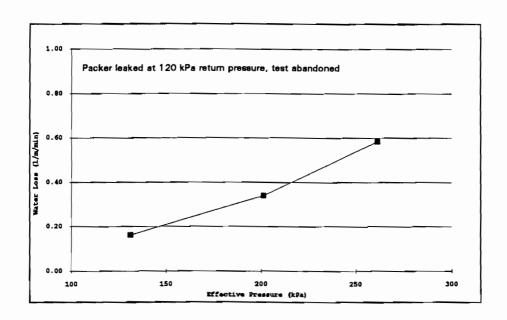
#### WATER PRESSURE TEST RESULTS

2 LUGEONS

Gauge Pressure (kPa)	Effective Pressure (kPa)	Test Duration (min)	Meter Start (litres)	Meter End (litres)	Water Loss (litres)	Leakage (1/m/min)	Lugeons
50	131.3	5	85	89.3	4.3	0.16	1.24
120	201.3	5	97.8	106.8	9	0.34	1.69
180	261.3	5	124.9	140.4	15.5	0.58	2.24
