REPORT ON CONE PENETROMETER TEST

Client **MAIN ROADS - GATEWAY UPGRADE PROJECT TEAM**
Project **GATEWAY UPGRADE**
Job Ref.
Location **E 9717.76 N 172409.32 SET DATUM**
Chainage
Sounding **CPTU149**
Test Date **23/06/2004**
Remarks **Dissipation Tests @ 5.5 & 11.0m**

Project No. **FM2055**
Surface RL **1.190**
Water Table **1.200**
Start Depth **1.000**
Refusal **21.650**

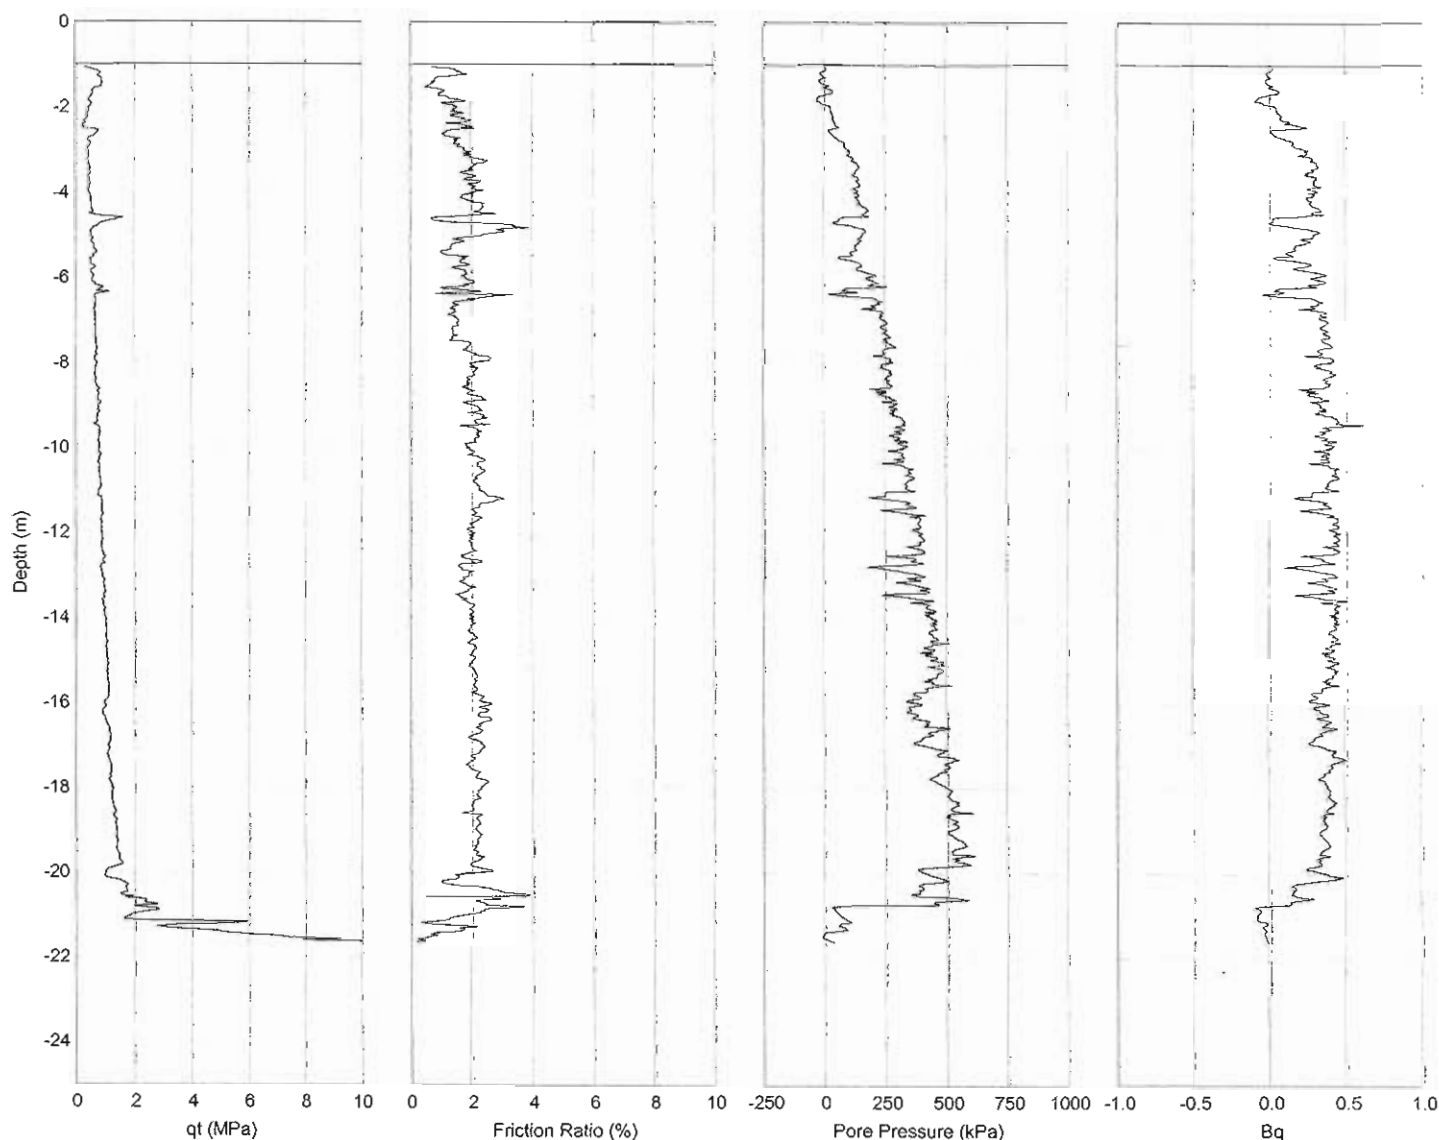
Date	8/07/2004	Cone Type	Piezocone
Checked	<i>[Signature]</i>	Cone ID	3167
Signatory	<i>[Signature]</i>	Factor "a"	0.580
		Factor "b"	0.014
		Test Method	Q151A
		Report No.	FM2055/CPTU149/Q151A

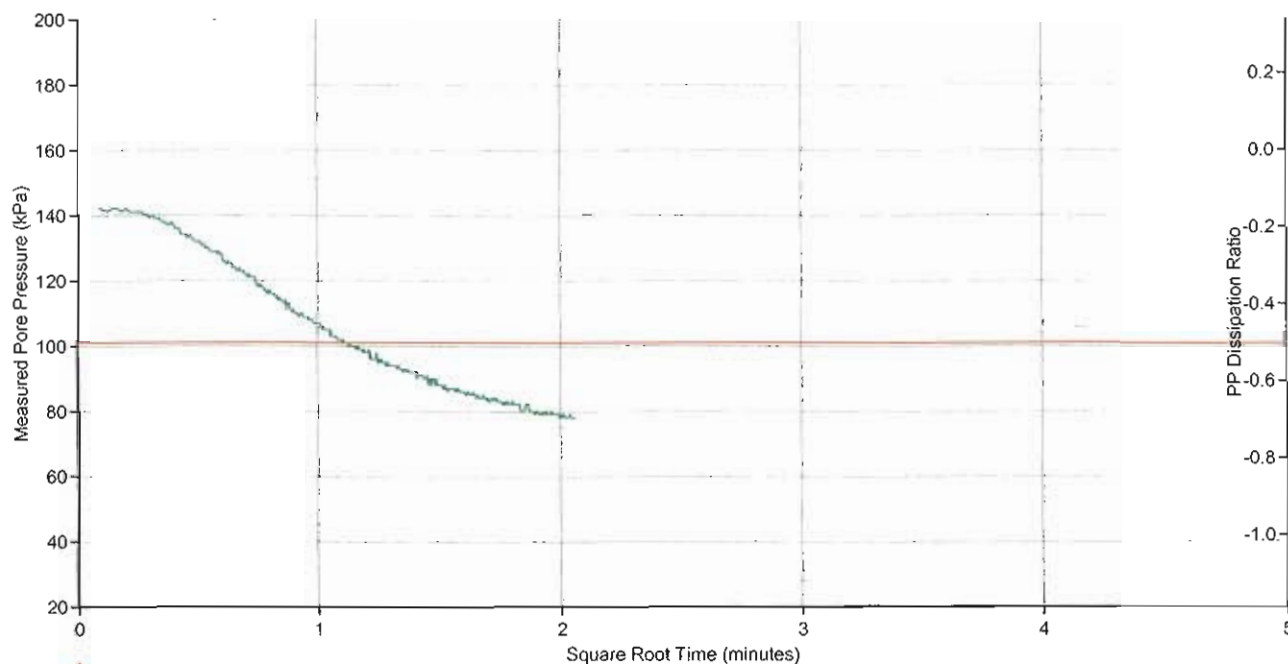
REPORT ON CPT_u DISSIPATION TEST

Client **MAIN ROADS - GATEWAY UPGRADE PROJECT TEAM**
Project **GATEWAY UPGRADE**
Job Ref.
Location **E 9717.76 N 172409.32 SET DATUM**
Chainage
Sounding **CPTU149**
Test Date **23/06/2004**
Remarks **Dissipation Tests @ 5.5 & 11.0m**

Project No. **FM2055**
Surface RL **1.190**
Water Table **1.200**
Start Depth **2.000**

Depth (m) **5.49**
Start Pressure (kPa) **160**
Dissipation (%) **50**
Dissipation Pressure (kPa) **101**
Time for Dissipation (min) **1.3**

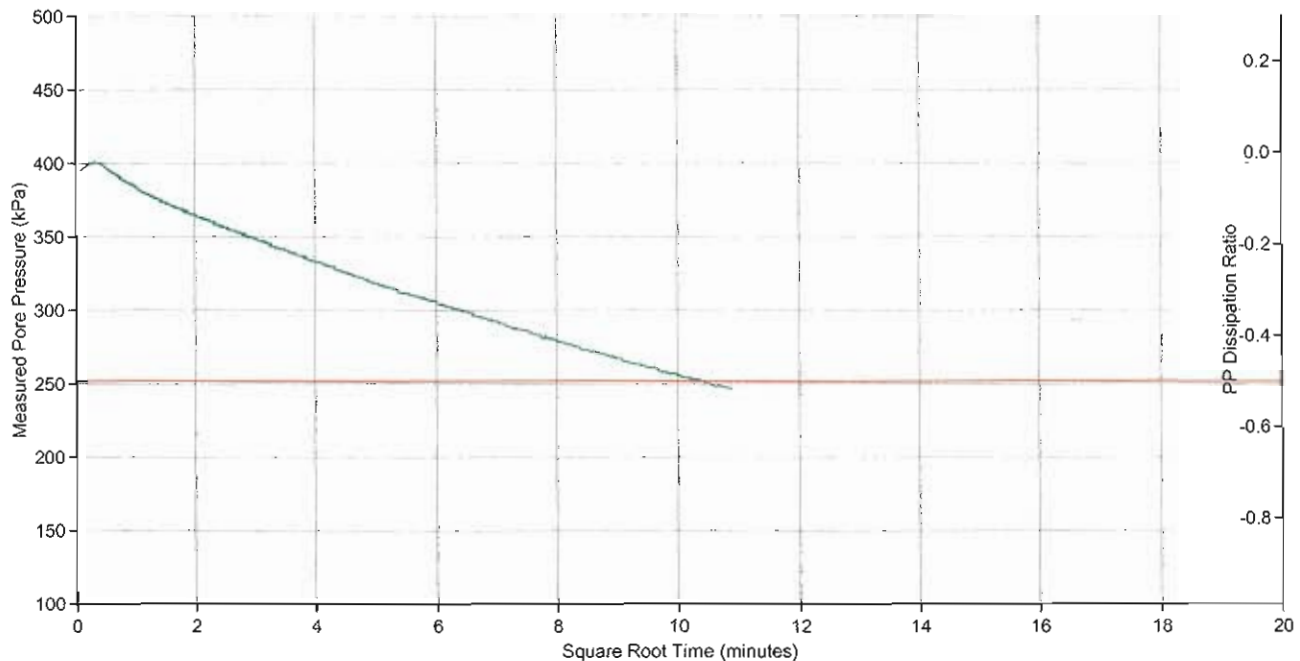
REPORT ON CPT_u DISSIPATION TEST

Client **MAIN ROADS - GATEWAY UPGRADE PROJECT TEAM**
Project **GATEWAY UPGRADE**
Job Ref.
Location **E 9717.76 N 172409.32 SET DATUM**
Chainage
Sounding **CPTU149**
Test Date **23/06/2004**
Remarks **Dissipation Tests @ 5.5 & 11.0m**

Project No. **FM2055**
Surface RL **1.190**
Water Table **1.200**
Start Depth **2.000**

Depth (m) **11.01**
Start Pressure (kPa) **407**
Dissipation (%) **50**
Dissipation Pressure (kPa) **252**
Time for Dissipation (min) **104**
