ENGINEERING BOREHOLE LOG

FOR GEOTECHNICAL TERMS AND SYMBOLS REFER FORM F:GEOT 017/6-2010
 BOREHOLE No
 _____BH14____

PROJECT	<u> </u>	lore	eton Bay	Rai	<u> Link</u>							
LOCATION	_ <u>C</u>	: <u>h.5</u>	<u>840 on (</u>	<u>Cent</u>	treline, Cut 5					CC	ORDINATES 502760.8 E; 6986348	. <u>5 N</u>
					SURFACE R.L. <u>26.30m</u> PLUNGE					<u>4/5/1</u>	1 GRID DATUMMGA94_Zone	<u> </u>
JOB No	_2	<u>50/</u>	120/3		HEIGHT DATUM <u>AHD</u> BEARING			DATE COM	IPLETED	<u>4/5/1</u>	1 DRILLER <u>R&D Drilling</u>	Pty Ltd

Project Name	Moreton Bay Rail Link (MBRL)		
Project No	FG5921	Date	04/05/11
Borehole No	BH 14	TMR H No	11024
Location	Mango Hill Station	Start Depth (m)	2.50
Detail	Cut	Finish Depth (m)	20.50
Chainage	5840 Approx	Submitted By	BW
Remarks			•

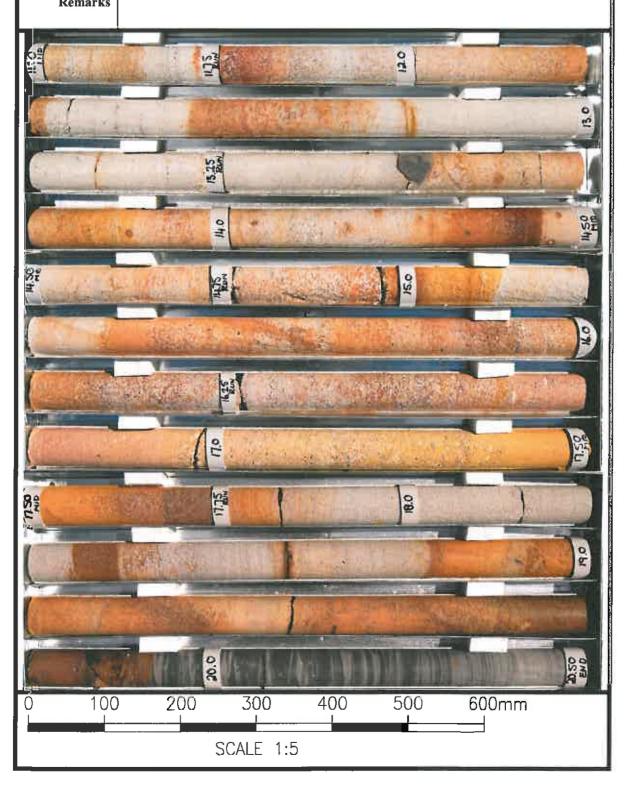
CORE PHOTO LOG DEPARTMENT OF TRANSPORT & MAIN ROADS

Project Name	Moreton Bay Rail Link (MBRL)		
Project No	FG5921	Date	04/05/11
Borehole No	BH 14	TMR H No	11024
Location	Mango Hill Station	Start Depth (m)	2.50
Detail	Cut	Finish Depth (m)	20.50
Chainage	5840 Approx	Submitted By	BW
Remarks		•
