ENGINEERING BOREHOLE LOG

BOREHOLE No	BH4
SHEET	_ <u>1</u> _ of _ <u>5</u> _
REFERENCE No	<u>H12011</u>

JECT Mt Whitestone: Slope Instability Investigation - Preliminary Inclinometer Boreholes ATION Below the road COORDINATES 416161.3 E; 6937854.7 N												
					SURFACE R.L. <u>212.52m</u> PLUNGE _				DATE STARTED			RID DATUM MGA94	
JOB			<u></u>		HEIGHT DATUM <u>AHD</u> BEARING _				ATE COMPLETED _			DRILLER Hinterland	
DEPTH (m)	R.L. (m)	JGER ASING ASH BORING ORE DRILLING	RQD ()%	SAMPLE	MATERIAL DESCRIPTION	OLOGY		l II	INTACT DEFECT SPACING (AS1726) (AS1726) (AS1726)	T	AI	DDITIONAL DATA AND TEST RESULTS	SAMPLES
30	182.52	 ₹9≷9		<i>/</i> S	Sandy CLAV with Cabbles and Bauldon	5	ĭĭ ≅			5	Prokon 70	uno.	/S ==
-31 -32 -33 -33			100 100 100 85		Sandy CLAY with Cobbles and Boulders (COLLUVIUM) as before						□ material Carbonac Carbonac Sandston Soft clay Sandston □ Soft clay Sandston □ Soft clay Sandston □ Soft clay S□ Sandston □ S	e boulder one seam, carbonaceous eous layer e cobble seam e boulder e cobble seam ### Cobble ### Seam ### Pass 2.360mm = 46 ### Pass 0.075mm = 24 ### Pass 0.002mm = 5

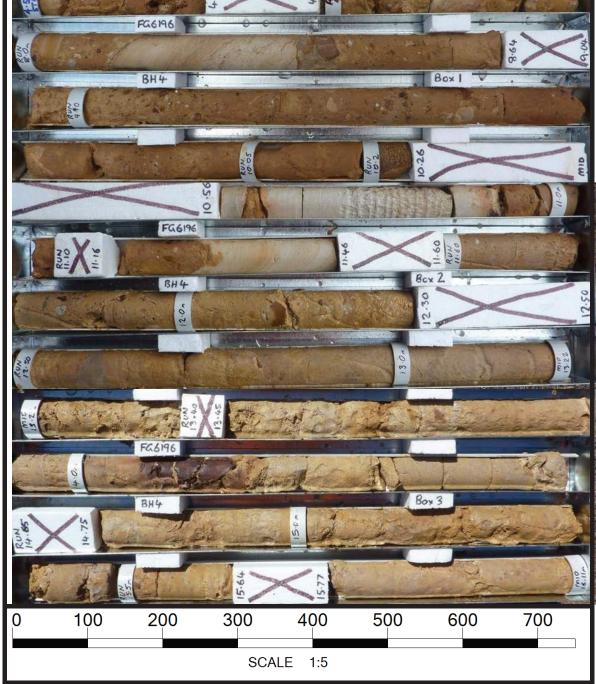
Page 1 GEOT043/2

066 3336			Government
Project Name	Mt Whitestone (Detailed Investi	igation)	
Project No.	FG6196	Start Date	4/11/14
Borehole No.	BH 4	Finish Date	7/11/14
Location		Start Depth (m)	4.50
Detail	Gatton Clifton Rd -313	Finish Depth (m)	41.60
Chainage	15.04-15.40km	Submitted By	TH
Remarks		·	
	Facine O O O	Tabah Arabah Ara	1
Sec.			13%
	BH4	BoxI	. 6

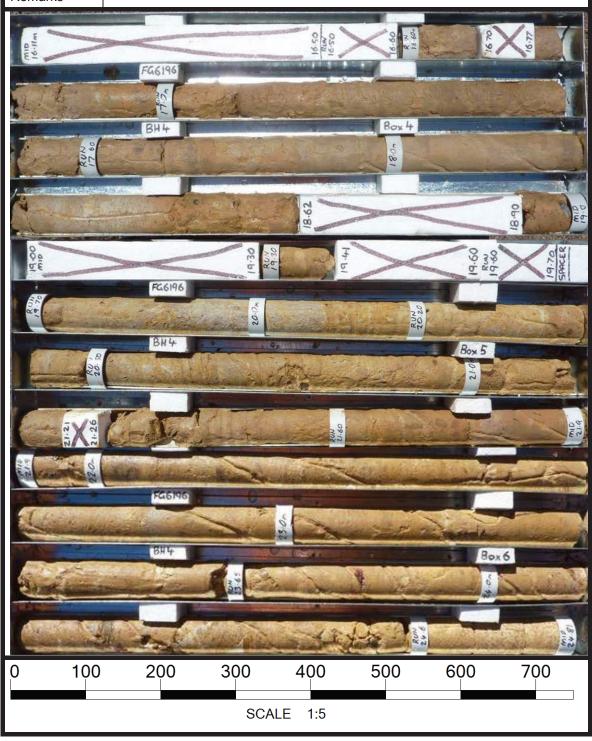
Page 2 GEOT043/2

Drainat Nama	Mt Whitestone (Detailed Investigation)		
Project Name	wit willtestone (Detailed investigation)		
Project No.	FG6196	Start Date	4/11/14
Borehole No.	BH 4	Finish Date	7/11/14
Location		Start Depth (m)	4.50
Detail	Gatton Clifton Rd -313	Finish Depth (m)	41.60
Chainage	15.04-15.40km	Submitted By	TH
Remarks

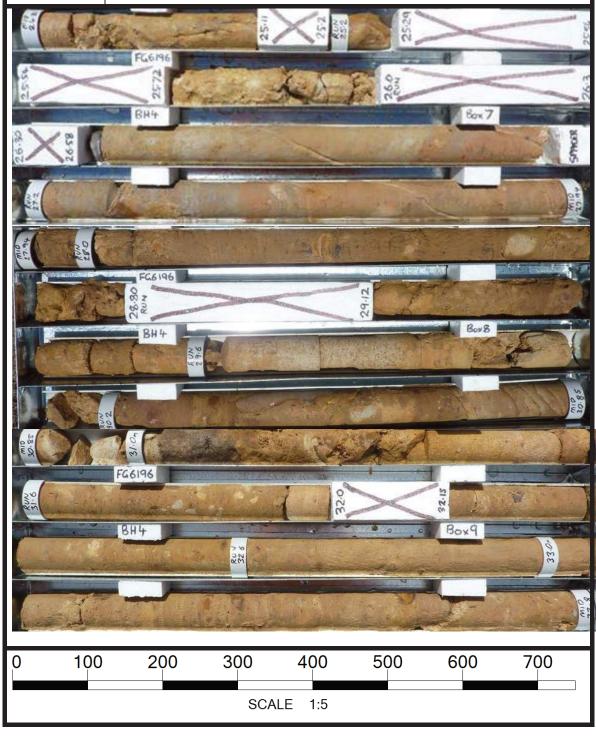
Page 3 GEOT043/2

Project Name	Mt Whitestone (Detailed Investigation)		
Project No.	FG6196	Start Date	4/11/14
Borehole No.	BH 4	Finish Date	7/11/14
Location		Start Depth (m)	4.50
Detail	Gatton Clifton Rd -313	Finish Depth (m)	41.60
Chainage	15.04-15.40km	Submitted By	TH
Remarks

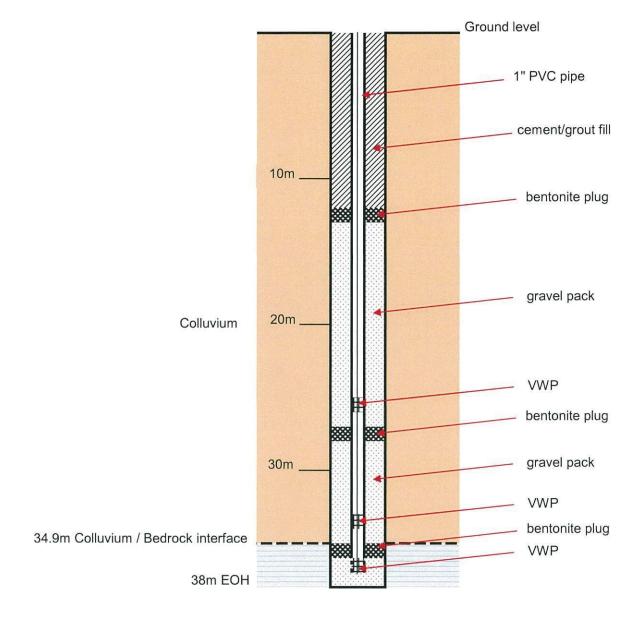
Stand Pipe Details - SP4

SCALE 1:5
