# REPORT ON CONE PENETROMETER TEST

Project GATEWAY UPGRADE

# REPORT ON CPTu DISSIPATION TEST

Chainage Sounding CPTU160 Water Table 1.500 Start Depth 1.525

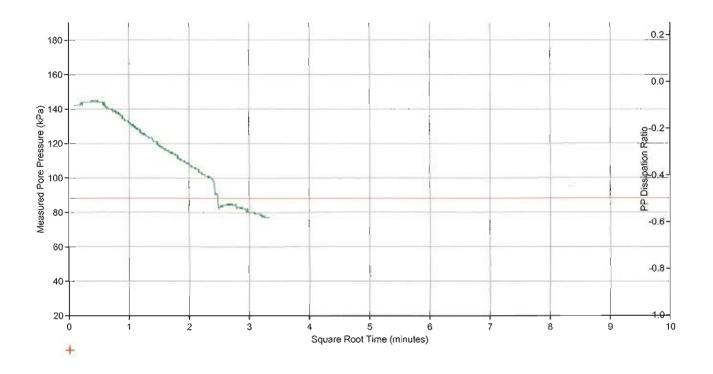
Remarks Dissipation Tests @ 3.5 & 5.5m

Depth (m)	3.58
Start Pressure (kPa)	156
Dissipation (%)	50
Dissipation Pressure (kPa)	88
Time for Dissipation (min)	6.8

Cone Type	Piezocone	
Date	1/03/2005 /	Cone ID	3167	LN.
100	14 A	Factor "a"	0.580	V <sup>α</sup> τ <sup>N</sup>
Checked /5/	Factor "b"	0.014	NATA Accreditation Number 230	
Signatory Bally	Test Method	Q151A	NATA Endorsed Test Report	
	Report No.	FG5389/CPTU160/Q151A	This document may not be reproduced except in full.

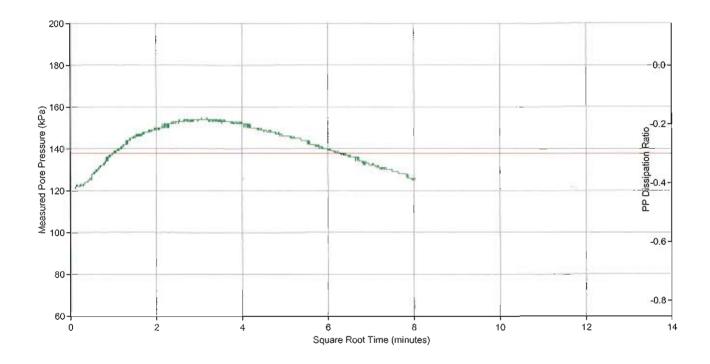
Test Date 10/02/2005
Remarks Dissipation Tests @ 3.5 & 5.5m

Depth (m)	5.51
Start Pressure (kPa)	180
Dissipation (%)	30
Dissipation Pressure (kPa)	138
Time for Dissipation (min)	39.7

1-27-2-2-2	Cone Type	Piezocone	
Date	1/03/2005	Cone ID	3167	N.
	and A	Factor "a"	0.580	N <sup>a</sup> zV
Checked /ST/	Factor "b"	0.014	NATA Accreditation Number 2302	
Signatory	Test Method	Q151A	NATA Endorsed Test Report	
	DAMPANO	Report No.	FG5389/CPTU160/Q151A	This document may not be reproduced except in full

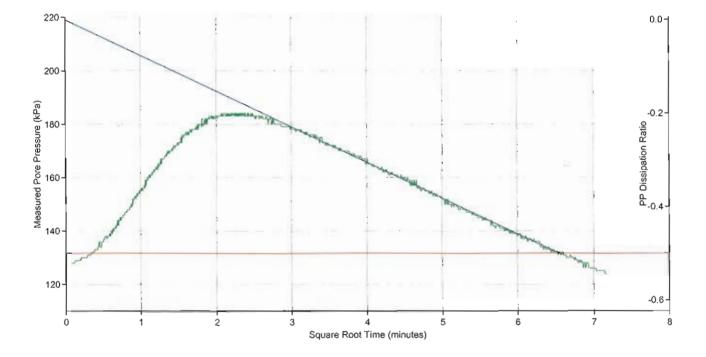
Remarks Dissipation Test at 7.0m

Water Table was not measured and is assumed.

Depth (m)	7.00
Start Pressure (kPa)	219
Dissipation (%)	50
Dissipation Pressure (kPa)	132
Time for Dissipation (min)	43.0

Cone Type	Piezocone
Date	08/11/2094	Cone ID	3167
	91	Factor "a"	0.580
Checked	13/1	Factor "b"	0.014
	DOM 12	Test Method	Q151A
Signatory	AND MAN	Report No.	FM2055/CPTU160/Q151A
