ENGINEERING BOREHOLE

BOREHOLE No ___BH1 _1_ of _2_ SHEET H9550 REFERENCE No

GATEWAY UPGRADE PROJECT - GATEWAY BRIDGE FOUNDATION INVESTIGATION ABUTMENT A LOCATION COORDINATES 10589.7 E; 167274.4 N PROJECT No FG5388 SURFACE R.L. _ 7.78 __. DATE STARTED _23/4/05 DATUM SETP JOB No 0405 DATE COMPLETED 23/4/05 DATUM _AHD _ DRILLER GEOTECH DRILLING R.L RQD INTACT DEFECT (m) ()% STRENGTH SPACING ADDITIONAL DATA Ξ MATERIAL (mm) DEPTH -ITHOLOGY AND SAMPLES DESCRIPTION AUGER CASIN WASH CORE SAMPL TESTS CORE TEST RESULTS REC % 0 7.78 RESIDUAL SILTY GRAVEL Grey and brown, moist. GC 6.98 SANDSTONE XW MEDIUM TO COARSE GRAINED (100)LAMINATED TO MASSIVE POORLY CEMENTED SEDIMENTARY ROCK VL strength clayey band. As above. Is(50)=0.51 MPa LP, 20°, PL, SM, CN.Is(50)=0.54 MPa MW: Pale grey to orange, laminated to o massive, medium to coarse grained, mainly JT, T, subvertical, iron stained. medium to high strength. Massive Minor orange iron stained bands and SW Is(50)=0.51 MPa carbonaceous interlaminations parallel to 0 04.GDT 31/8/05 bedding in parts. Is(50)=0.32 MPa x Is(50)=0.41 MPa o Defects: Bedding/lamiantion partings (55) mainly 10-20°, occasionally 30°. Is(50)=1.59 MPa ENGINEERING BOREHOLE 09_

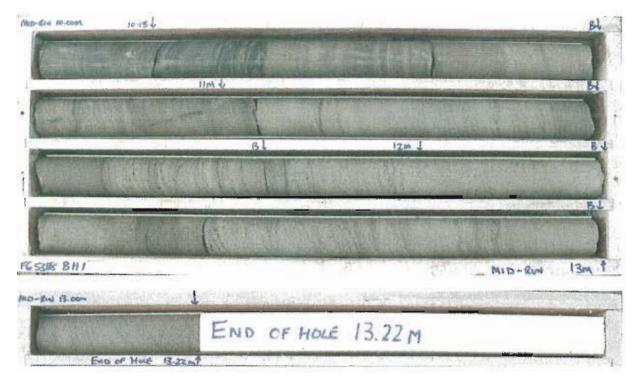
Borehole No: BH 1
Start Depth: 1.00m
Finish Depth: 13.22m

Project: Gateway Upgrade Project - Gateway Bridge

Project No: FG 5388 H No: 9550
