## REPORT ON CONE PENETROMETER TEST

Client **MAIN ROADS - GATEWAY UPGRADE PROJECT TEAM**  
Project **GATEWAY UPGRADE**  
Job Ref.  
Location **E 9537.86 N 172843.36 SET DATUM**  
Chainage  
Sounding **CPTU131**  
Test Date **9/06/2004**  
Remarks **Dissipation Tests @ 3.0, 5.1, 7.0, 10.0, 17.0, 17.5 & 23.0m**

Project No. **FM2055**  
Surface RL **1.630**  
Water Table **0.900**  
Start Depth **0.000**  
Refusal **24.950**

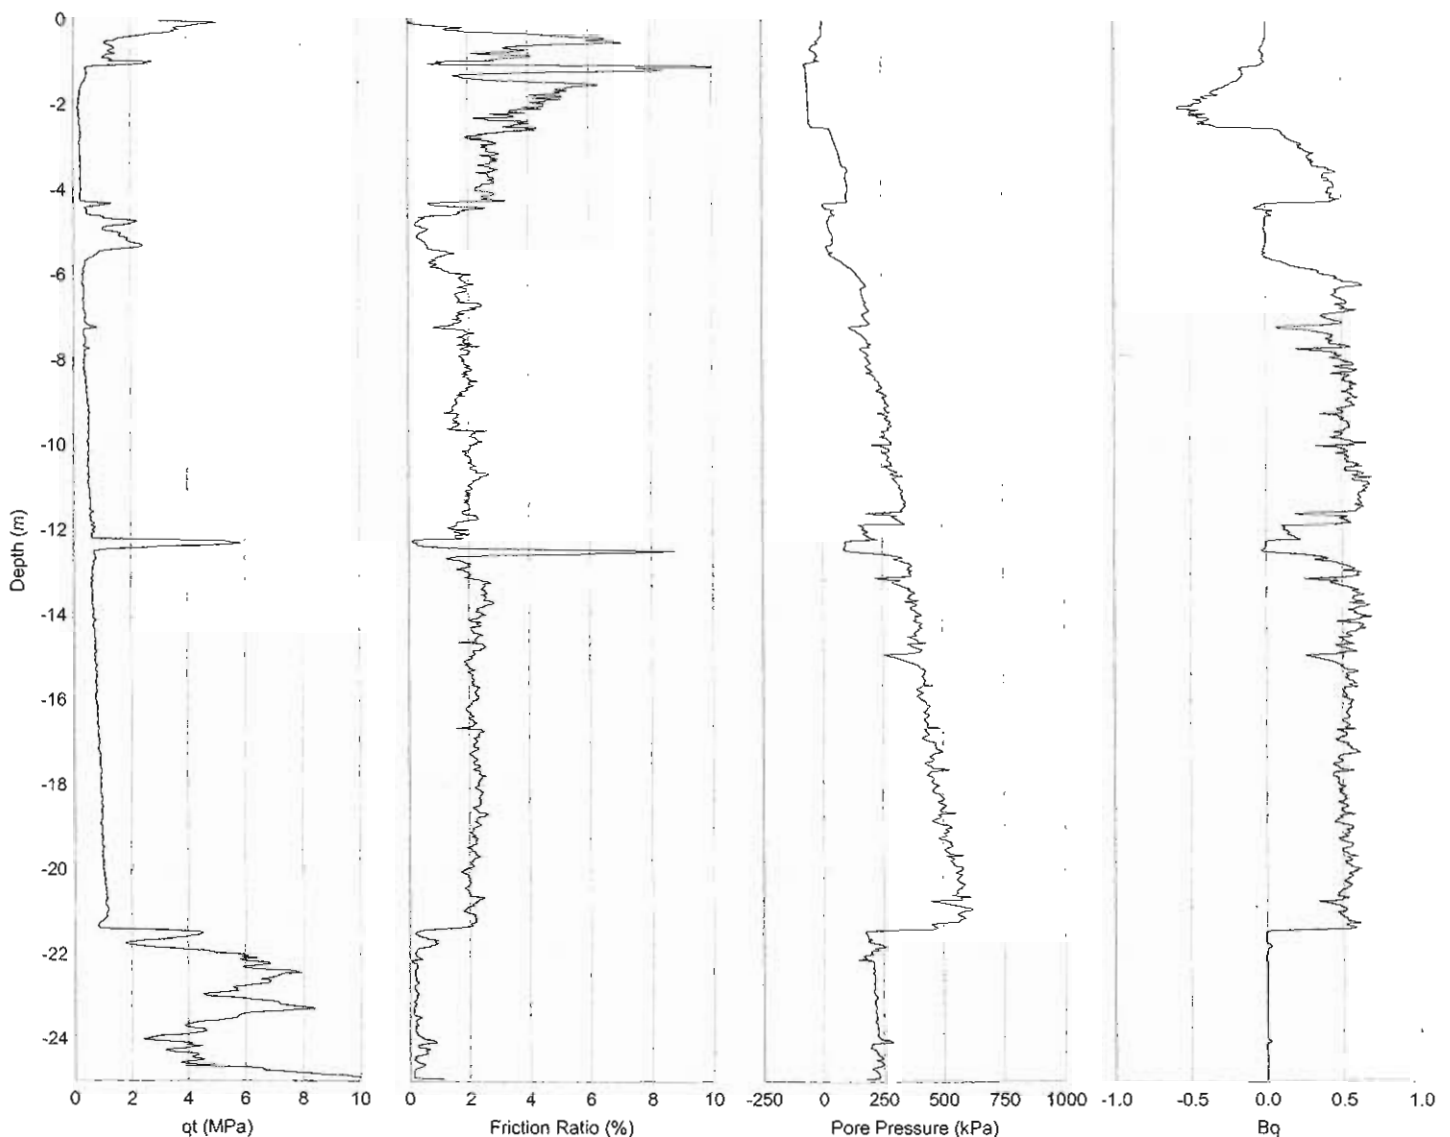
Date	7/07/2004	Cone Type	Piezocone
Checked	 	Cone ID	3167
Signatory	 	Factor "a"	0.580
		Factor "b"	0.014
		Test Method	Q151A
		Report No.	FM2055/CPTU131/Q151A

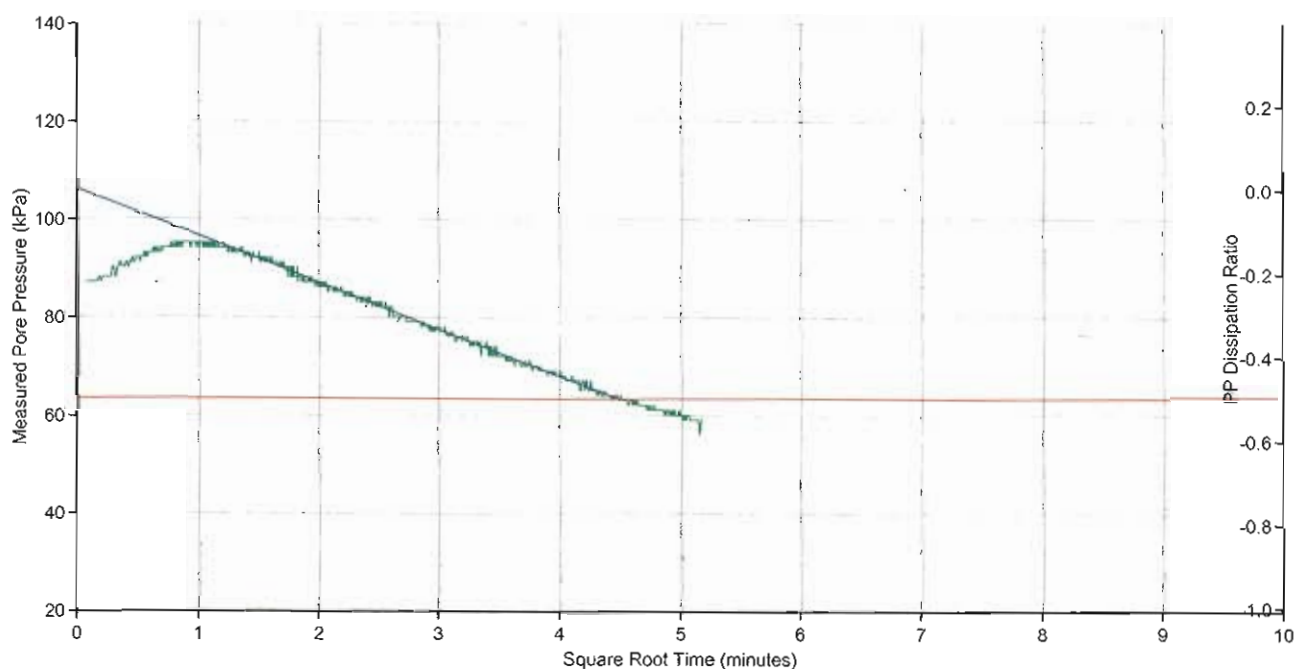
## REPORT ON CPT<sub>u</sub> DISSIPATION TEST

Client **MAIN ROADS - GATEWAY UPGRADE PROJECT TEAM**  
Project **GATEWAY UPGRADE**  
Job Ref.  
Location **E 9537.86 N 172843.36 SET DATUM**  
Chainage  
Sounding **CPTU131D**  
Test Date **9/06/2004**  
Remarks

Project No. **FM2055**  
Surface RL **1.630**  
Water Table **0.900**  
Start Depth **1.600**

Depth (m) **3.01**  
Start Pressure (kPa) **106**  
Dissipation (%) **50**  
Dissipation Pressure (kPa) **63**  
Time for Dissipation (min) **20.0**

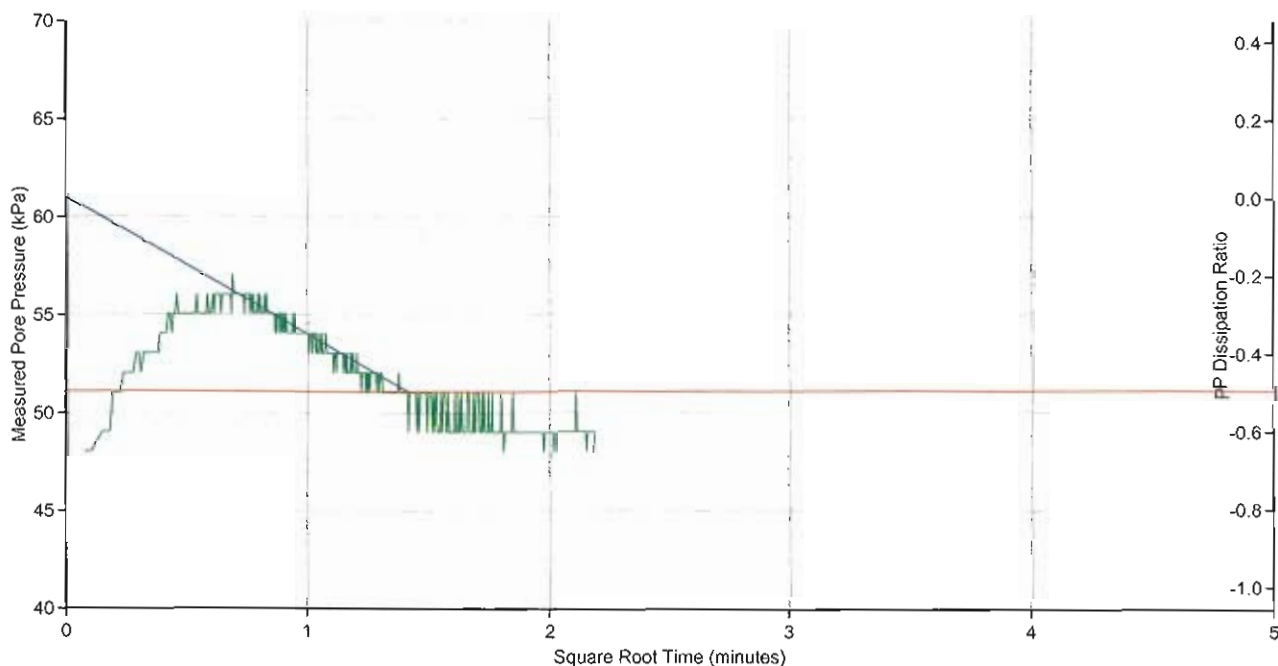
## REPORT ON CPT<sub>u</sub> DISSIPATION TEST

Client **MAIN ROADS - GATEWAY UPGRADE PROJECT TEAM**  
Project **GATEWAY UPGRADE**  
Job Ref.  
Location **E 9537.86 N 172843.36 SET DATUM**  
Chainage  
Sounding **CPTU131F**  
Test Date **23/06/2004**  
Remarks

Project No. **FM2055**  
Surface RL **1.630**  
Water Table **0.900**  
Start Depth **1.025**

Depth (m) **5.10**  
Start Pressure (kPa) **61**  
Dissipation (%) **50**  
Dissipation Pressure (kPa) **51**  
Time for Dissipation (min) **2.0**

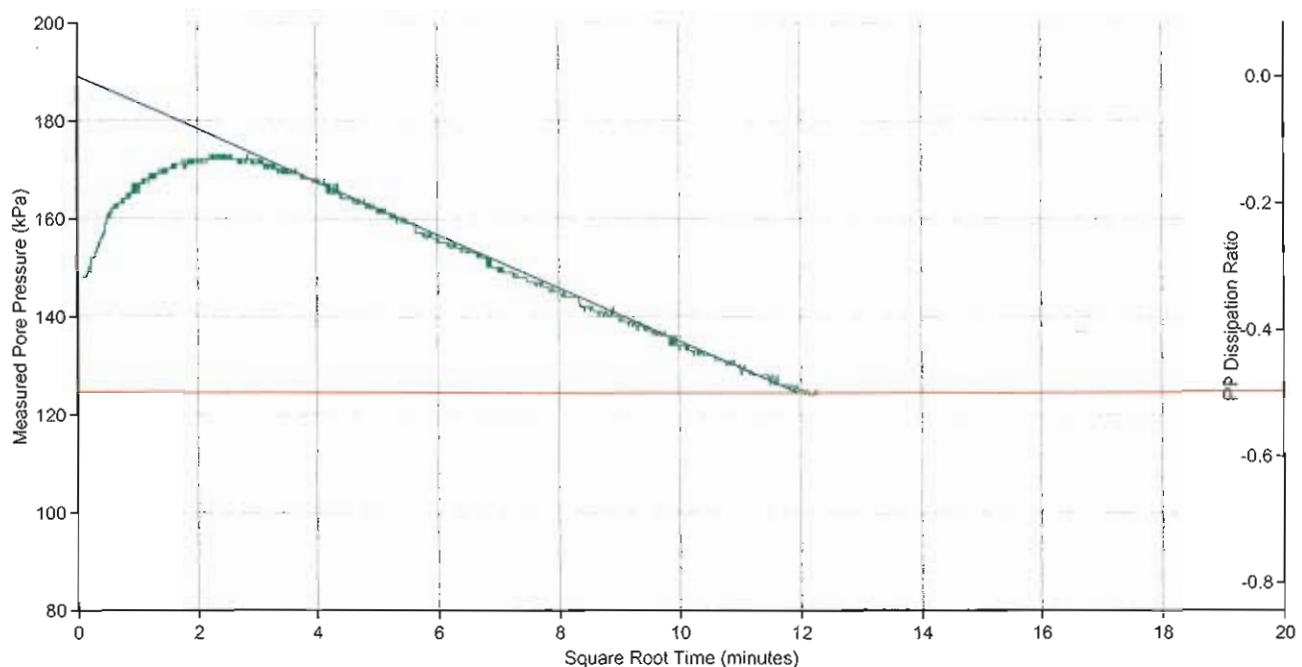
## REPORT ON CPT<sub>u</sub> DISSIPATION TEST

Client **MAIN ROADS - GATEWAY UPGRADE PROJECT TEAM**  
Project **GATEWAY UPGRADE**  
Job Ref.  
Location **E 9537.86 N 172843.36 SET DATUM**  
Chainage  
Sounding **CPTU131F**  
Test Date **23/06/2004**  
Remarks

Project No. **FM2055**  
Surface RL **1.630**  
Water Table **0.900**  
Start Depth **1.025**

Depth (m) **7.00**  
Start Pressure (kPa) **189**  
Dissipation (%) **50**  
Dissipation Pressure (kPa) **124**  
Time for Dissipation (min) **143**

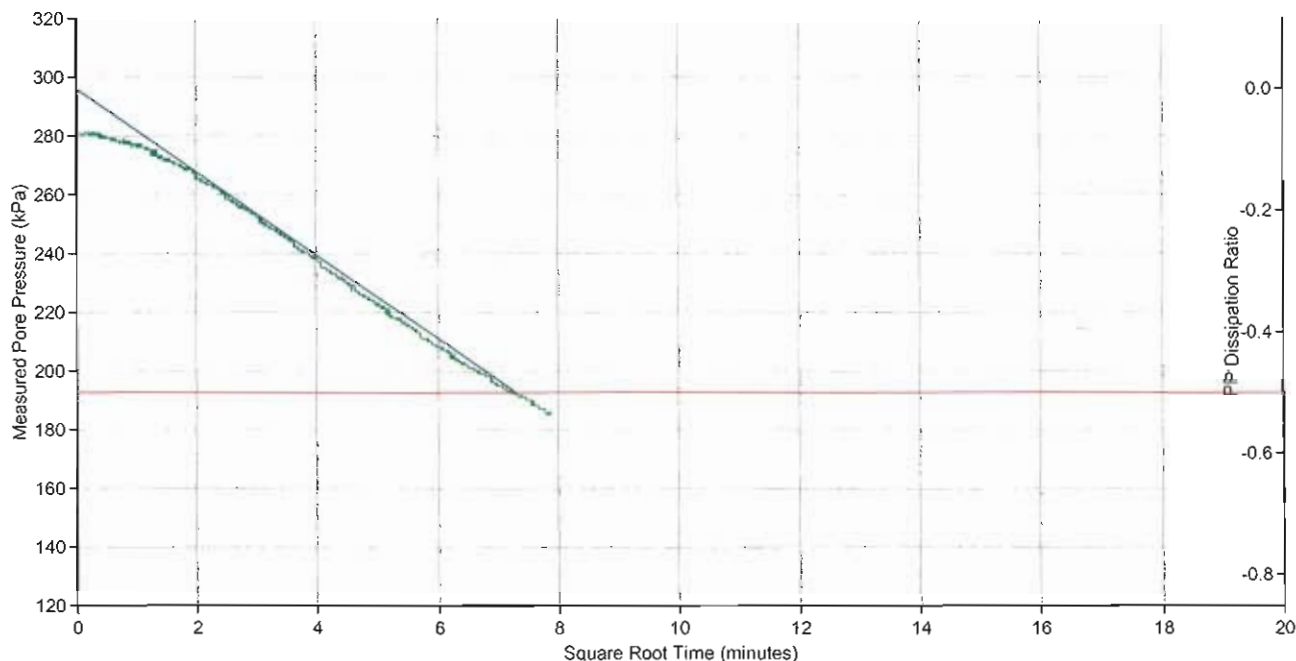
## REPORT ON CPT<sub>u</sub> DISSIPATION TEST

Client **MAIN ROADS - GATEWAY UPGRADE PROJECT TEAM**  
Project **GATEWAY UPGRADE**  
Job Ref.  
Location **E 9357.86 N 172843.36 SET DATUM**  
Chainage  
Sounding **CPTU131E**  
Test Date **10/06/2004**  
Remarks

Project No. **FM2055**  
Surface RL **1.630**  
Water Table **0.900**  
Start Depth **2.000**

Depth (m) **10.00**  
Start Pressure (kPa) **296**  
Dissipation (%) **50**  
Dissipation Pressure (kPa) **193**  
Time for Dissipation (min) **53.0**

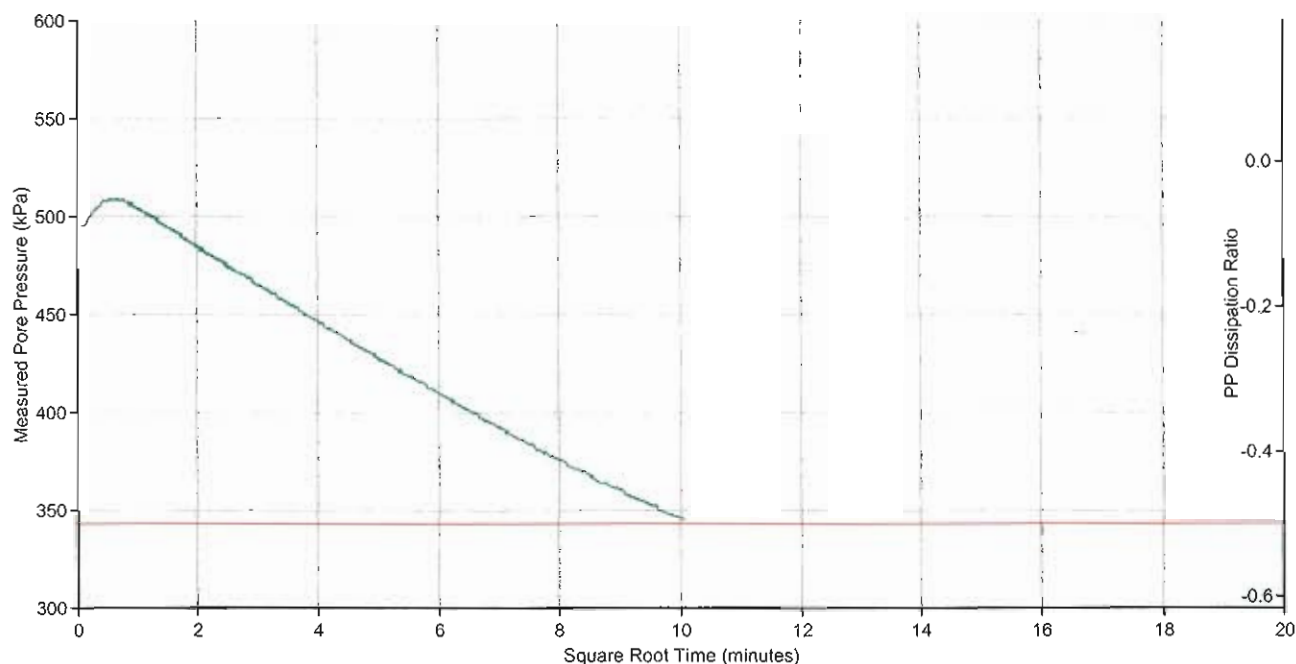
## REPORT ON CPT<sub>u</sub> DISSIPATION TEST

Client **MAIN ROADS - GATEWAY UPGRADE PROJECT TEAM**  
Project **GATEWAY UPGRADE**  
Job Ref.  
Location **E 9537.86 N 172843.36**  
Chainage  
Sounding **CPTU131G**  
Test Date **24/06/2004**  
Remarks

Project No. **FM2055**  
Surface RL **1.630**  
Water Table **0.900**  
Start Depth **7.000**

Depth (m) **16.99**  
Start Pressure (kPa) **528**  
Dissipation (%) **50**  
Dissipation Pressure (kPa) **343**  
Time for Dissipation (min) **102**

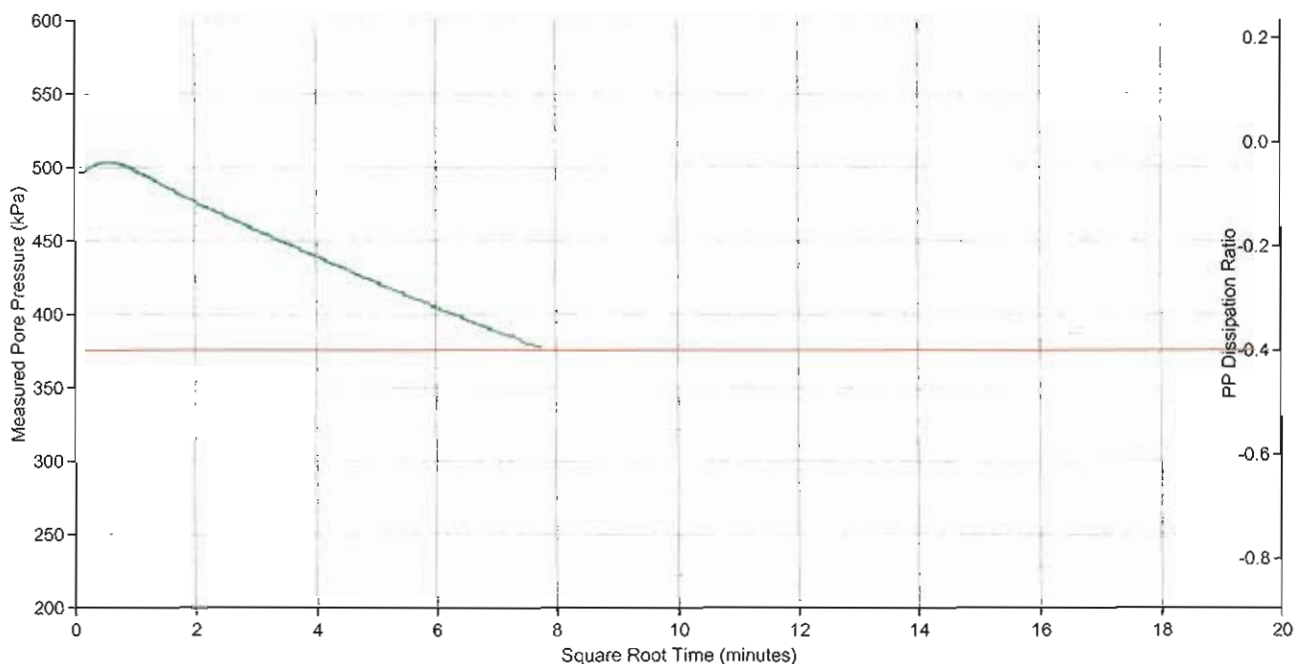
## REPORT ON CPT<sub>u</sub> DISSIPATION TEST

Client **MAIN ROADS - GATEWAY UPGRADE PROJECT TEAM**  
Project **GATEWAY UPGRADE**  
Job Ref.  
Location **E 9357.86 N 172843.36 SET DATUM**  
Chainage  
Sounding **CPTU131E**  
Test Date **10/06/2004**  
Remarks

Project No. **FM2055**  
Surface RL **1.630**  
Water Table **0.900**  
Start Depth **2.000**

Depth (m) **17.50**  
Start Pressure (kPa) **517**  
Dissipation (%) **40**  
Dissipation Pressure (kPa) **375**  
Time for Dissipation (min) **59.3**

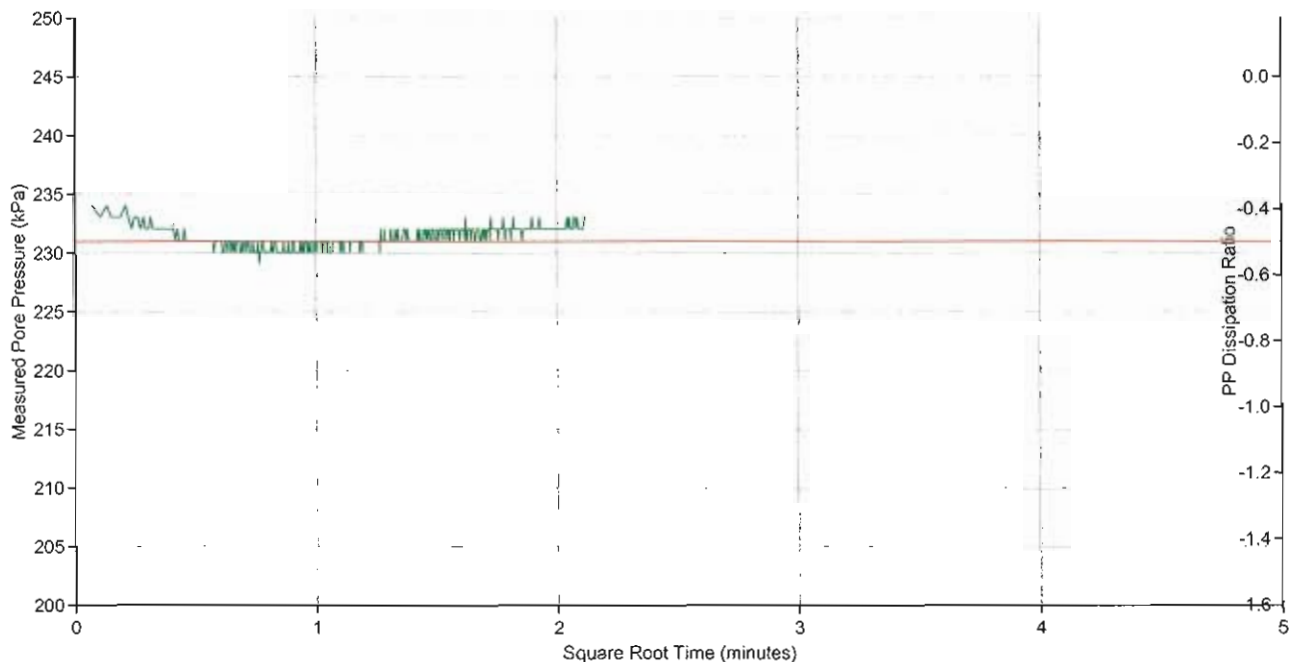
## REPORT ON CPT<sub>u</sub> DISSIPATION TEST

Client **MAIN ROADS - GATEWAY UPGRADE PROJECT TEAM**  
Project **GATEWAY UPGRADE**  
Job Ref.  
Location **E 9537.86 N 172843.36**  
Chainage  
Sounding **CPTU131G**  
Test Date **24/06/2004**  
Remarks

Project No. **FM2055**  
Surface RL **1.630**  
Water Table **0.900**  
Start Depth **7.000**

Depth (m) **23.02**  
Start Pressure (kPa) **245**  
Dissipation (%) **50**  
Dissipation Pressure (kPa) **231**  
Time for Dissipation (min) **0.3**
