BOREHOLE No BH15
SHEET 1 of 13
REFERENCE No H9564

ENGINEERING BOREHOLE

PROJECT GATEWAY UPGRADE PROJECT - GATEWAY BRIDGE DUPLICATION FOUNDATION INVESTIGATION
LOCATION PIER 7 - SOUTHERN FACE OF PILE CAP- DOWNSTREAM RIGHT HAND SIDE COORDINATES 10230.6 E; 167936.4 N
PROJECT No FG5388 SURFACE R.L. -2.70 DATE STARTED 11/04/05 DATUM SETP
JOB No DATUM AHD DATE COMPLETED 14/04/05 DRILLER CAIRNS DRILLING

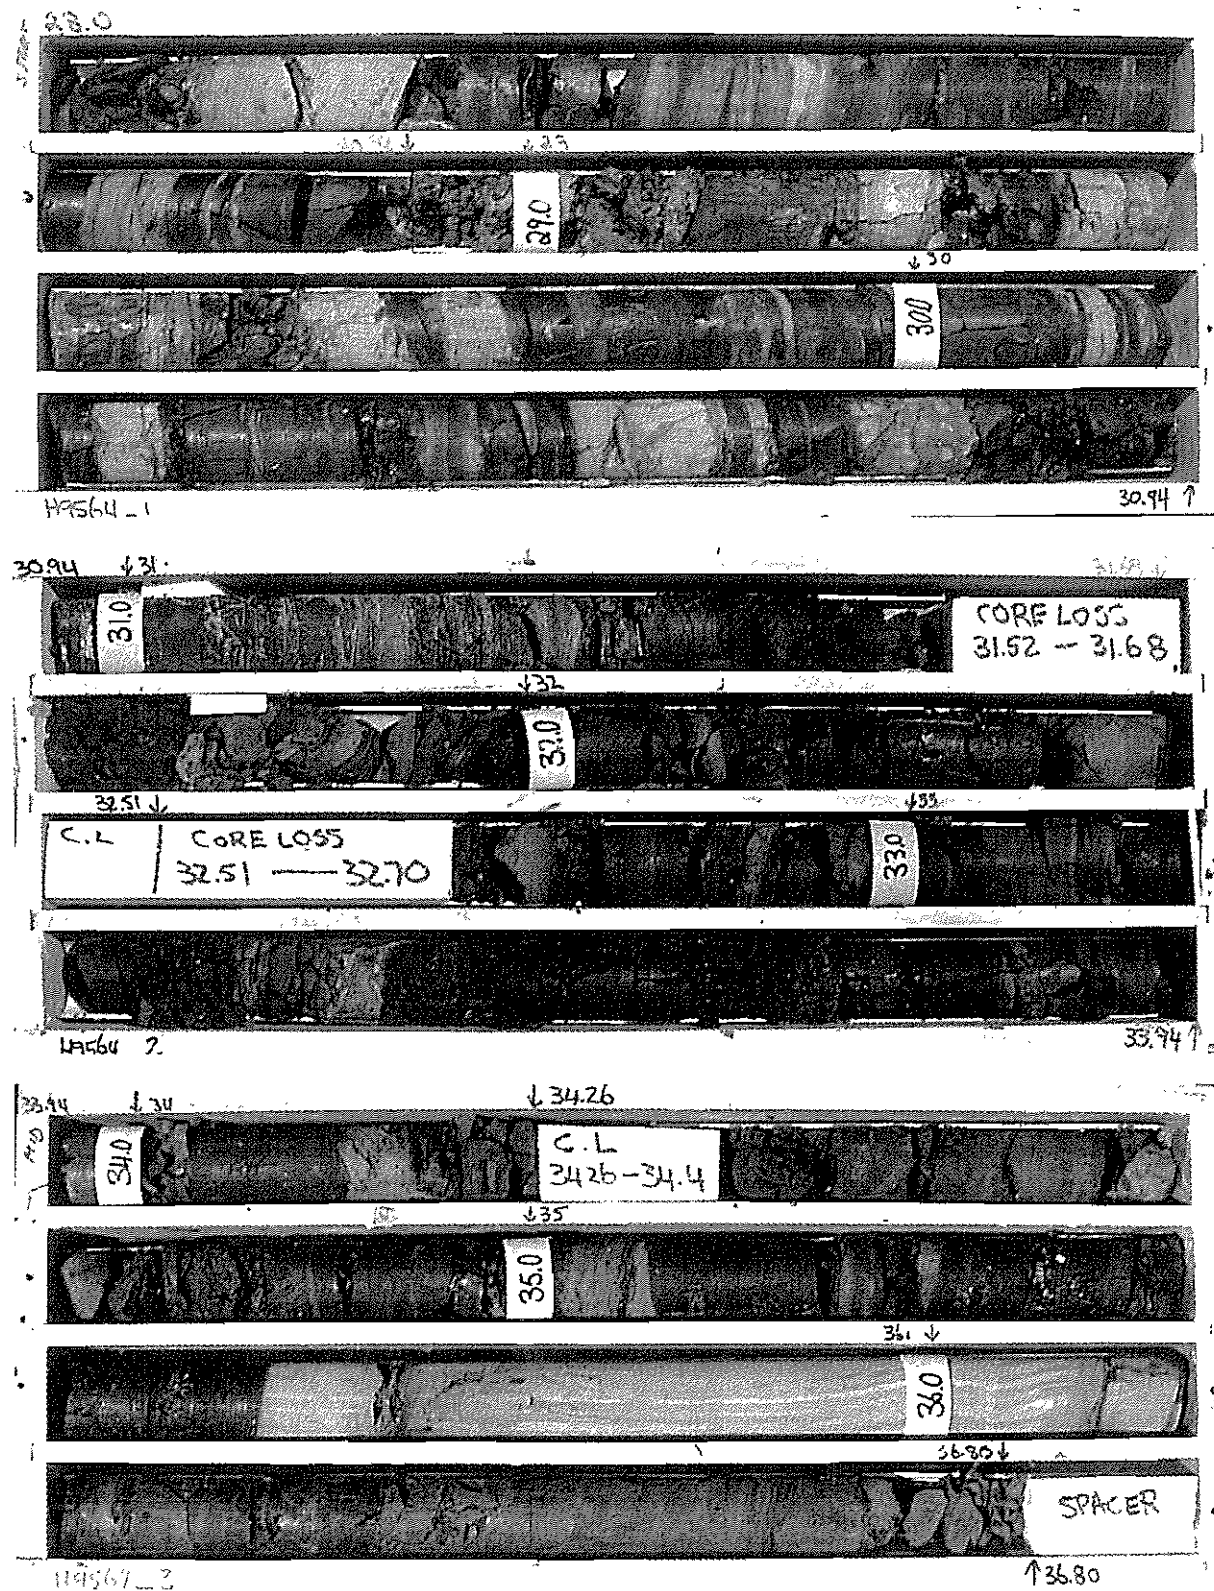
Project: **Gateway Upgrade Project - Gateway Bridge**

Borehole No: **BH 15**

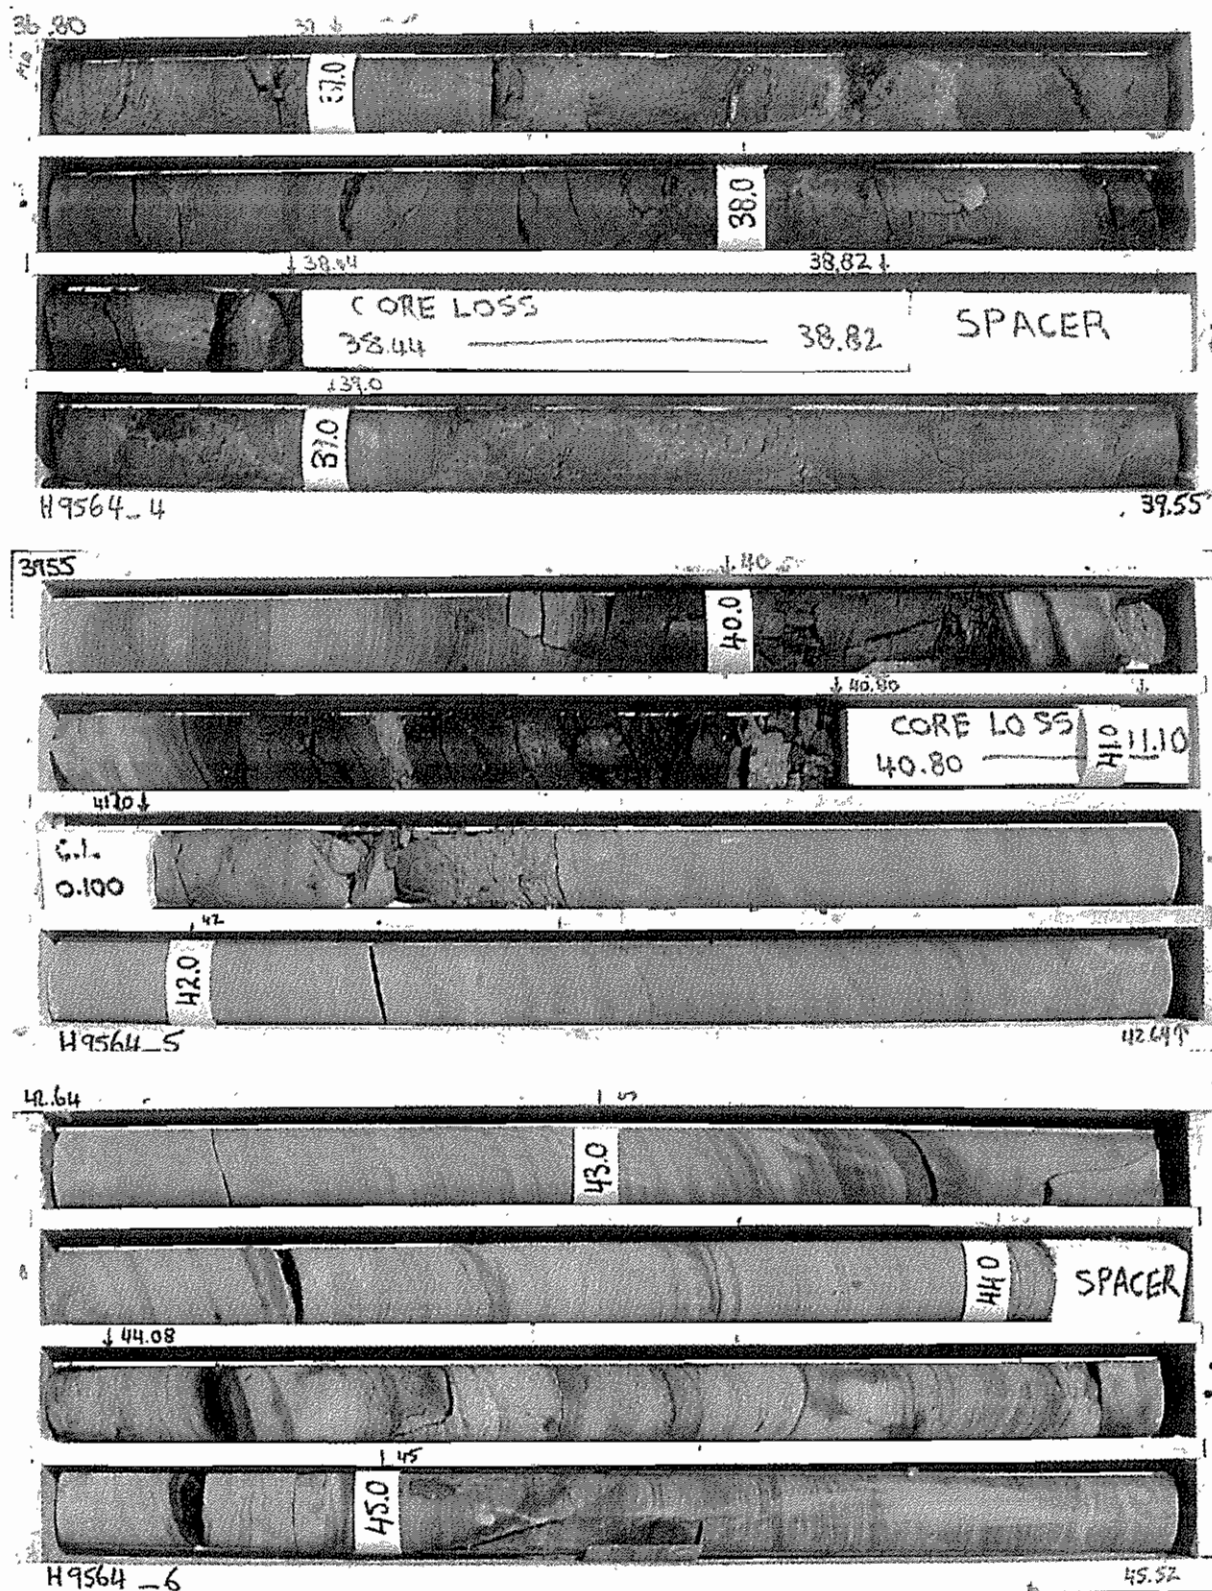
Project: **Gateway Upgrade Project - Gateway Bridge**
 Borehole No: **BH 15**
 Start Depth: 28.00m
 Finish Depth: 60.75m
 Project No: FG 5388
 H No: 9564
