### ENGINEERING BOREHOLE LOG

BOREHOLE No	BHABA
SHEET	_1_ of _3_
REFERENCE No	H9905

LO.	PROJECT HOUGHTON HIGHWAY BRIDGE DUPLICATION - HOUGHTON HIGHWAY UPGRADE PROJECT  LOCATION APPR 24m RIGHT,5M STH FROM EASTN PILE-STHN ABUTMT OF EXIST BRIDGE COORDINATES 38870.7 E; 51923.5 N  PROJECT No FG5423 SURFACE R.L. 1.59 PLUNGE DATE STARTED 22/05/06 GRID DATUM PROJECT DATUM										
JO	B No	<u> 165/</u>	122/35		HEIGHT DATUMAHD BEARING						
o DEPTH (m)	R.L. (m)	AUGER WASH BORING CORE DRILLING	RQD ()% CORE REC%	SAMPLE	MATERIAL DESCRIPTION	LITHOLOGY	USC WEATHERING	INTACT DEFECT SPACING (mm)	GRAPHIC LOG	ADDITIONAL DATA AND TEST RESULTS	SAMPLES
MRD_UB_V12.GLB_25/10/06	0.99	AUGE WASH CORE		A B C C F	FILL - SAND (Driller's record only.) Grey.  FILL - CLAYEY SILTY SAND Red mottled brown to red, moist, soft to firm.  Fine grained sand.  ESTUARINE SAND / SILTY SAND Dark grey, wet, very loose to mainly loose.  Slightly organic and high content of shell fragments in the upper area; mainly fine to medium grained sand; minor fraction of silt.  RESIDUAL SANDY SILTY CLAY / SILTY CLAY Mottled red to white, mainly moist to dry, very stiff, becoming stiff with depth.  Frequent lateritic and slightly concret

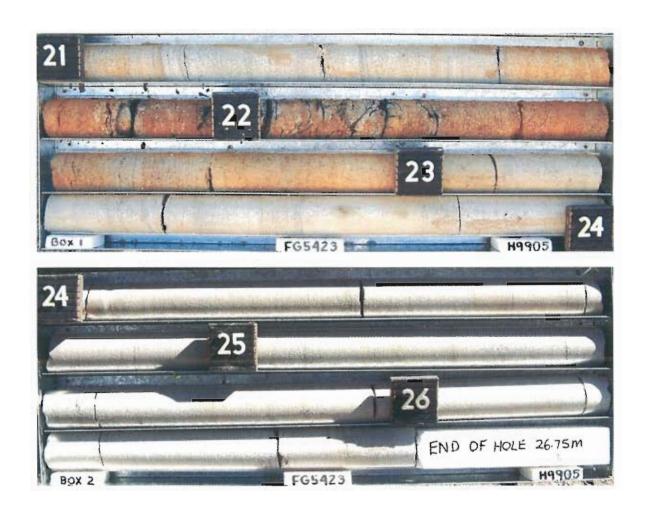
Borehole No: BH ABA

Start Depth: 21.00m Finish Depth: 26.75m Project No: FG5423 H No: 9905
