# ENGINEERING BOREHOLE LOG

## Project: Oakey Creek Bridge Texas Borehole No: BH 5 Start Depth: 4.10

# **Point Load Strength Index - Test Report**

Project: Oaky Creek Bridge Texas Project No: FG5573

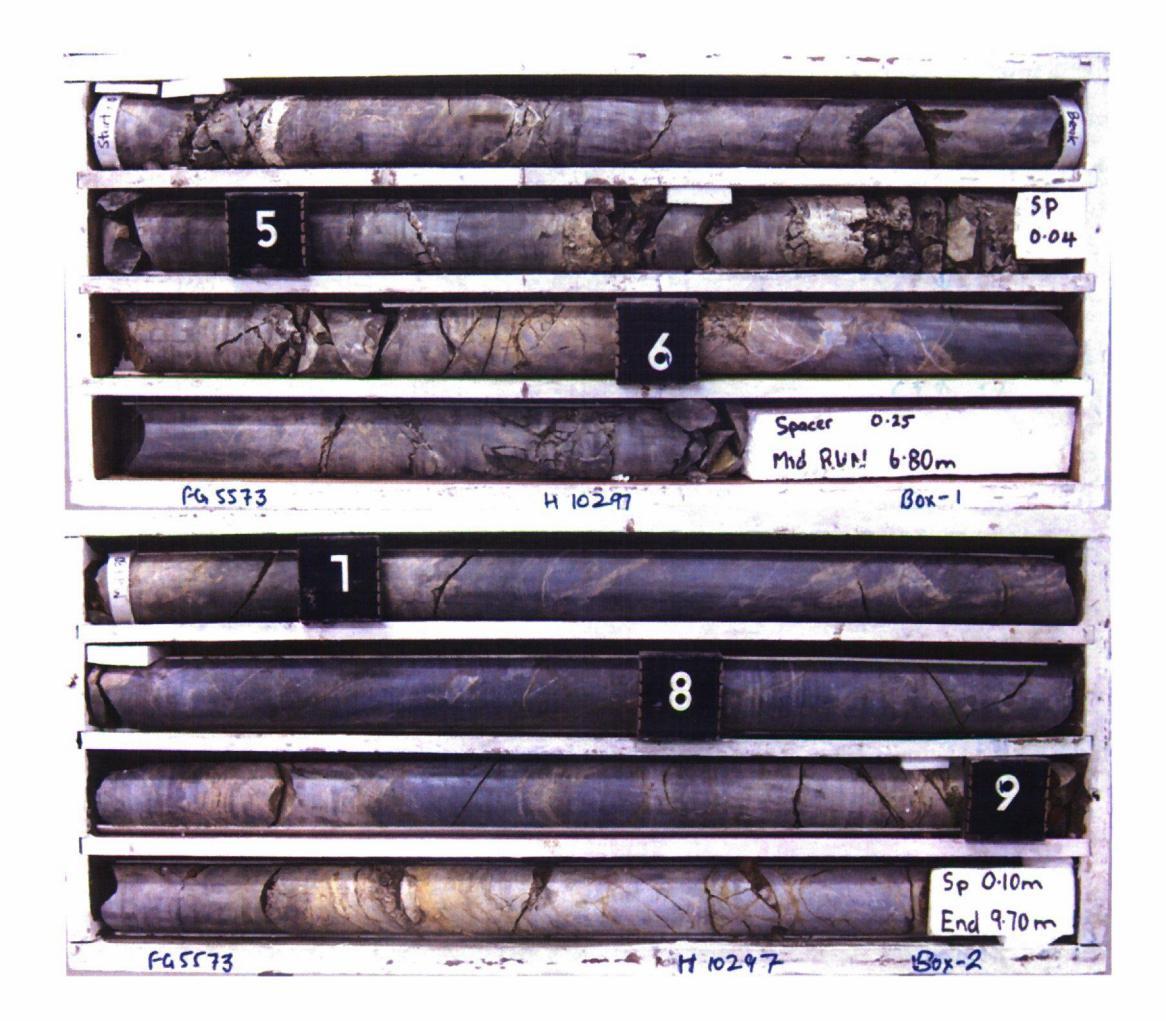
Start Depth:4.10Finish Depth:9.70Project No:FG5573H No:10297

Sample Number	Sample Location	Depth (m)	Test Type D,A,B,I*	ls (MPa)	ls50 (MPa)	Strength Descriptor*	Lithology
GS08/335.A	BH 5	4.80	D	1.6	1.6	н	Mudstone
GS08/335.B	BH 5	5.10	Α	1.74	1.74	н	Mudstone
GS08/335.C	BH 5	6.20	D	7.88	7.88	VH	Mudstone
GS08/335.D	BH 5	6.82	А	0.93	0.95	м	Mudstone
GS08/335.E	BH 5	7.40	D	4.36	4.33	VH	Mudstone
GS08/335.F	BH 5	8.70	D	1.58	1.58	H	Mudstone
GS08/335.G	BH 5	9.14	А	1.84	1.85	H	Mudstone
