ENGINEERING BORE LOG

PROJECT AIRPORT DRIVE ROUNDABOUT GRADE SEPARATION FOUNDATION INVESTIGATION

HOLE No. 28

LOCATION Chainage 22128.3, 9m right of control line.

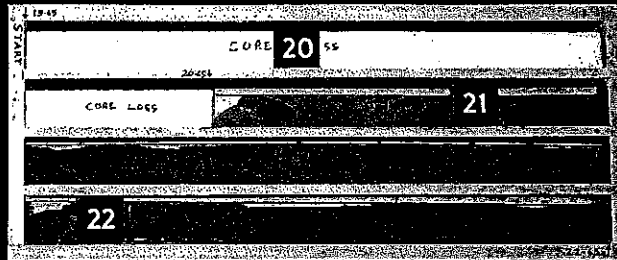
HOLE 28
H 6104

AIRPORT DRIVE ROUNDABOUT GRADE SEPARATION F.I

START
19.65M
