ENGINEERING BOREHOLE LOG

BOREHOLE No	BH1B
SHEET	1 of5
REFERENCE No	11597

CORE PHOTO LOG

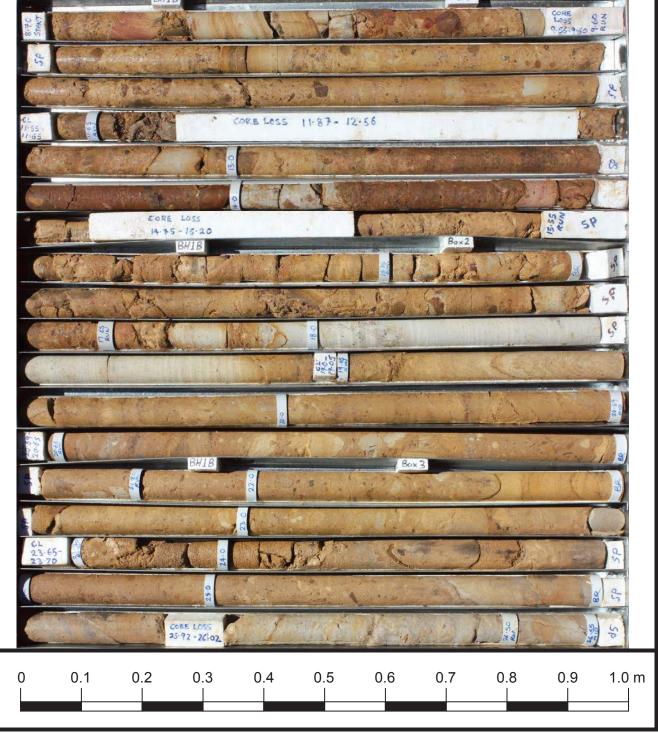
Project Name	Mt Whitestone: Slope Instability Investigation, Supp. Inclinometer Boreholes										
Project No.	FG6128	Date	23/6/14								
Borehole No.	BH1B	TMR H No.	H11597								
Location	Gatton-Clifton Rd	Start Depth (m)	8.70m								
Detail	LHS table drain	Finish Depth (m)	40.75m								
Chainage	Ch 15.308km	Prepared By	TAH								
Remarks		·

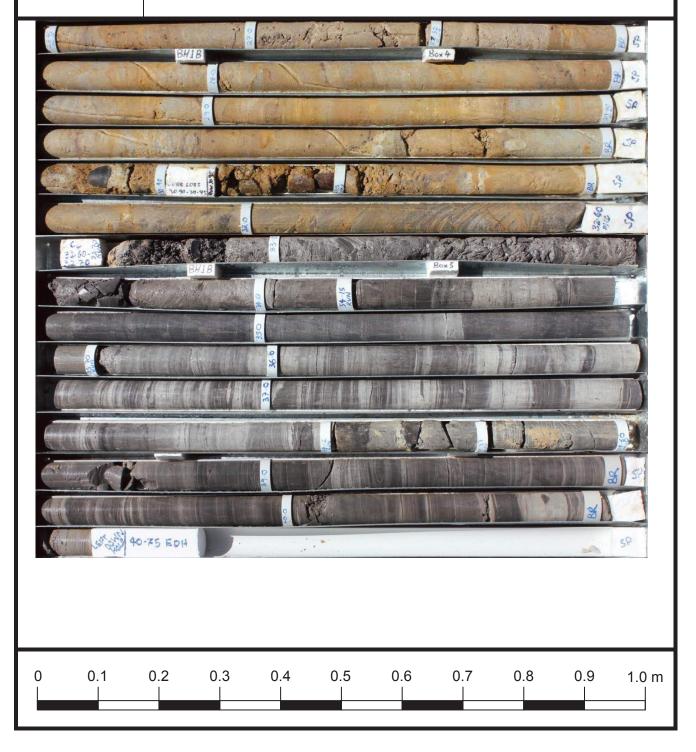
CORE PHOTO LOG

Project Name	Mt Whitestone: Slope Instability Investigation, Supp. Inclinometer Boreholes										
Project No.	FG6128	Date	23/6/14								
Borehole No.	BH1B	TMR H No.	H11597								
Location	Gatton-Clifton Rd	Start Depth (m)	8.70m								
Detail	LHS table drain	Finish Depth (m)	40.75m								
Chainage	Ch 15.308km	Prepared By	TAH								
Remarks
