ENGINEERING BOREHOLE LOG

BOREHOLE No BH C42
SHEET 1 of 2
REFERENCE No H11131

PROJECT Bruce Highway Upgrade (Cooroy to Curra) Section C
LOCATION Cut 10 COORDINATES 471559.5 E; 7094938.6 N
PROJECT No FG5799 SURFACE R.L. 82.00m PLUNGE _____ DATE STARTED 26/07/11 GRID DATUM MGA94
JOB No 232/10A/2 HEIGHT DATUM AHD BEARING _____ DATE COMPLETED 26/07/11 DRILLER Drillsure Pty Ltd

CORE PHOTO LOG - BH C42

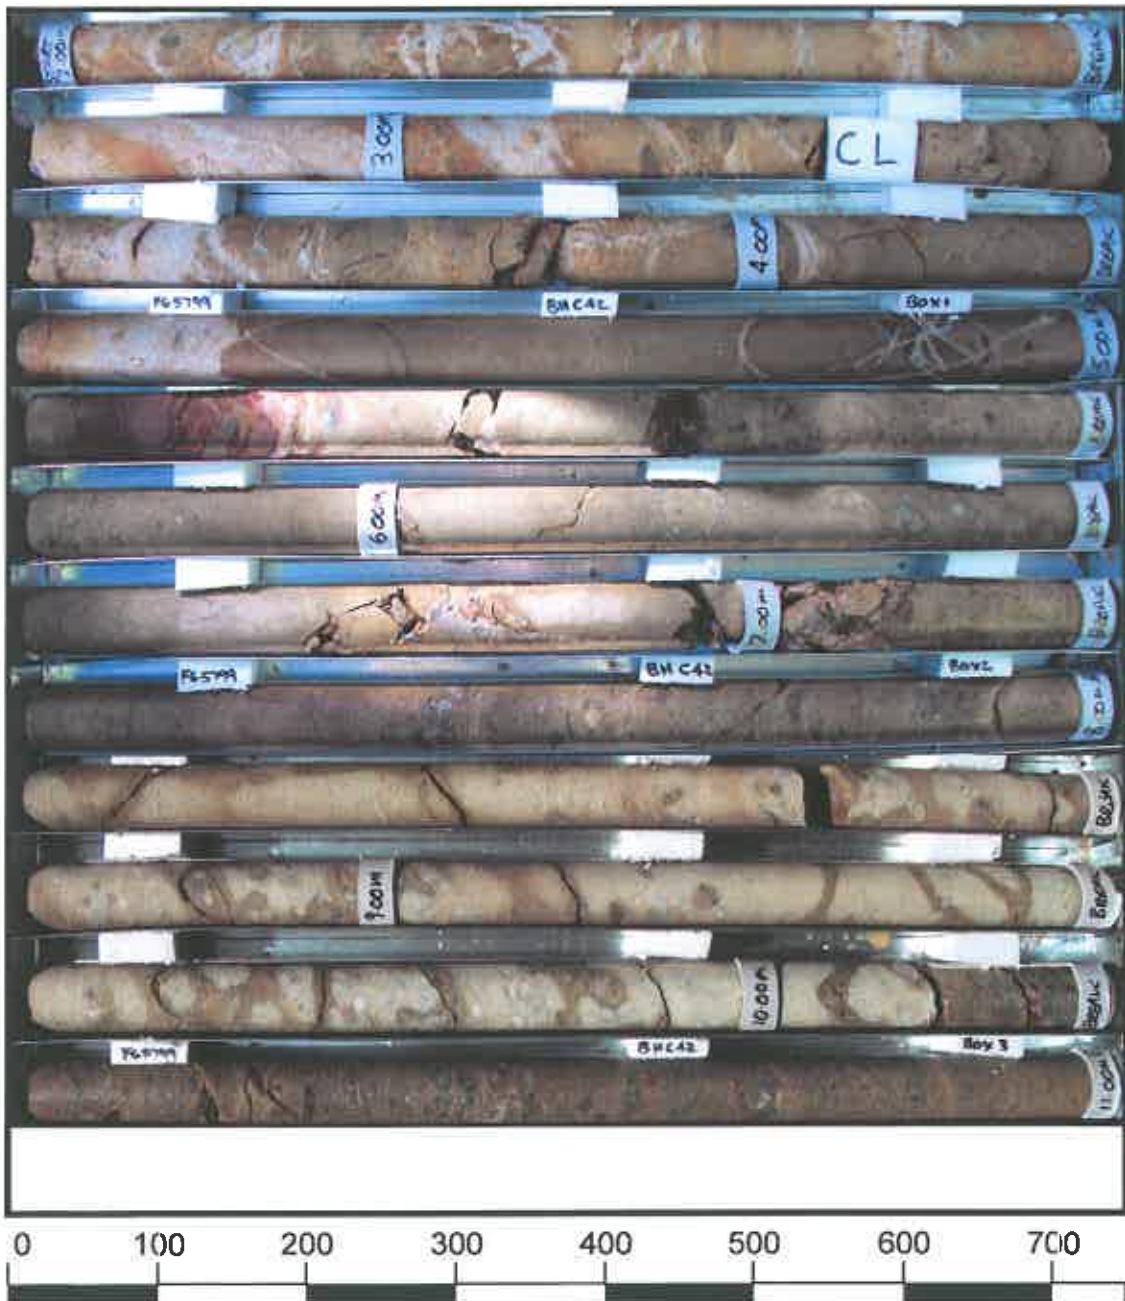
Project Name:	BRUCE HIGHWAY UPGRADE - SECTION C		
Project No.:	FG5799	Date:	08/09/2011
Details:	Cut 10	Start Depth (m):	2.00
Reference No.:	H11131	Finish Depth (m):	20.00

SCALE 1:5

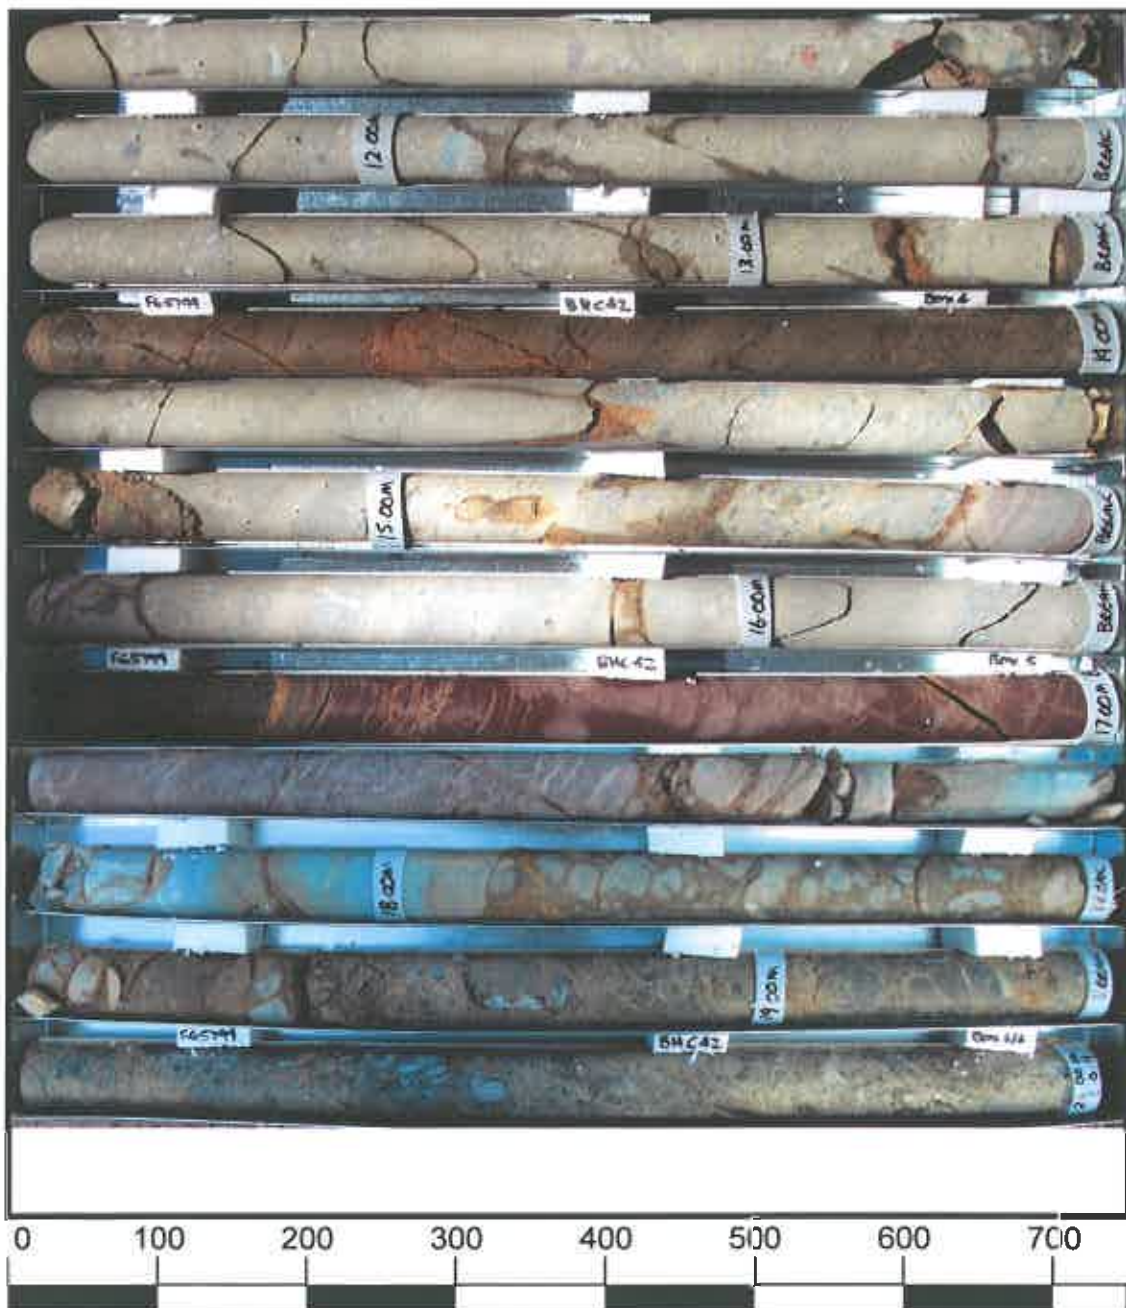
CORE PHOTO LOG - BH C42

Project Name:	BRUCE HIGHWAY UPGRADE - SECTION C		
Project No.:	FG5799	Date:	08/09/2011
Details:	Cut 10	Start Depth (m):	2.00
Reference No.:	H11131	Finish Depth (m):	20.00

SCALE 1:5
