## ENGINEERING BOREHOLE

BOREHOLE No BH128

PROJECT GATEWAY UPGRADE PROJECT GEOTECHNICAL INVESTIGATION - NORTHERN SECTION

LOCATION CONTROL LINE: MCWO - Ch. 831.8 - OFFSET 5.1R COORDINATES 9164.2 E; 173530.0 N

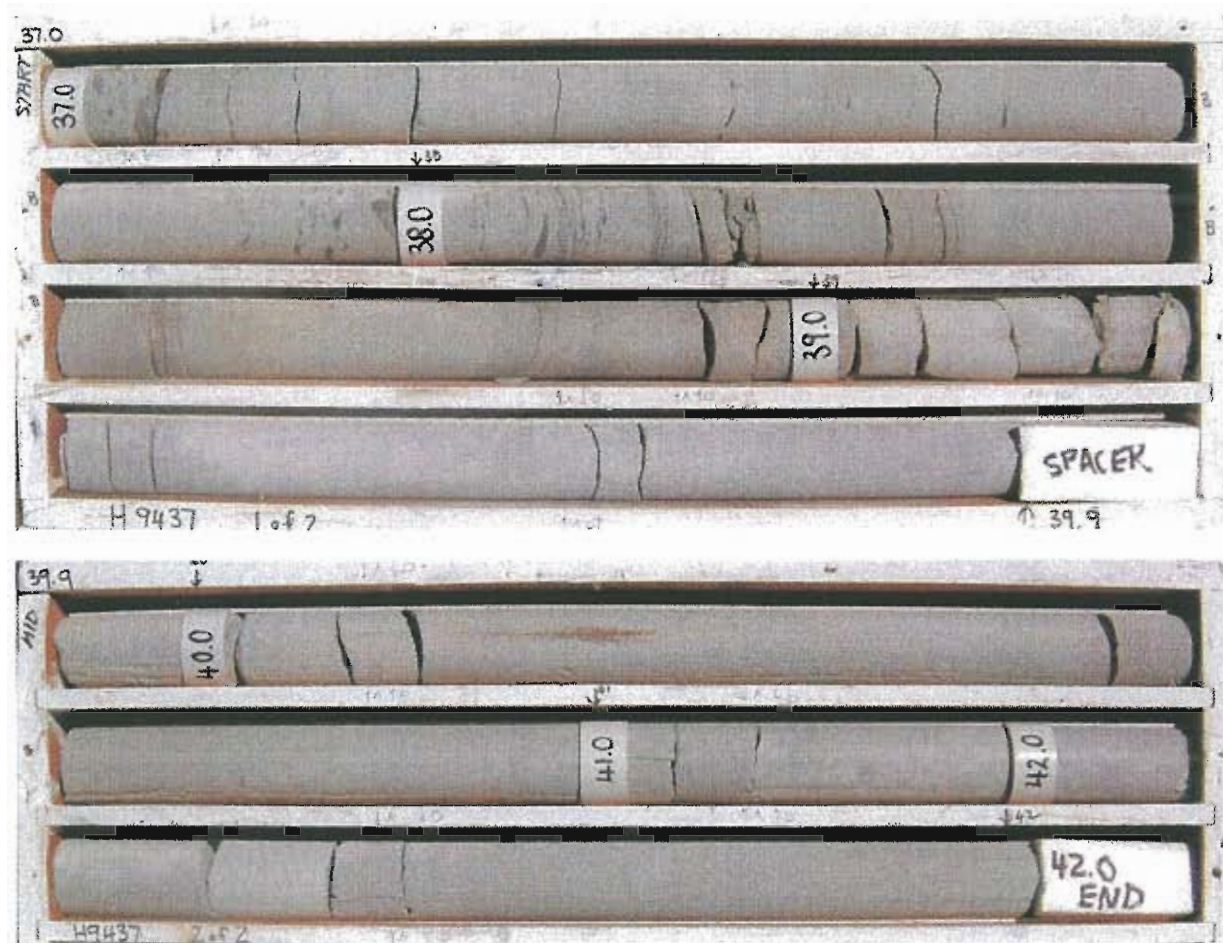
Borehole No: **BH 128**

Project: **Gateway Upgrade Project Geotechnical Investigation**

Start Depth: 37.0m

Finish Depth: 42.0m
