# ENGINEERING BOREHOLE

BOREHOLE No BH39

REFERENCE No H9752

PROJECT IPSWICH MOTORWAY / LOGAN MOTORWAY GEOTECHNICAL INVESTIGATION

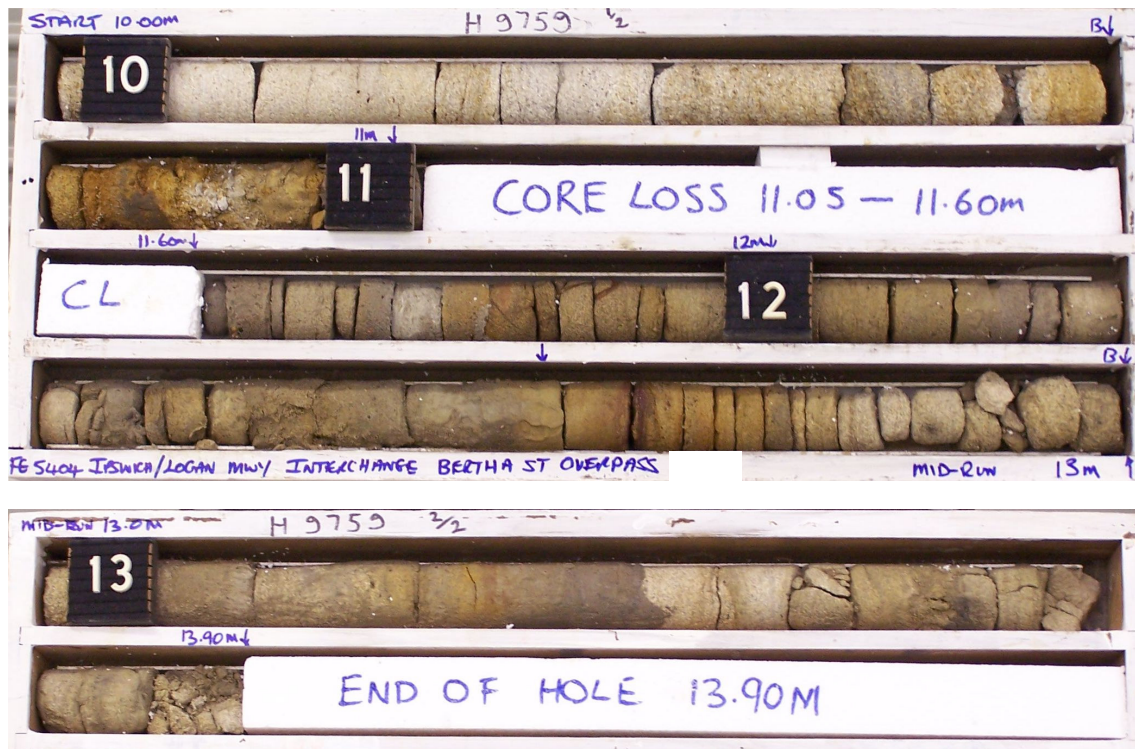
Project: **Ipswich Motorway / Logan Motorway Interchange**  
Borehole No: **BH39**  
Start Depth: 10.00m  
Finish Depth: 13.90m  
Project No: FG5404  
H No: 9759

DEPTH (m)	R.L. (m)	AUGER CASING WASH BORING CORE DRILLING	RQD ( ) %	CORE REC %	SAMPLE	MATERIAL DESCRIPTION	USC WEATHERING	INTACT STRENGTH					DEFECT SPACING (mm)				GRAPHIC LOG	ADDITIONAL DATA AND TEST RESULTS		SAMPLES TESTS
								EH	VH	H	M	J	VL	EL	20	60		200	600	
10	0.40					<b>SANDSTONE</b>  Grey, medium to coarse grained, massive. Upper medium to high strength.	SW											Is(50)=1.25 MPa Is(50)=1.08 MPa Is(50)=1.21 MPa Is(50)=1.00 MPa	x o x o	
	-0.36			(25)		Orange ironstained, medium to coarse grained, becoming finer with depth, poorly cemented, extremely low strength.	HW									Clayey band.				
11																				
				66 (17)		Becoming grey, fine to medium grained, clayey in parts.  Very low strength, some diametral erosion of the core has occurred during drilling.										Clayey band. Clayey band. Clayey band.				
12							HW										Clayey band.			
13																	Clayey band.

-3.50			100													Clayey band.			
14						Borehole terminated at 13.9m														
15																				
16																				
17																				
18																				
19																				
20
