ENGINEERING BOREHOLE LOG

BOREHOLE No BH41
SHEET 1 of 2
REFERENCE No H11038

PROJECT Moreton Bay Rail Link
LOCATION Fill 19, Ch. 11700 COORDINATES 507272.0 E; 6988569.9 N
PROJECT No FG5921 SURFACE R.L. 3.10m PLUNGE _____ DATE STARTED 23/5/11 GRID DATUM MGA94 Zone 56
JOB No 250/120/3 HEIGHT DATUM AHD BEARING _____ DATE COMPLETED 23/5/11 DRILLER R&D Drilling Pty Ltd

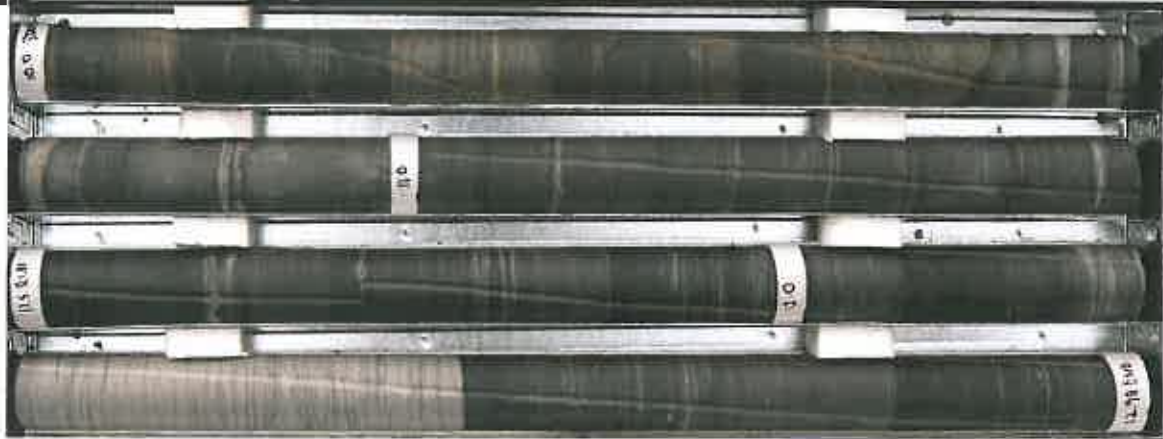
Project Name	Moreton Bay Rail Link (MBRL)		
Project No	FG5921	Date	23/05/2011
Borehole No	BH 41	TMR H No	
Location	On centre line	Start Depth (m)	10.00
Detail	Embankment	Finish Depth (m)	12.98
Chainage	11700	Submitted By	BW
Remarks
