ENGINEERING BOREHOLE LOG

BOREHOLE No __BH_C11__

REFERENCE No __H11105__

PROJECT		Bruce Highway Upgrade (Cogrey to Curra) Section C											
		<u>Cut 4</u>					COORDINATES 472887.4 E; 7089840.1 N					0.1 N	
				SURFACE R.L. 99.00m PLUNGE							D DATUM <u>MGA94</u>	-	
JOB	No	232/1	232/10A/2		HEIGHT DATUM _AHD BEARING _		DATE COMPLETED _06/08/11_				DRILLER <u>Drillsure Pts</u>	Ltd	
o DEPTH (m)	R.L. (m) 99.00	AUGER CASING WASH BORING CORE DRILLING	RQD ()% CORE REC%	SAMPLE	MATERIAL DESCRIPTION	LITHOLOGY	USC	INTACT STRENGTH	DEFECT SPACING (mm)	GRAPHIC LOG		DITIONAL DATA AND EST RESULTS	SAMPLES

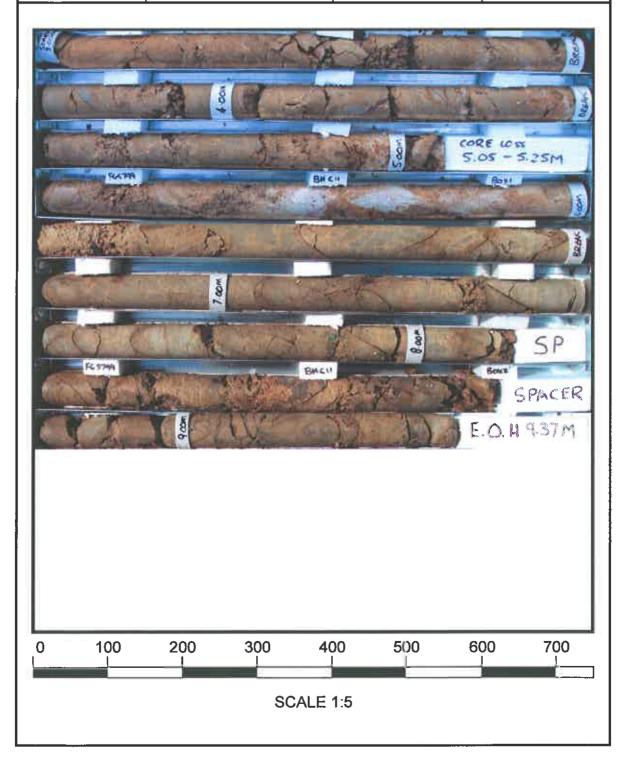
CORE PHOTO LOG - BH C11

•					
Project Name:	BRUCE HIGHWAY UPGRADE - SECTION C						
Project No.:	FG5799	Date:	06/09/2011				
Details:	Cut 4	Start Depth (m):	3.00				
Reference No.:	H11105	Finish Depth (m):	9.37
