ENGINEERING BOREHOLE

BOREHOLE No **BH30**

PROJECT **GATEWAY BRIDGE DUPLICATION FOUNDATION INVESTIGATION - GATEWAY UPGRADE PROJECT**

LOCATION **PIER 18 - DOWN STREAM END** COORDINATES **9825.4 E, 168723.5 N**

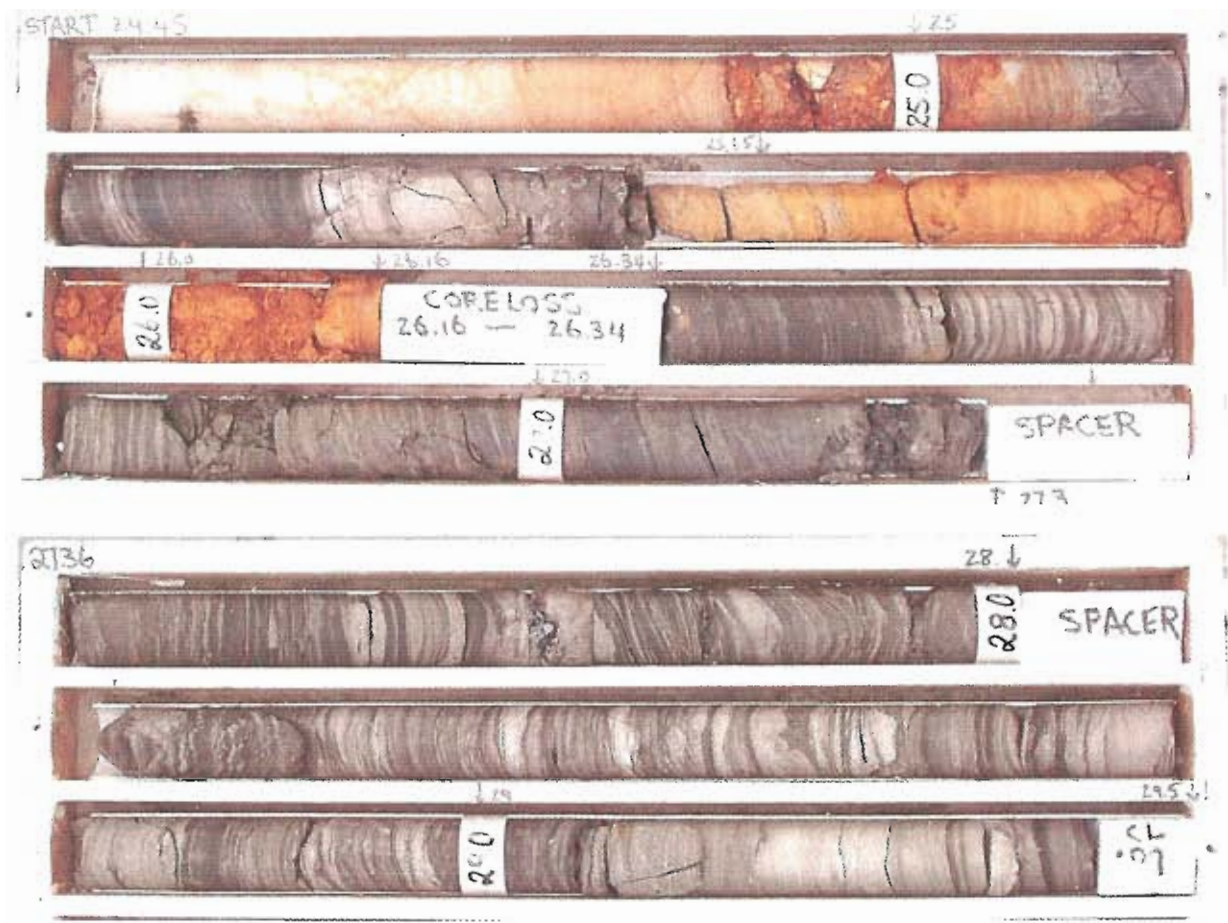
Borehole No: **BH 30**

Project: **Gateway Bridge Duplication Investigation**

Start Depth: 24.45m

Finish Depth: 29.50m

27	-22.60		100 (47)						MW						
28	-23.41		74 (60)			SW : Pale grey to dark grey, thinly laminated and bedded, low to mainly medium strength rock becoming high below 28.0m. Defects - Frequent drilling induced lamination partings <30° (5-10/m). - Joints - 45° (1-2/m). - Joints - 65° (1-2/m).			SW				Sheared and healed zone Is(50)=0.34 MPa Is(50)=0.42 MPa	x o	
29			100 (61)										Is(50)=0.82 MPa Is(50)=1.20 MPa	x o	
30	-26.57		100			Becoming predominantly sandstone with depth.									
						Borehole terminated at 29.5m
