ENGINEERING BOREHOLE LOG

BOREHOLE No BH01
SHEET 1 of 3
REFERENCE No H11011

PROJECT Moreton Bay Rail Link
LOCATION Yebri Creek Rail Bridge, Ch.800 COORDINATES 498379.4 E; 6984285.8 N
PROJECT No FG5921 SURFACE R.L. 3.64m PLUNGE DATE STARTED 6/6/11 GRID DATUM MGA94 Zone 56
JOB No 250/120/3 HEIGHT DATUM AHD BEARING DATE COMPLETED 6/6/11 DRILLER R&D Drilling Pty Ltd

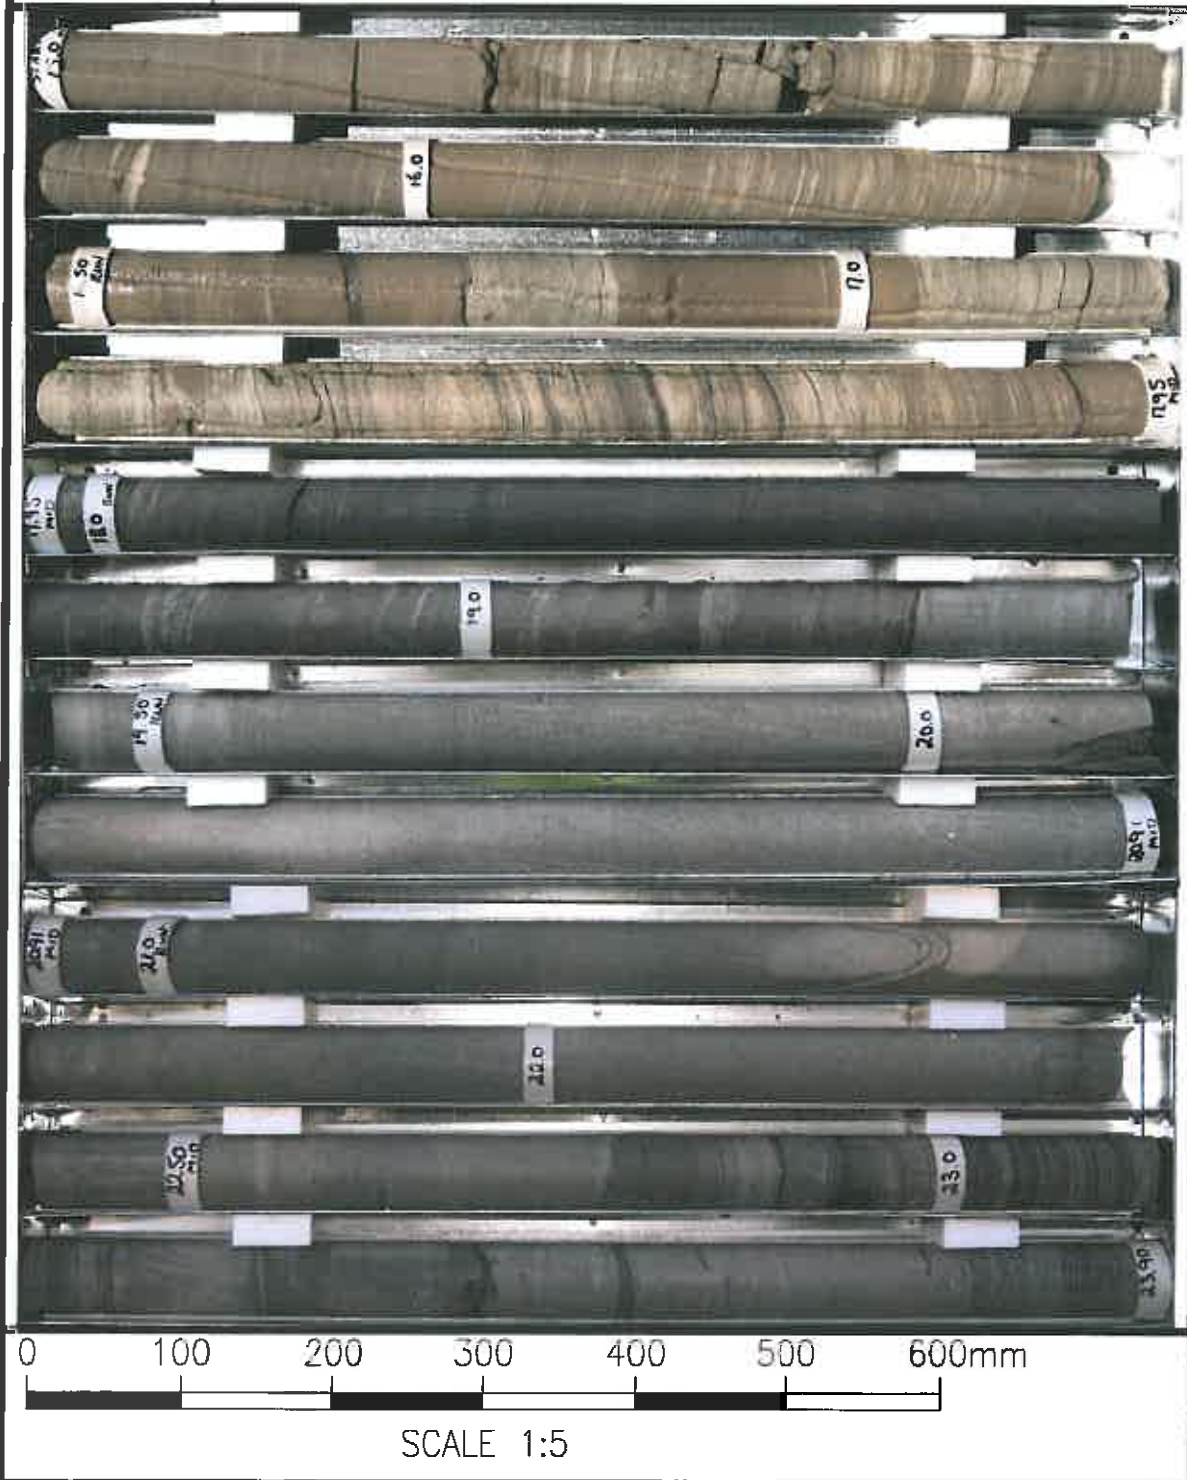
Project Name	Moreton Bay Rail Link (MBRL)		
Project No	FG5921	Date	06/06/11
Borehole No	BH 1	TMR H No	11011
Location	Yebri Creek Rail Bridge	Start Depth (m)	15.00
Detail	Structure	Finish Depth (m)	23.90
Chainage	795 Approx	Submitted By	BW
Remarks
