ENGINEERING BOREHOLE LOG

BOREHOLE No **BH118**
SHEET **1** of **4**
REFERENCE No **12064**

PROJECT Mackay Ring Road Geotechnical Investigation - Stage 1
LOCATION Peak Downs Hwy Overpass Pier 2; CH: 5612m; COORDINATES 720972.9 E; 7657966.6 N
PROJECT No FG6184 SURFACE R.L. 12.86m PLUNGE _____ DATE STARTED 24/9/14 GRID DATUM GDA 94 /MGA Zone 55
JOB No _____ HEIGHT DATUM AHD BEARING _____ DATE COMPLETED 1/10/14 DRILLER Saxon Drilling

CORE PHOTO LOG

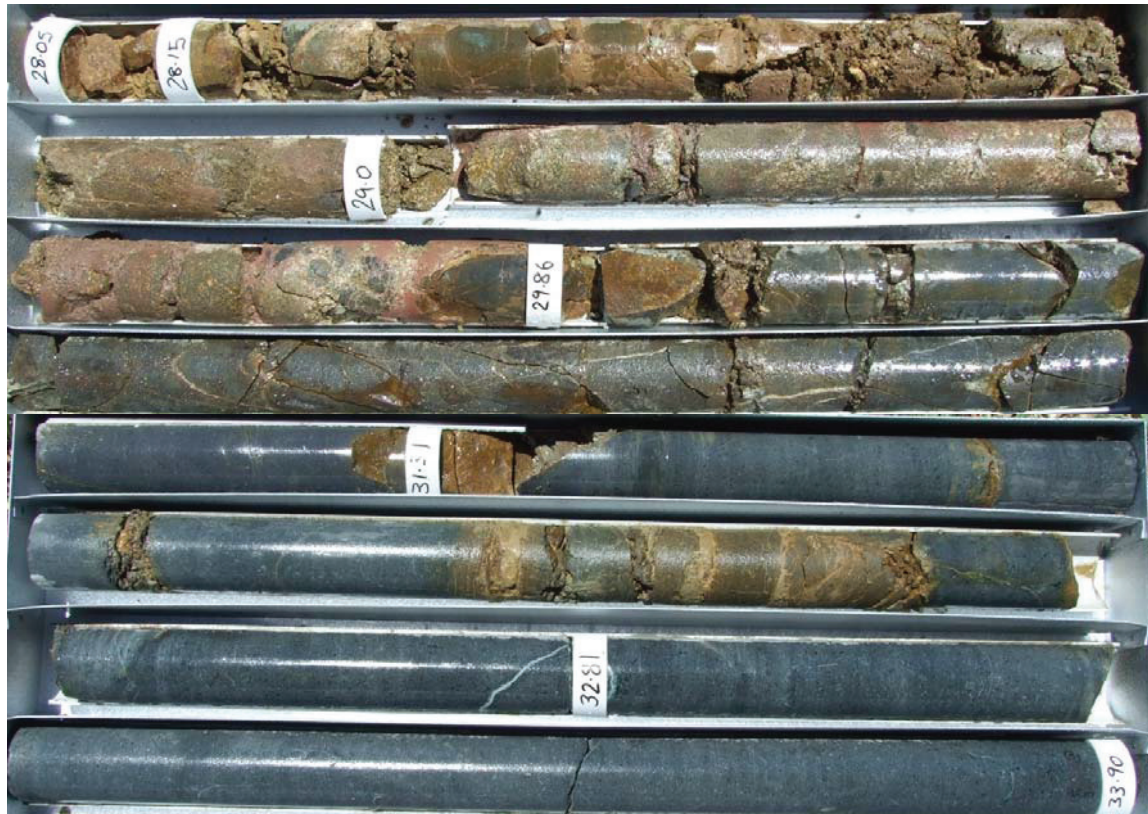
| DEPTH (m) | R.L. (m) | AUGER WASH BORING CORE DRILLING | RQD () % | CORE REC % | SAMPLE | MATERIAL DESCRIPTION | LITHOLOGY | USC WEATHERING | INTACT STRENGTH | DEFECT SPACING (mm) | GRAPHIC LOG | ADDITIONAL DATA AND TEST RESULTS | SAMPLES TESTS |
|---|---|---|---|---|---|--|---|---|---|---|---|---|---|
| 30 | -17.00 | | | | | GRANODIORITE (Kgwu) MW: Brown and grey, medium to coarse grained, medium strength. Defects: - Js; 0°-30° (10/m); Pl/Sm, OP, Cly Vr; - Js; 60°-70° (1/m); Pl/Sm, OP, Cly Vr; | | | | | | 29.86m: Dolerite contact at 60°; Pl. | |

| DEPTH (m) | R.L. (m) | AUGER WASH BORING CORE DRILLING | RQD () % | CORE REC % | SAMPLE | MATERIAL DESCRIPTION | LITHOLOGY | USC | WEATHERING | INTACT STRENGTH | DEFECT SPACING (mm) | GRAPHIC LOG | ADDITIONAL DATA AND TEST RESULTS | SAMPLES TESTS |
|---|---|---|---|---|---|---|---|---|---|---|---|---|---|---|
| 30 | -17.14 | | | | | <<ListBuildSepTrim(| | | | | | | Is(50) = 3.08MPa; # | D (30.00m) |
| 31 | | | | 100 (77) | | | | | | | | | UCS=80.3MPa Is(50) = 7.23MPa Is(50) = 3.55MPa | D (31.75m) A (31.78m) |
| 32 | | | | | | | | | SW | | | | 32.07m: Clay seam, 5°, 10mm. 32.20m: Clay seam, 10°, 10mm. 32.25m: Clay seam, 10°, 5mm. | |
| 33 | | | | 100 (100) | | | | | | | | | Is(50) = 5.44MPa Is(50) = 8.10MPa | A (33.17m) D (33.24m) |
| 34 | -21.14 | | | 100 | | Borehole terminated at 34m . | | | | | | | | |
