ENGINEERING BOREHOLE LOG

BOREHOLE No **BH133**
SHEET **1** of **4**
REFERENCE No **12078**

PROJECT Mackay Ring Road Geotechnical Investigation - Stage 1
LOCATION Peak Downs Hwy Overpass Pier 1; CH: 5599m; COORDINATES 720977.7 E; 7657952.6 N
PROJECT No FG6184 SURFACE R.L. 12.44m PLUNGE _____ DATE STARTED 4/10/14 GRID DATUM GDA 94 /MGA Zone 55
JOB No _____ HEIGHT DATUM AHD BEARING _____ DATE COMPLETED 6/10/14 DRILLER Saxon Drilling

CORE PHOTO LOG

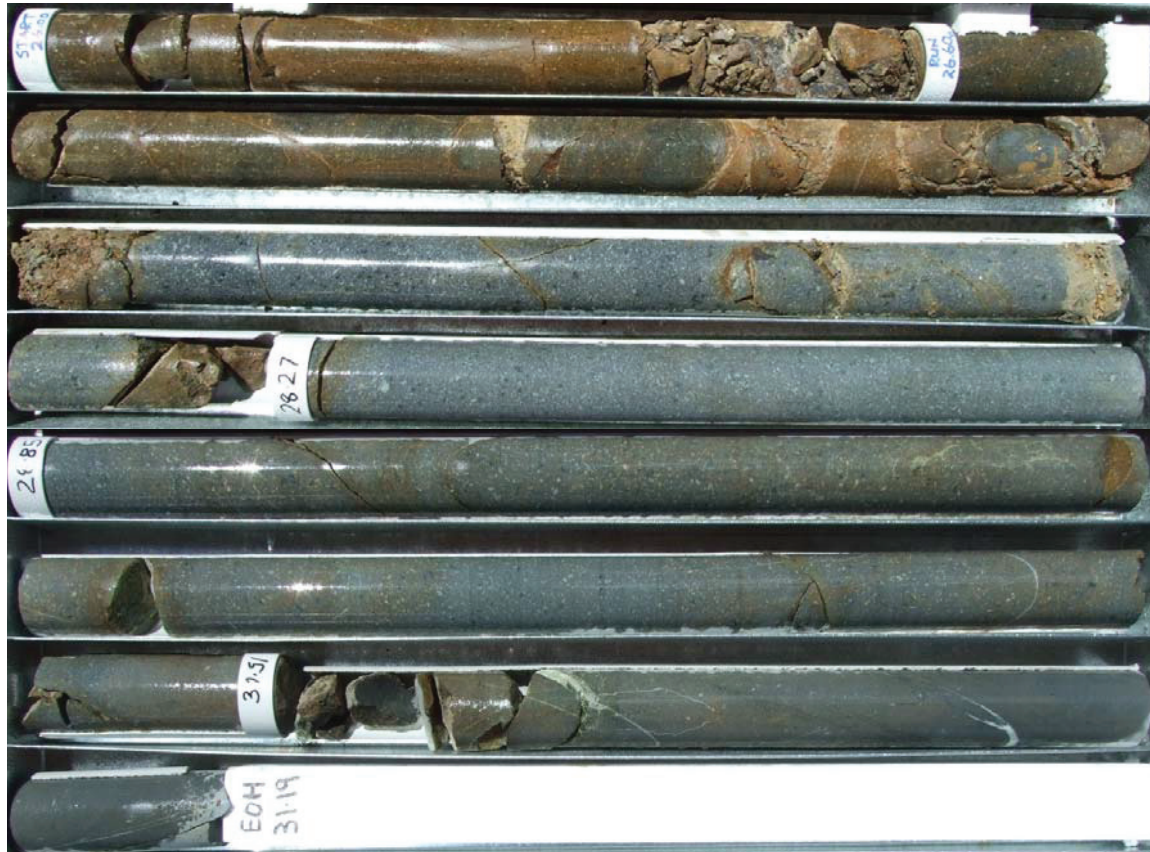
Project Name	Mackay – Ring Road		
Project No	FG6184	Date	06/10/14
Borehole No	BH133	TMR H No	12078
Location	Peak Downs Hwy Overpass	Start Depth (m)	26.0
Detail	Pier 1	Finish Depth (m)	31.19
Chainage	5599m	Submitted By	M.Ensor
Remarks

SCALE 1:5

27	-15.09											26.42m-26.60m: HFZ; Is(50) = 1.62MPa; #	D (26.70m)
28	-15.09					MICRODIORITE (Kgwu) SW: Grey, fine to medium grained, massive, very high strength. Defects: - Js; 0°-30° (2/m); Pl/Ro, TI;	SW					27.08m: Clay seam, 10°, 10mm. 27.42m-27.55m: HW zone Is(50) = 9.87MPa Is(50) = 7.49MPa 28.20m: Clay seam, 5°, 20mm. Is(50) = 10.54MPa Is(50) = 4.35MPa UCS=88.5MPa	A (27.85m) D (27.90m) A (28.63m) D (28.68m)
29												Is(50) = 5.73MPa; #	D (29.60m)
